International Conference on Dam Safety, 2023

A CASE STUDY ON REHABILITATION OF SARDAR SAROVAR DAM WITH SIKA SYSTEM

REHABILITATION OF SARDAR SAROVAR DAM

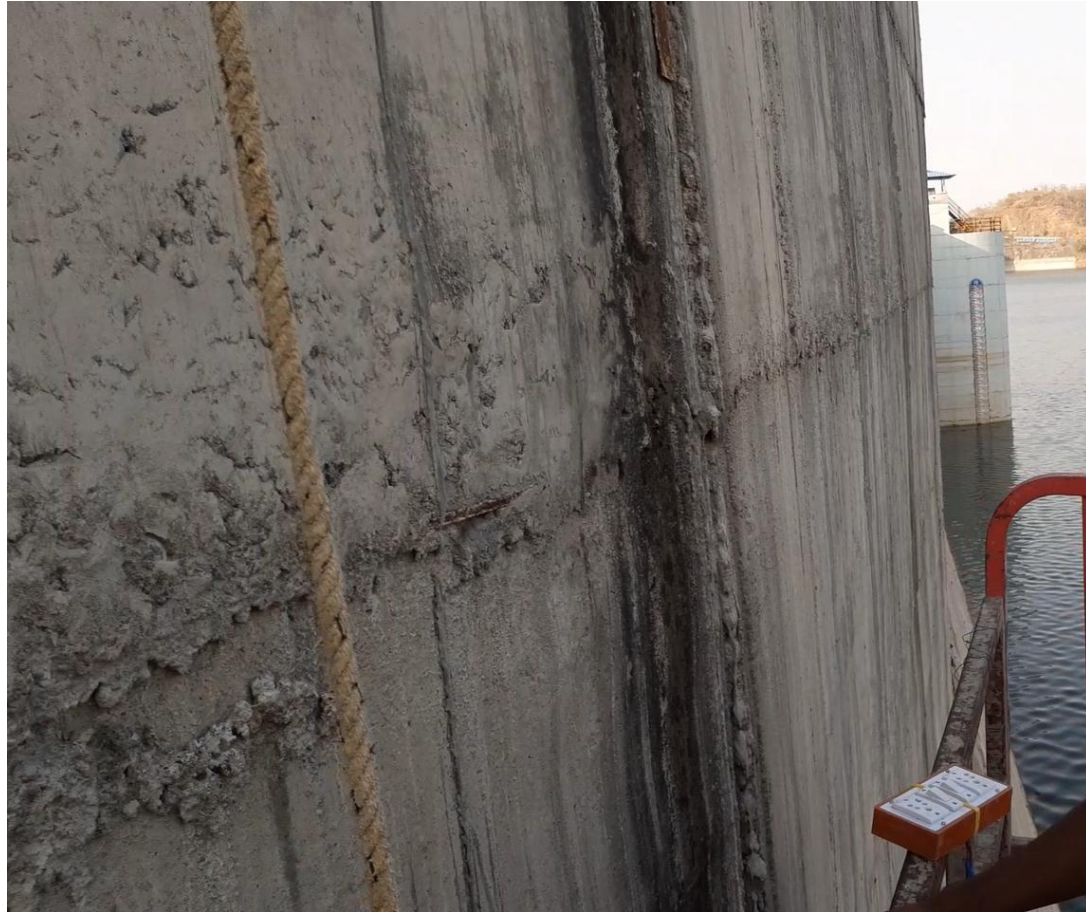
- **Honeycombed Area**
- **Leakage in Dam Gallery**

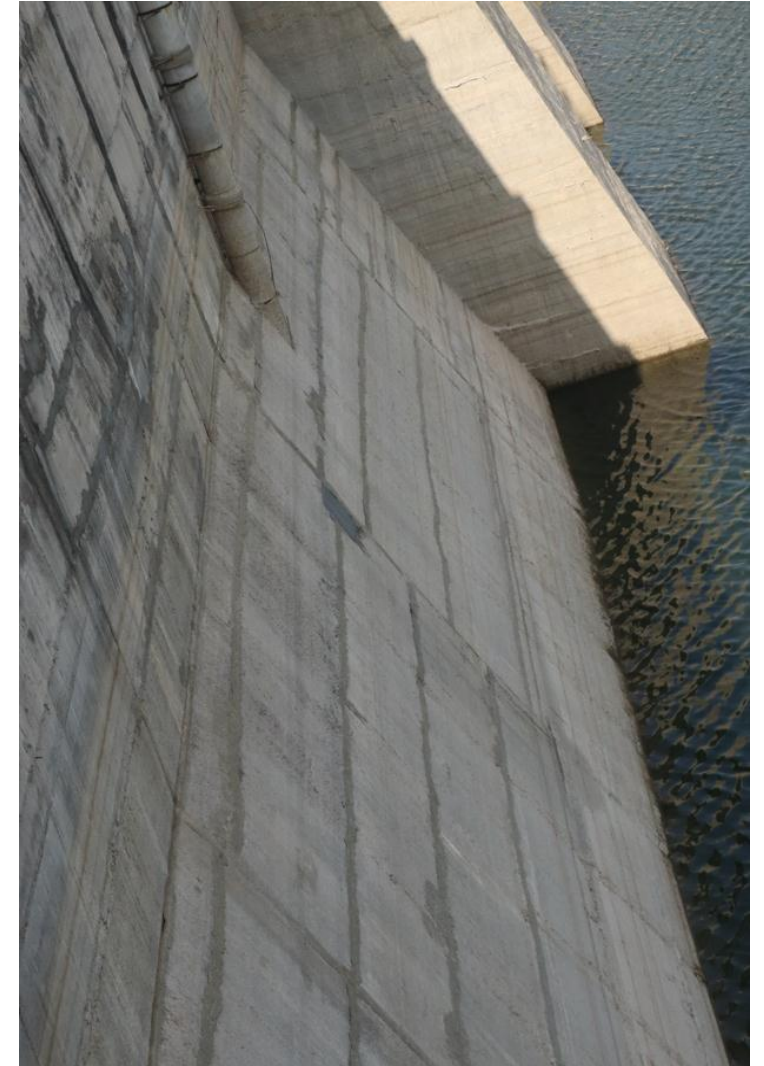
- **Horizontal Lift Joints**
- **Vertical Block Joint**
- **Leakage from Upstream face**
