International Conference on Dam Safety, 2023

**CURTAIN GROUTING & CUT-OFF TRENCH ALONG U/S RIGHT
BANK OF JOSHIYARA BARRAGE OF MANERI BHALI, STAGE-II
HEP-304 MW, TO PREVENT WATER LOGGING IN GYANSU
VILLAGE AREA IN DISTT-UTTARKASHI (UTTARAKHAND)
EXECUTED UNDER DRIP PHASE-II: A CASE STUDY**

UJVN LTD, DEHRADUN (UTTARAKHAND)

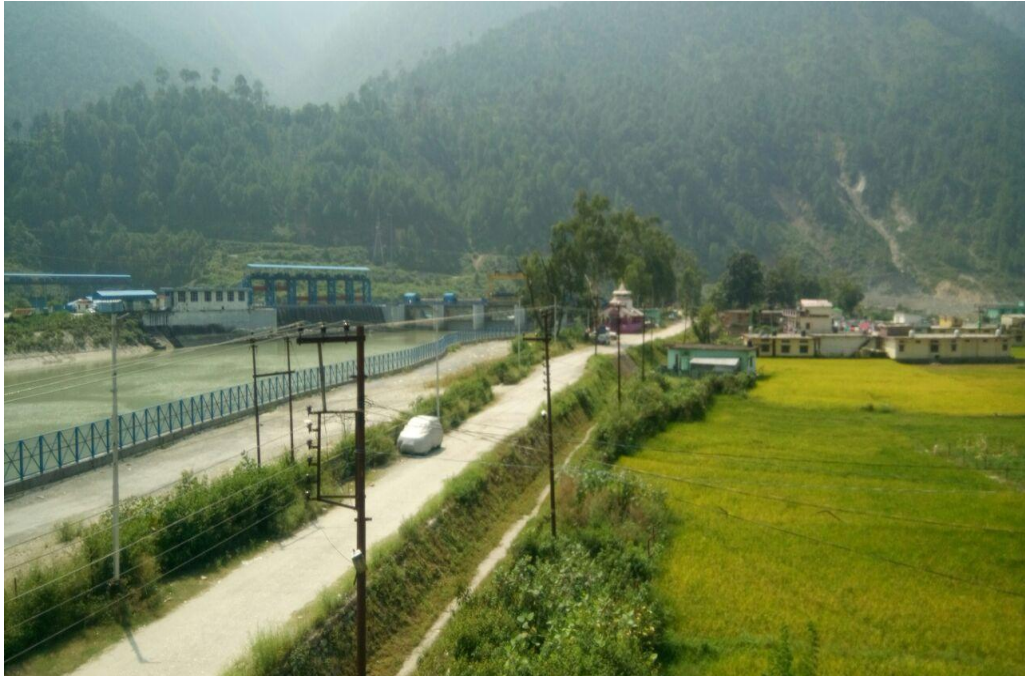
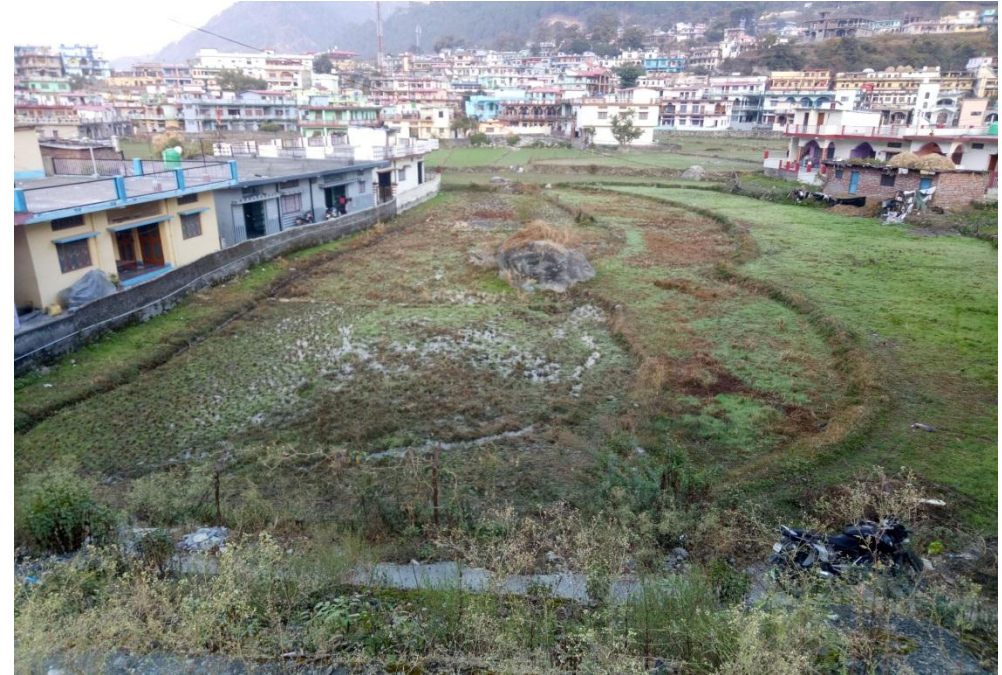
- Waterlogging in the agricultural land (level < 1105 m).
- Seepage of water inside floors of residential houses of Gyansu village.
- Overflow of septic tanks of houses.

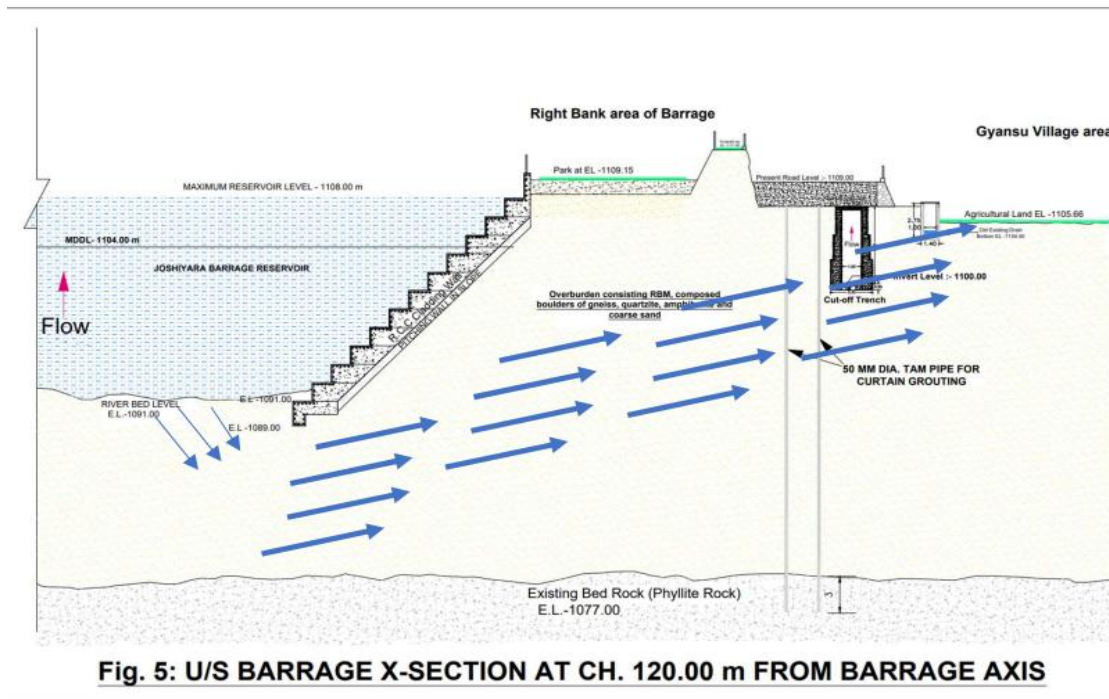
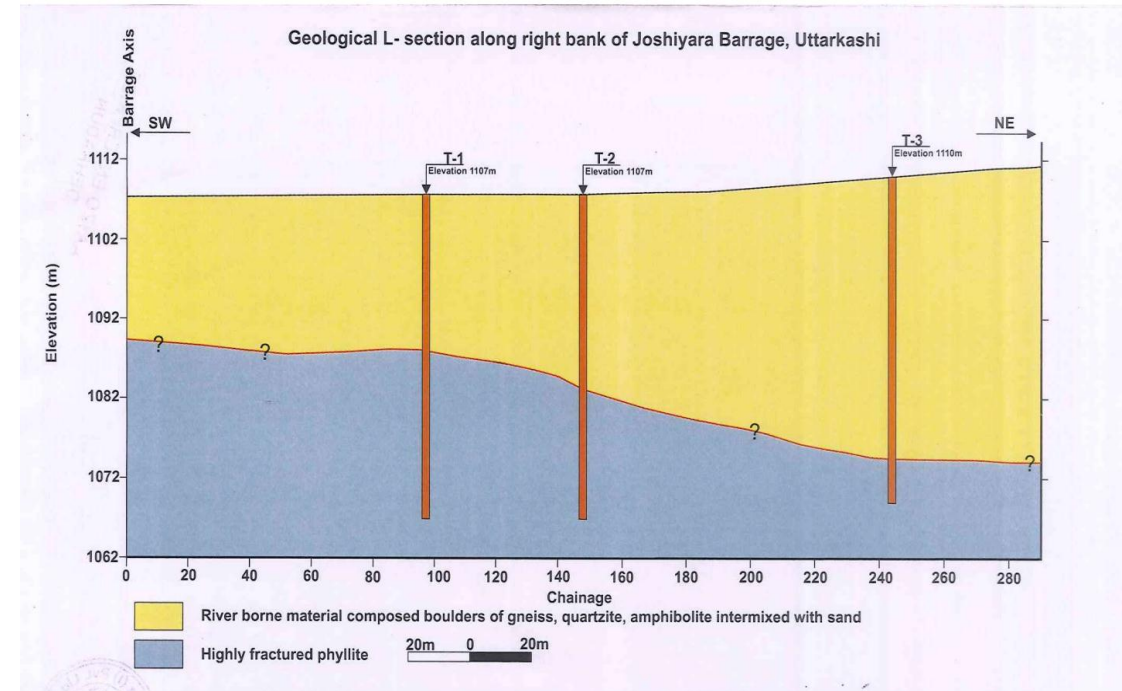
- The foundation rock of right embankment is of highly fractured phyllite nature.
- High permeability of overburden strata in the affected areas to the tune of 10^{-1} cm/sec.
- The existing cut-off trench was not sufficient deep to catch the seepage line
- The affected area having EL 1105m – 1102m is lower than the FRL (EL 1108 m) of reservoir.

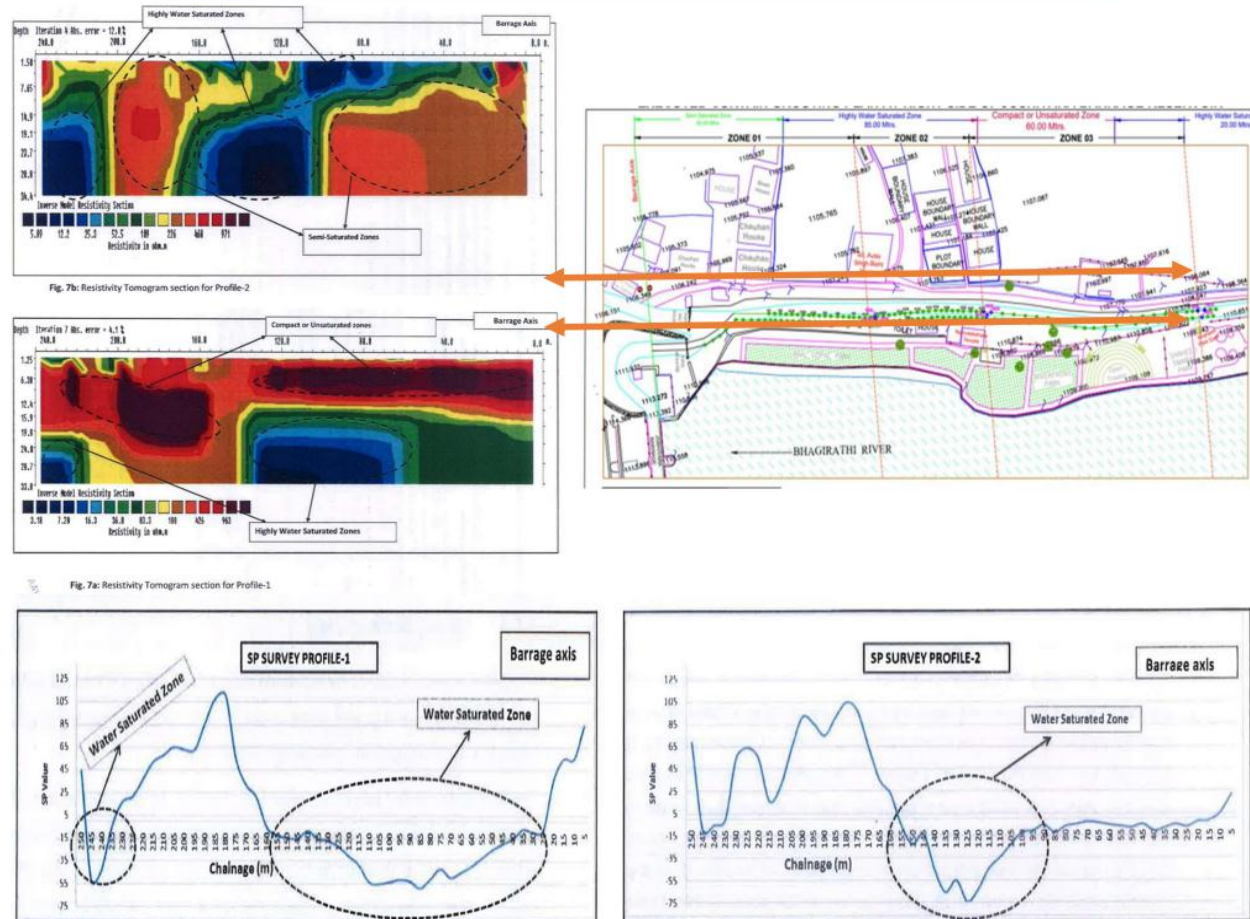
- One highly water saturated zone from chainage 15m at a depth of 21m below ground level
- Second highly water saturated zone from chainage 100m to 180 m at a depth of 16m below ground level
- Most of the portion of SP curve showing –ive values means presence of water saturation in that zone.

Profile-1: Towards reservoir side
Profile-2: Towards agricultural land & houses
Survey conducted in 250m length in affected reach and results interpreted for 35m depth

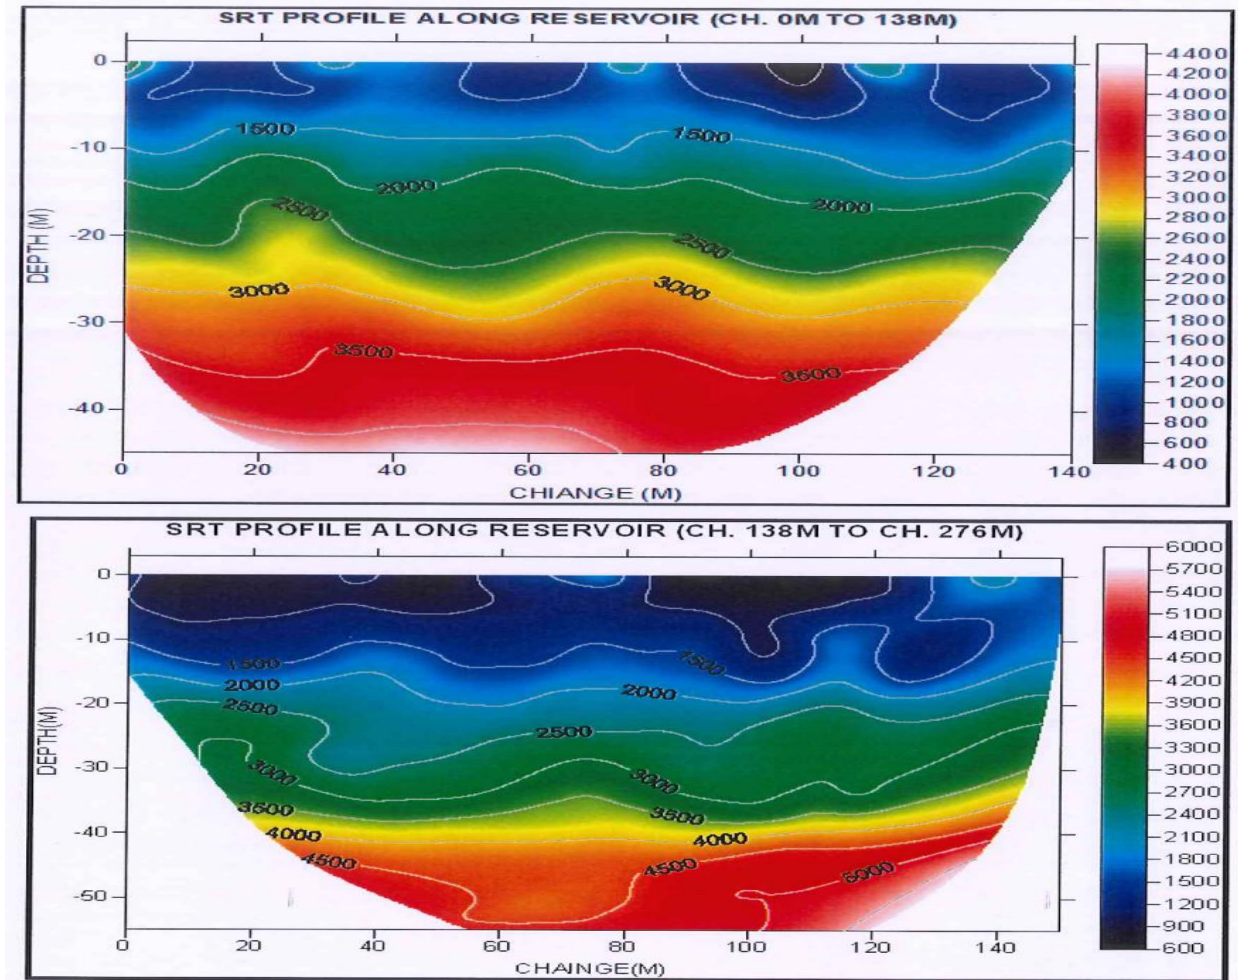
Fig.-13. Seismic Refraction Tomogram section of Profile

- ERT was performed in 276 m length of 02 segment each 138m length along the reservoir near proposed grouting zone
- Upper layer of soil/dense unconsolidated overburden varies in thickness of approximately 12m.
- Highly to moderately weathered rock that rests below the upper layer of soil has been projected to a maximum depth of 35m.
- Beyond 35m depth there exist a better strength of rock i.e bed rock

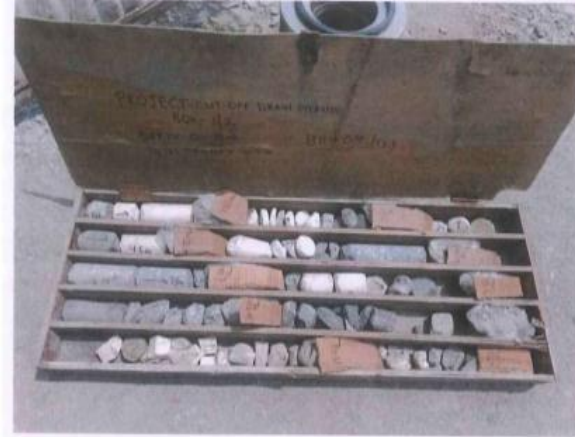
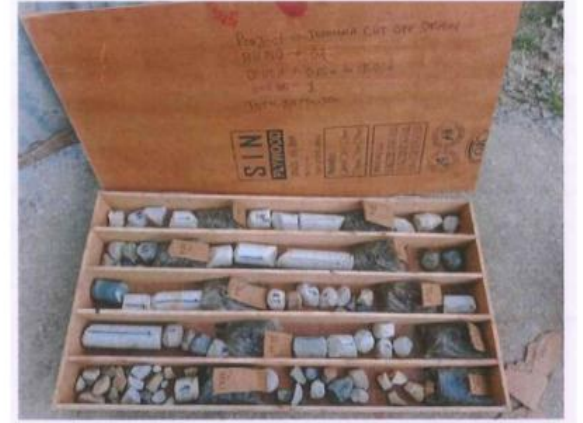
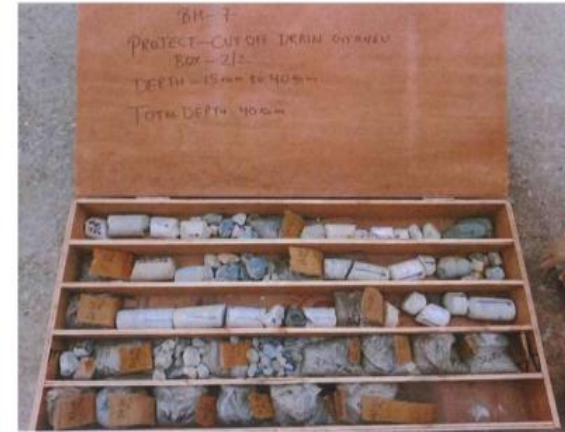
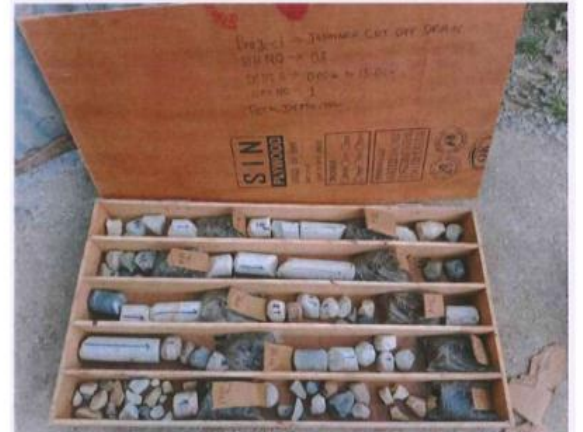
Core samples obtained from diamond core drilling

- From 0m to 27m depth boulders of quartzite, gneiss and amphibolite are occurred intermixed with coarse sand. After 27m depth highly fractured phyllite was encountered
- Due to presence of sand & pebbles core recovery was 10 to 45%.
- RQD cannot determined as, no core obtained more than 10 cm.
- The core recovery was very poor due to high angle of foliation & core bit was parallel to foliation

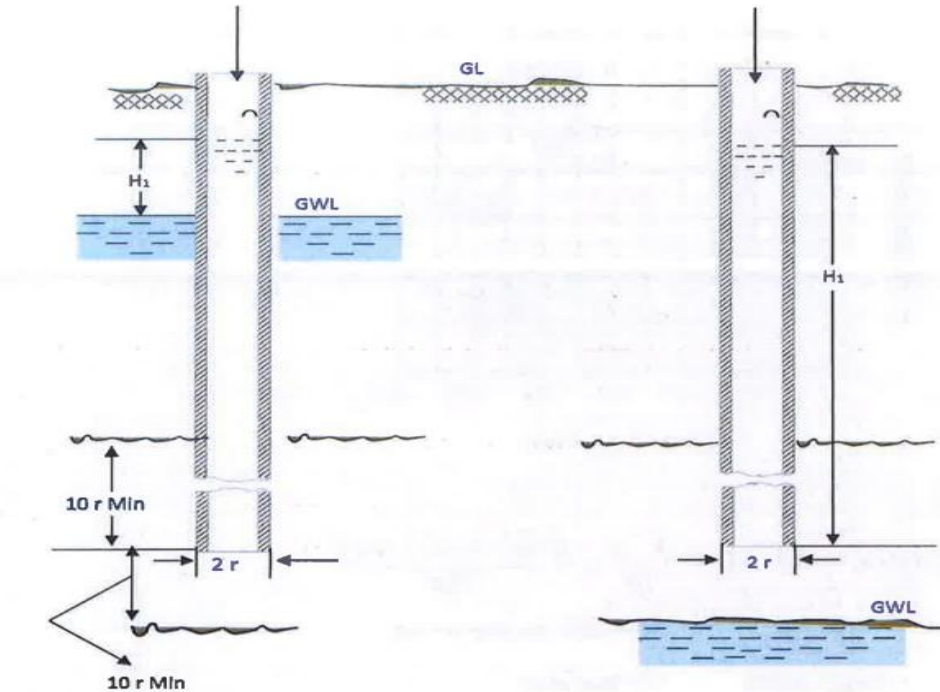
- Based on ERT, SP & SRT test 03 vulnerable zones selected for permeability test.
- Due to high permeable strata containing RBM & composed boulders constant head permeability test used.
- Based on these results the pre-grouting permeability of strata is calculated around 10^{-1} cm/sec to 10^{-2} cm/sec

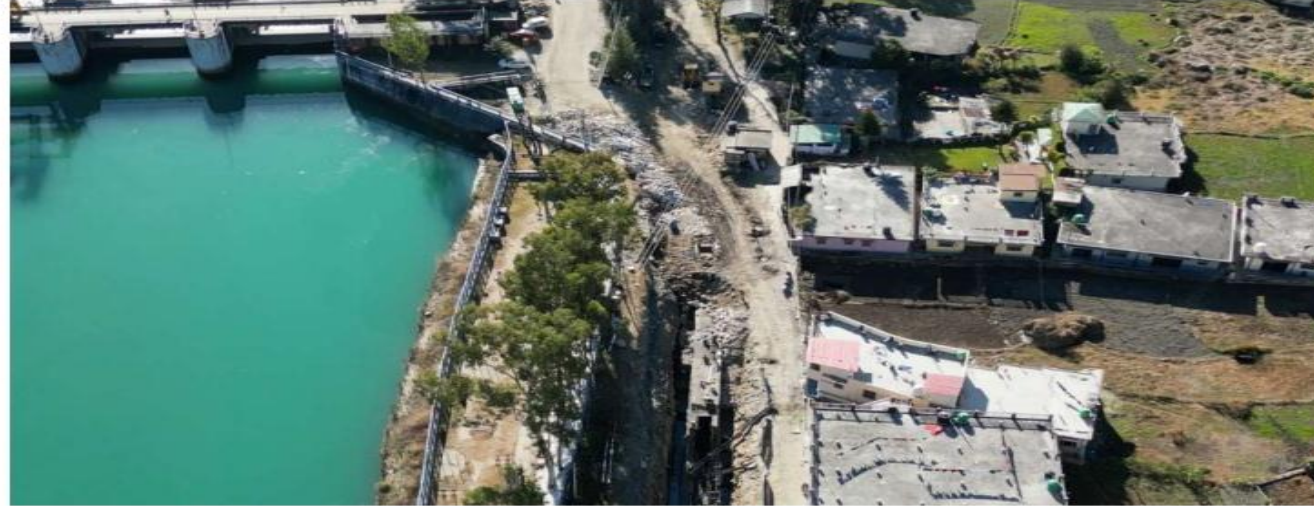
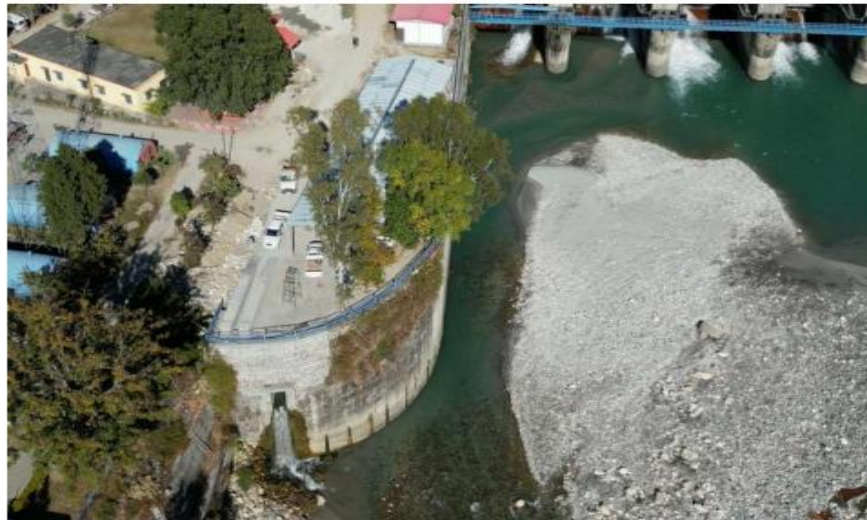
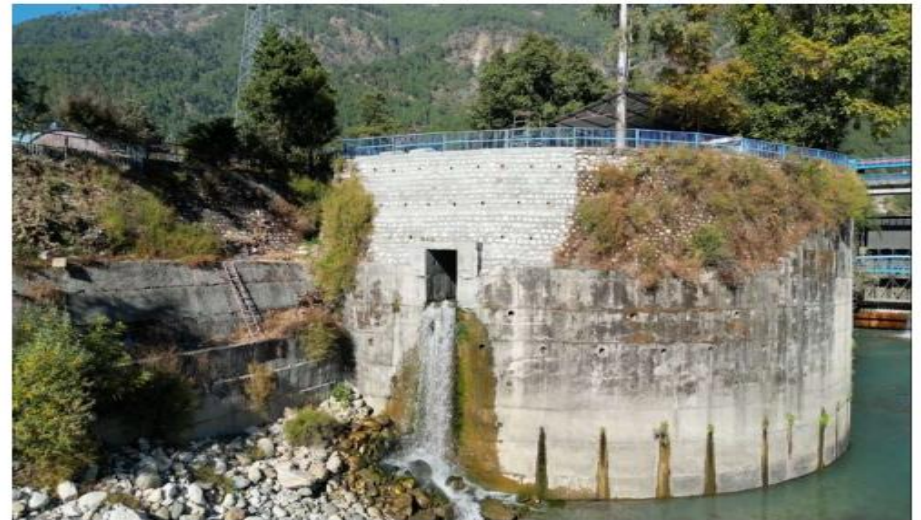
Cut-off trench in its function:

All is well if end is well_Problem Resolved
