International Conference on Dam Safety, 2023

Lessons Learned from Dam Failure

Anil Jain, A.K. Verma and Gaurav Tiwari

Central Water Commission

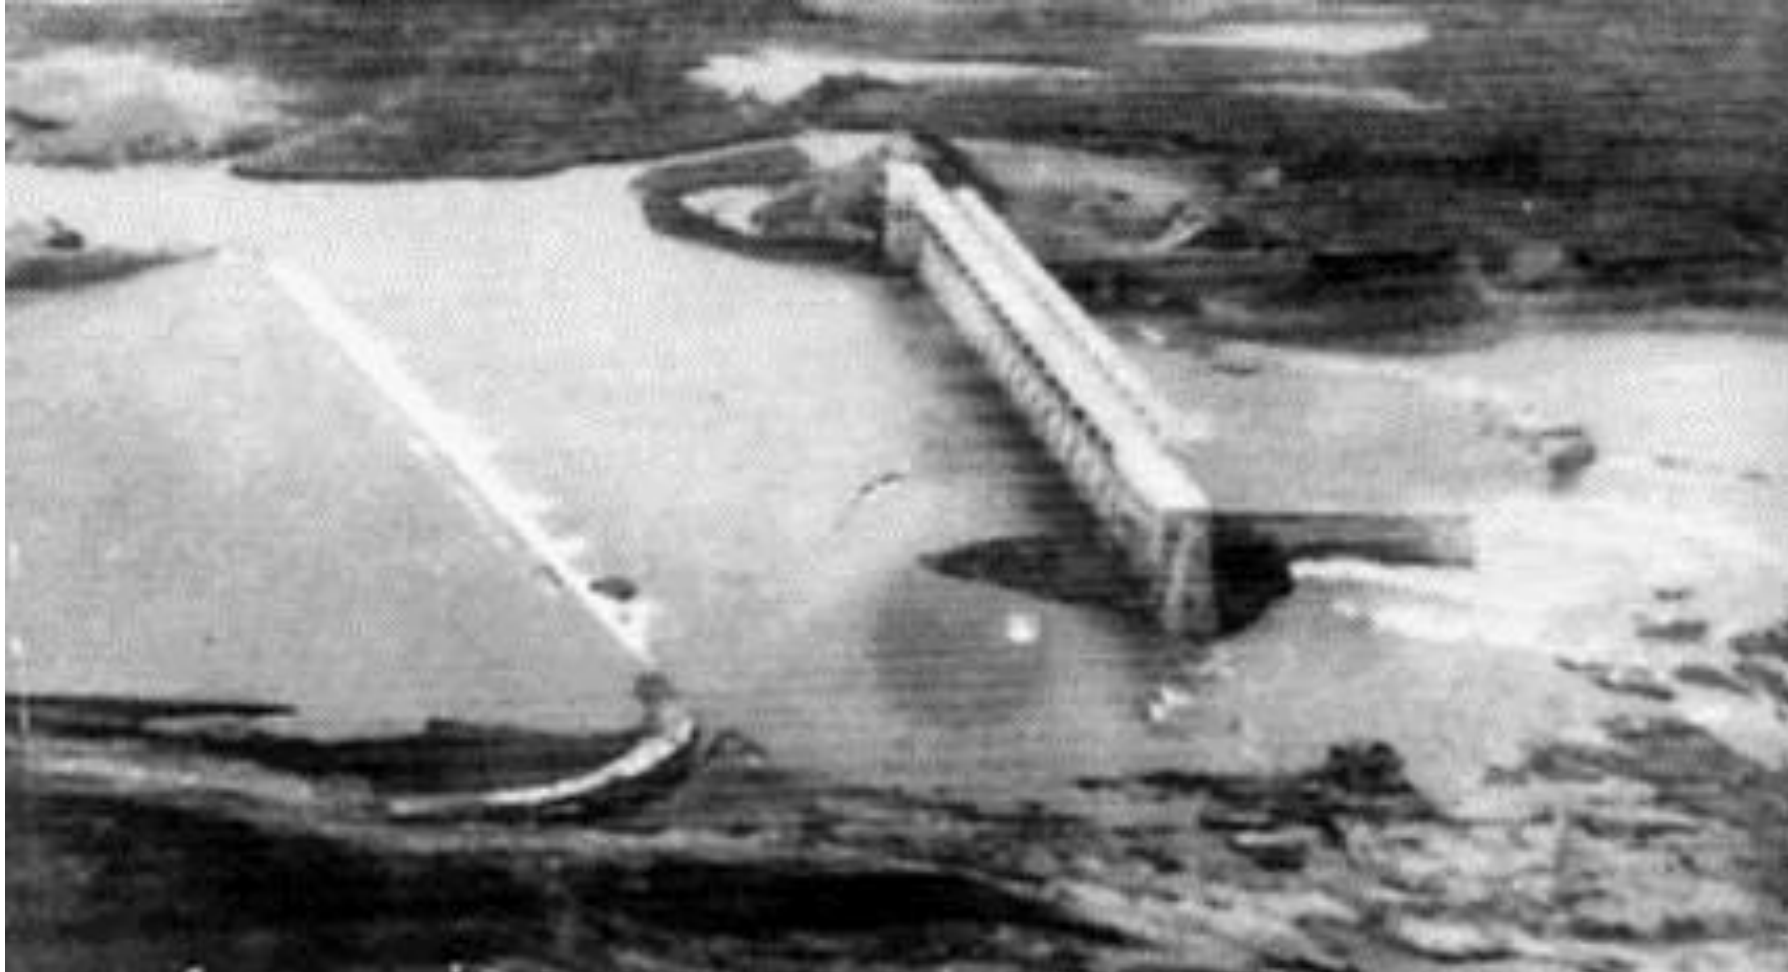
Dam failure major incident : Machu II Dam

- Machhu II dam failure occurred on August 11, 1979, near the town of Morbi in the state of Gujarat, India
- The dam's collapse resulted in one of the most catastrophic floods in Indian history
- **Cause of Failure: Overtopping of embankment**

- Abnormal floods and inadequate spillway capacity leading to disintegration of earthen walls of 4km long Machhu dam.
- Actual observed flow reached to $16307\text{m}^3/\text{s}$, thrice of what dam was designed for.

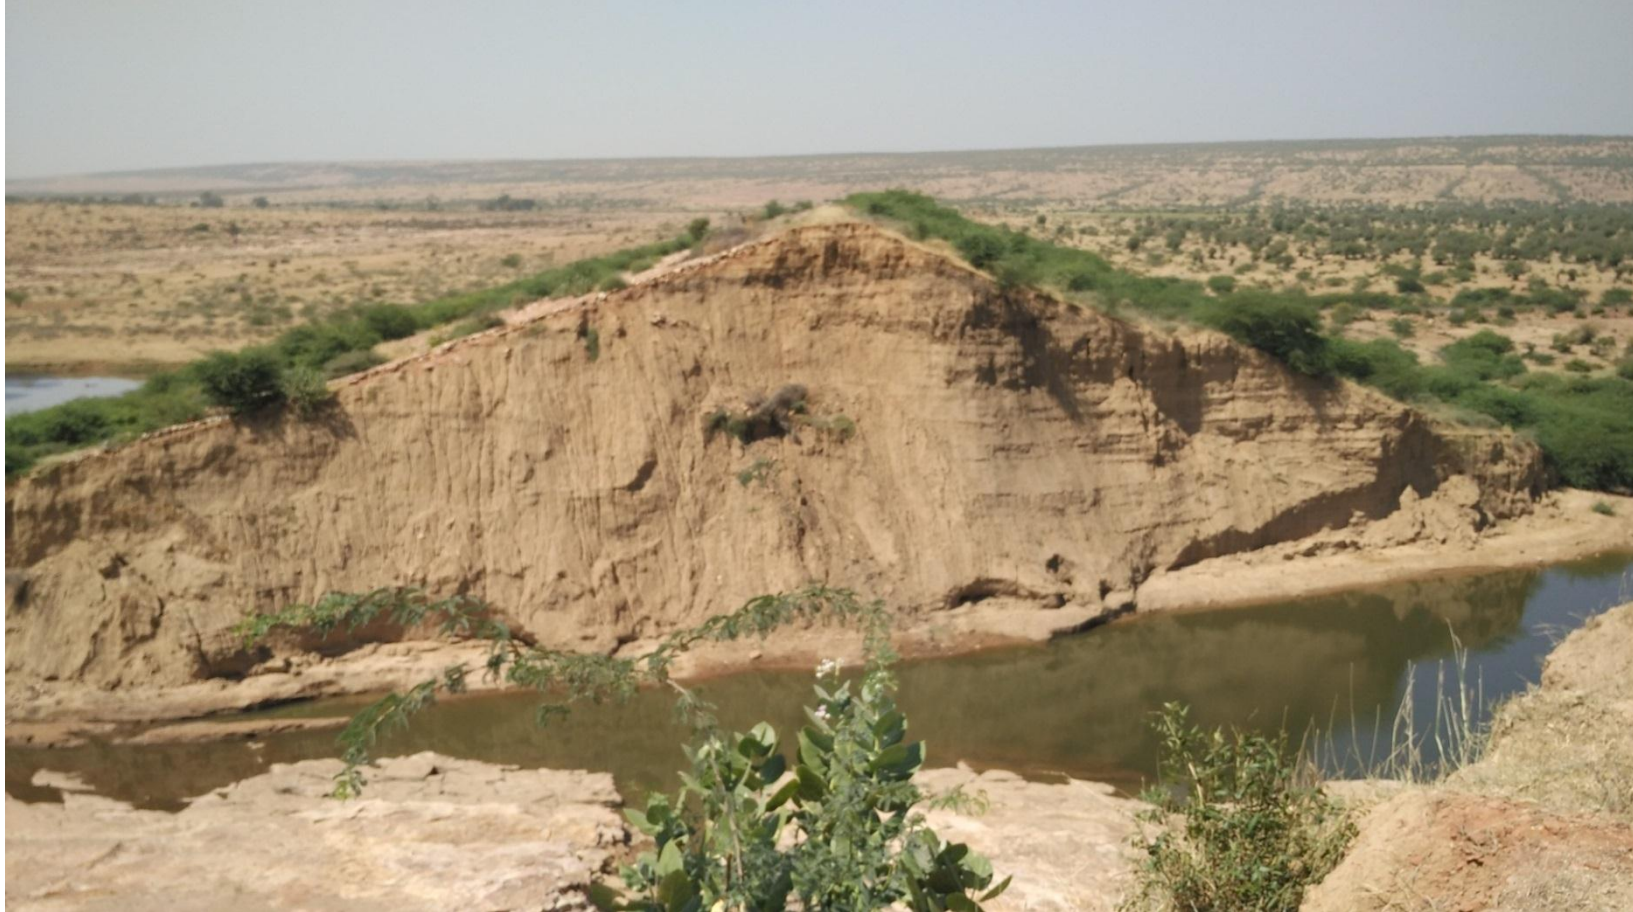
Dam failure major incident : Gararda Dam

- Garada irrigation project, Rajasthan consists of 30m high earthen dam with masonry spillway. Total length of the dam is around 4270 meter
- The Dam taps the discharge of the three Chambal basin drainage channels, namely Mangli Nala towards the left end across which there is a spillway site, Dungi river is in the middle and the Ganeshi nala is at the right end of Dam axis.
- The Garada dam, a zoned earthfill dam was completed in March, 2010 and subsequently breached on 15.08.2010 during initial filling of the reservoir when it was filled only up to 4.0m below the ungated crest level (FRL).

- The Gararda Dam was subjected to an uncontrolled filling. In absence of any arrangements to control the initial reservoir filling, it was not possible to undertake any effective remedial measure, which resulted in dam failure through river closer section.
- Adequate supervision of the works was missing. There were compromises in quality of earthwork – especially on issues of construction, specification of dam materials, layer thickness, laying of filters etc.
- Seepage cut-off arrangement (COT) was not appropriately designed.

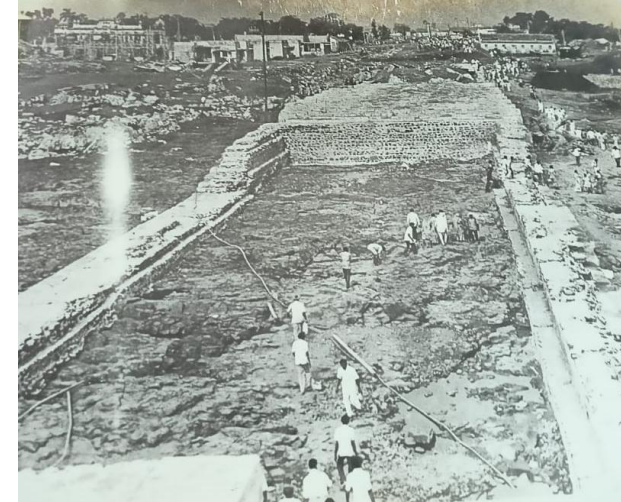
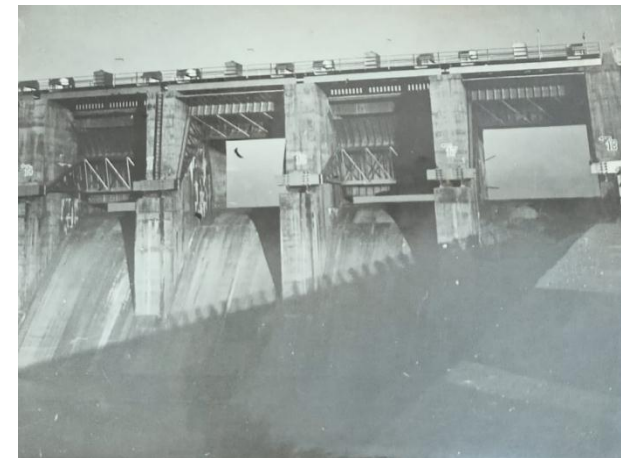
- Tigra Dam was first constructed between 1913 and 1917 to provide an irrigation and water supply source for the nearby major city of Gwalior, India in the central state of Madhya Pradesh.
- The dam failed tragically during a flood event on August 4, 1917, shortly after first filling.
- The 86-foot high, 4,400-foot long masonry gravity dam impounded a massive storage volume of 106,041 acre-feet. The structure was composed of a rubble masonry interior placed with lime mortar and faced with stacked masonry with cement mortar joints. The dam had a vertical upstream face and a 2:3 downstream slope.

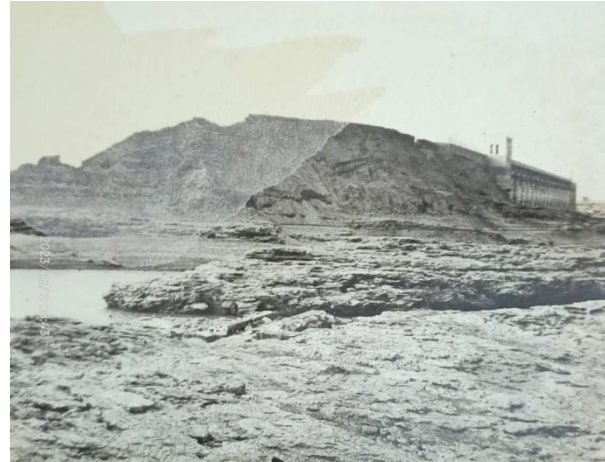
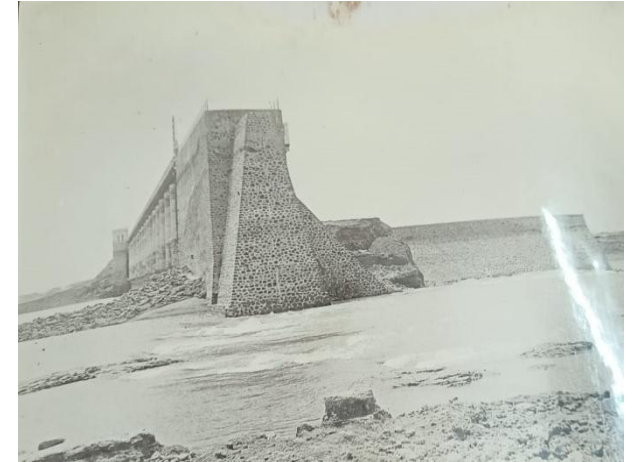
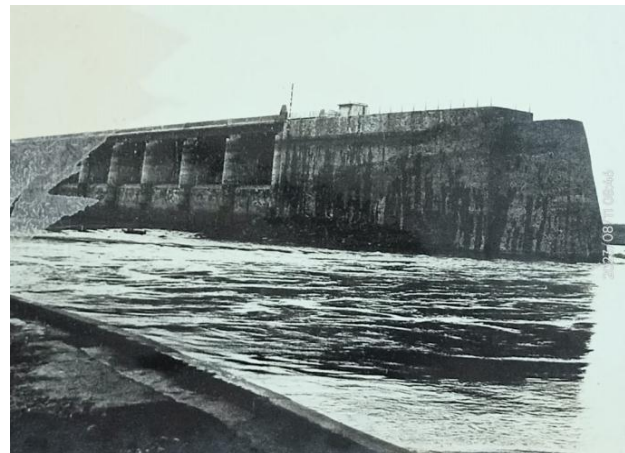
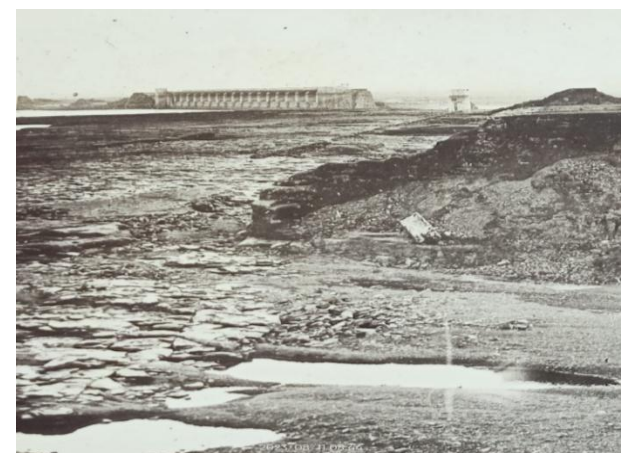
- The dam was founded on stratified sandstone with near horizontal bedding planes. Excavation for the dam was limited to about a 2-foot depth although weaker zones in the sandstone were reportedly excavated deeper and filled with concrete.
- There were apparently no additional seepage control or cutoff measures installed in the dam foundation.
- Records indicate that the spillway activated during the monsoon season each year during construction, and cracking of the masonry structure was noted prior to the planned first filling of the reservoir.

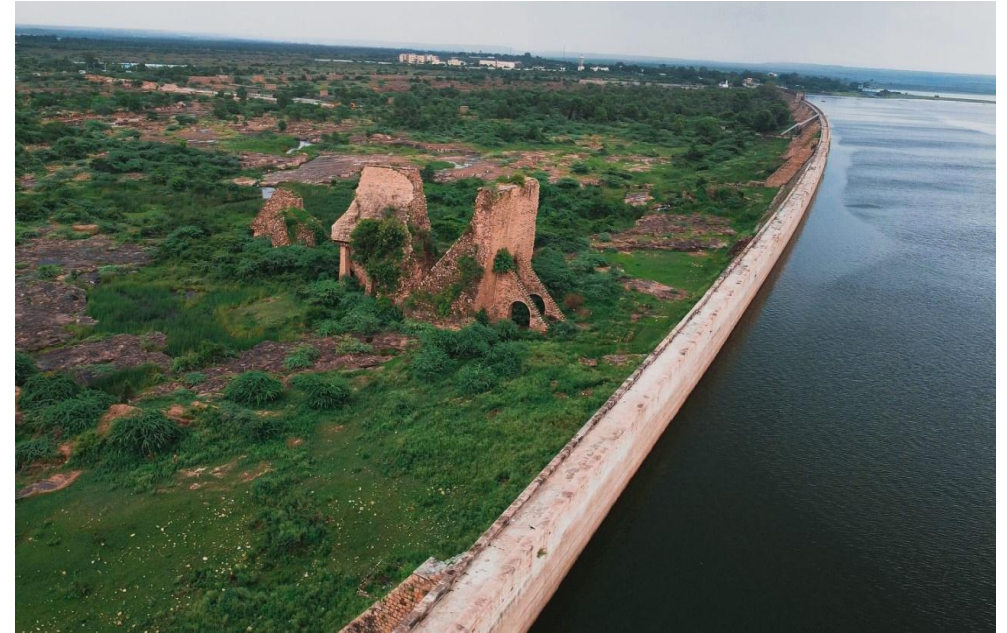
- On 4th August, 1917, the water surface elevation in the reservoir rose to a historic level and overtopped the dam by about one foot from abutment to abutment.
- During the overtopping event, two of the spillway monoliths were moved several hundred feet downstream resulting in an uncontrolled release of the reservoir. These two monoliths still stand today at the site as a distinct reminder of the dam failure.
- The cause of failure is generally agreed to be the result of sliding of sections of the gravity dam along the **untreated, stratified foundation**. The development of **excessive uplift pressures** creating tension at the heel of the dam and **downstream scour due to overtopping** likely contributed to the ability of the dam to slide.

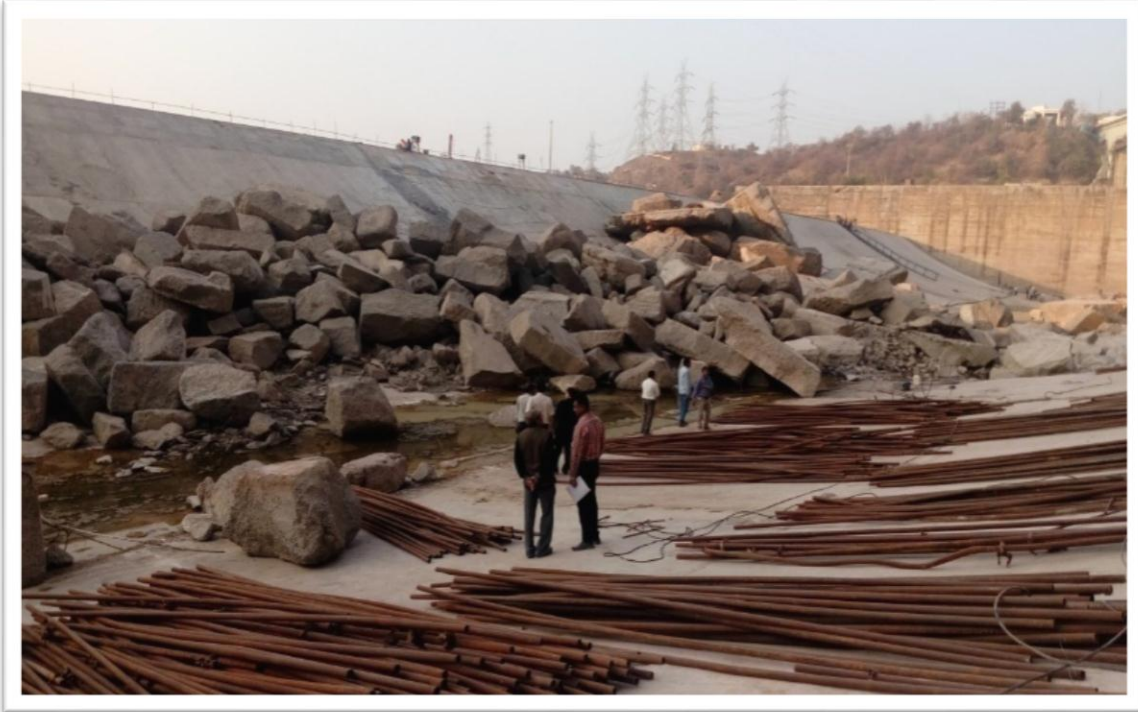
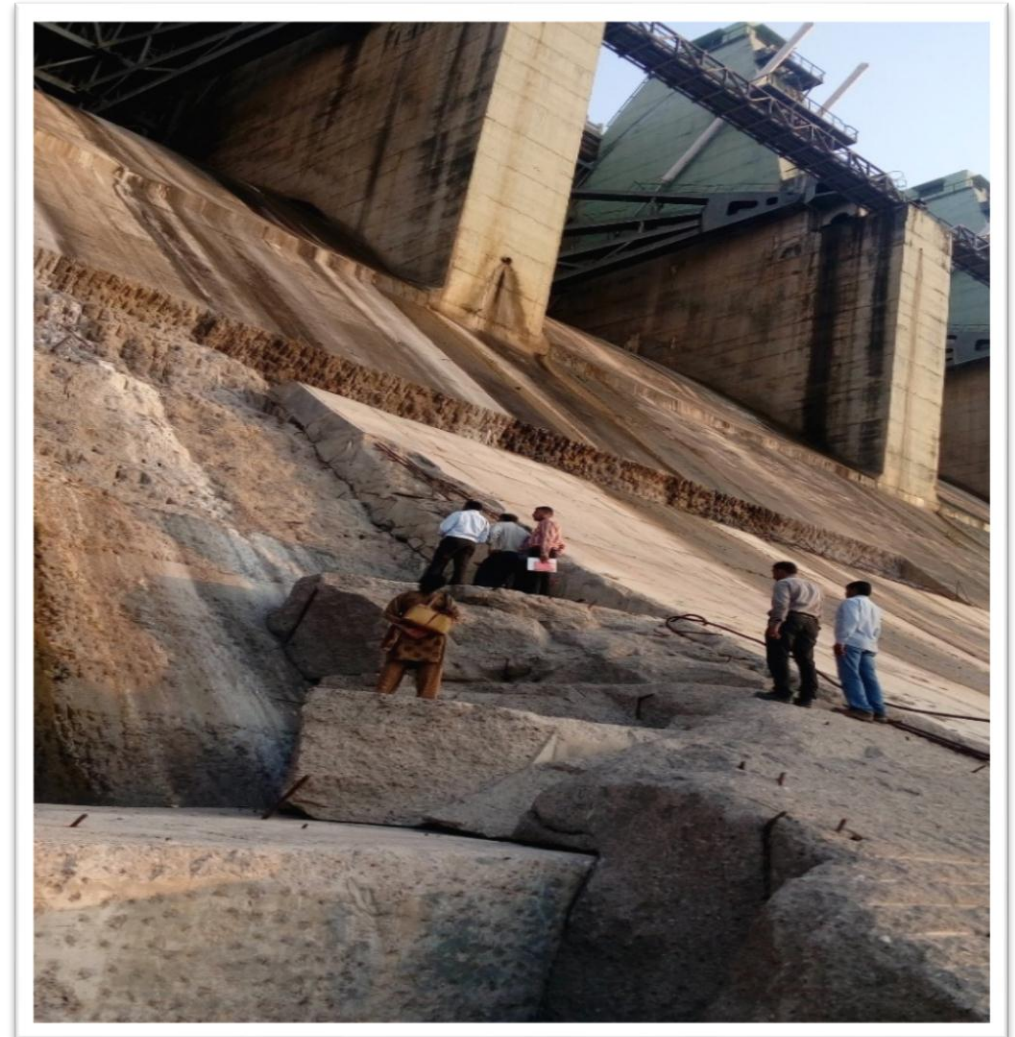
Dam incident at Indira Sagar Dam, MP

- The energy dissipator provided was original in the form of a slotted roller bucket.
- The project is in operation from 2004-2005. Discharges of the magnitude 30,000 m³/s were released during the monsoon of 2013 and then it was observed that the entire slotted roller bucket in front of spans 6 to 12 was washed away.

- The teeth of the roller bucket were overturned and thrown away by the flood waters.
- Theoretical analysis for actual discharges passed over the spillway from 2006 to 2012 indicated that the roller action was not forming for these conditions and instead ski action was taking place due to deficient tailwater levels.

- There was also a transition from ski action to roller action for increasing discharges till the tailwater build was realized.
- In fact, this is the inherent shortcoming of roller bucket type of energy dissipators and damages to the bucket have been reported elsewhere also.

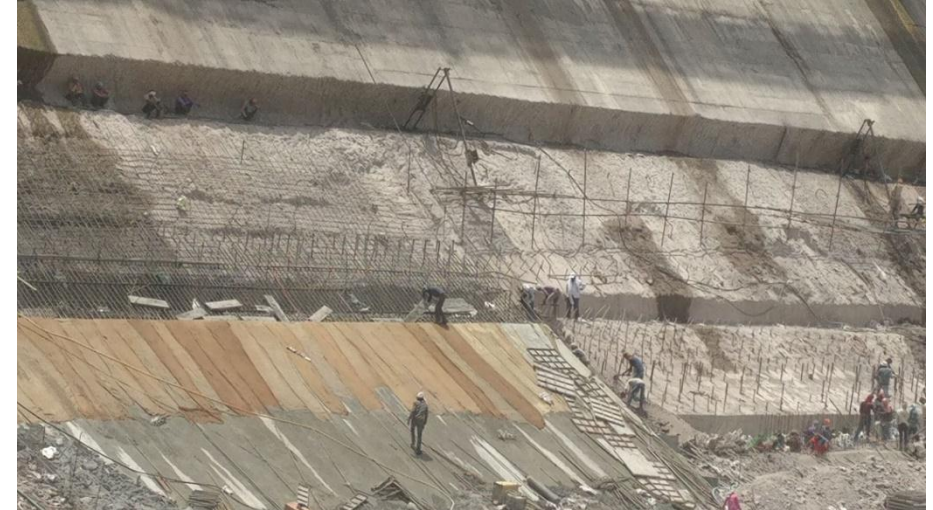
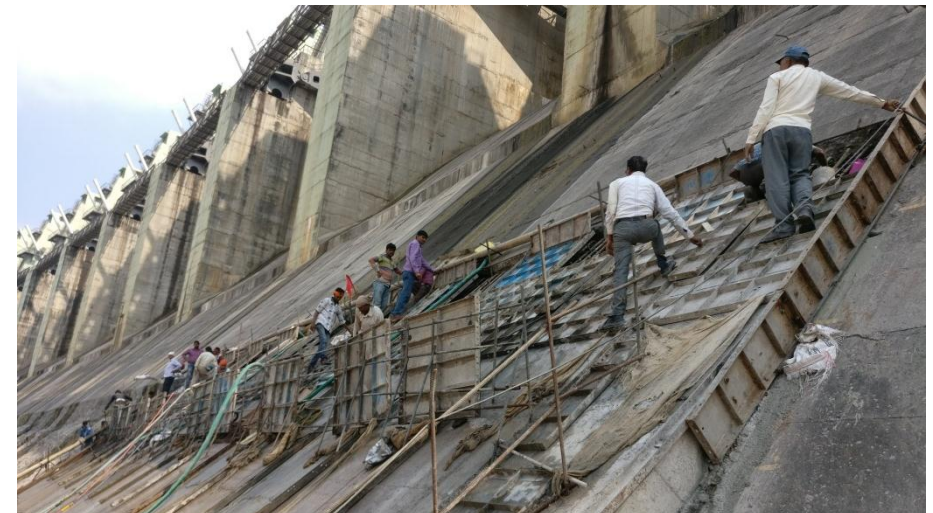
- These are provided for spillways where the downstream river bed is of sound rock. However, when the tailwater levels are not realized during the release of floods over the spillway and surface and ground rollers are not formed, it results in a possible sweep of the flood out of the bucket.

- Deficient tailwater levels during the initial period of operation of the bucket leading to ski action, generation of high hydrodynamic pressures during roller formation due to very high incoming velocities and occurrence of negative pressures on the bucket teeth, are some of the hydraulic parameters that lead to damage to the slotted roller bucket.

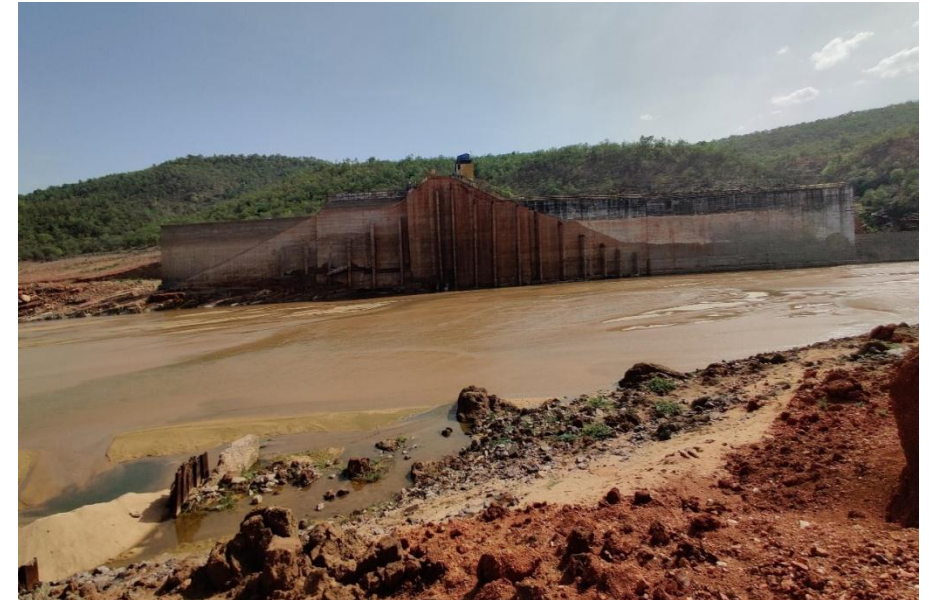
- Medium Irrigation Project across Cheyyeru River, a tributary of Pennar River. Construction started in 1976-77 and completed in 2001.
- 336 m long earth dam along with 94 m long concrete Ogee spillway with 5 radial gates
- Designed for discharging 8069 cumec (200-year return period flood), however, model studies indicated discharging capacity of 6144 cumec only. Discharging capacity further reduced to 5097 cumec (with 5 gates operational) due to problems of right wing wall.
- 5th spillway gate was damaged during cyclone NIVAR in Nov. 2020. Observed peak flood = 9200 cumec
- On 19. Nov. 2021, reported inflow of about 9061 cumec sustained over 2 hours, overtopped the embankment dam causing its breach in entire length.

- Unprecedented inflow of more than 9065 cumec
- Few units of stoplogs washed away during Nivar cyclone. Rectification works were not carried out and thus one radial gates remained in-operational.

- Energy dissipation not taking place in the stilling basin effectively
- As per Indian Standard IS 11223:1985, the project qualifies for Probable Maximum Flood of 23,296 cumec as its design flood.

- As per clause 3.6 of Indian Standard IS 11223: 1985 for mechanical and human failure a contingency of 10% of the spillway gates inoperative may be considered as an emergency condition (like earthquake) for safety of the dam and energy dissipation arrangements. As per the above clause, the flood shall pass safely with only 4 gates in operation.

- In case of Annamayya dam, the water levels in the reservoir with 10% inoperative gates (i.e. one gate inoperative) have been computed to be far above the TBL which is highly undesirable

- Discharging capacity of the spillway provided at dam was inadequate to handle such a large flood. Embankment dams are highly vulnerable to overtopping.

- Due to inadequacy of the spillway, overtopping of Annamayya embankment dam was inevitable for the inflow flood encountered in November, 2021. The entire embankment dam was washed out, first by erosion of downstream toe and subsequently by overtopping & breach of Embankment dam.
