Efficient Design and Usage of Synthetic Geomembranes for Wateproofing in Dams to restore Watertightness and increase service life of the structure

Jagadeesan Subramanian & Vinayagam Subramanian

September 14th – 16th 2023, Jaipur, Rajasthan

UPPER BHAVANI DAM

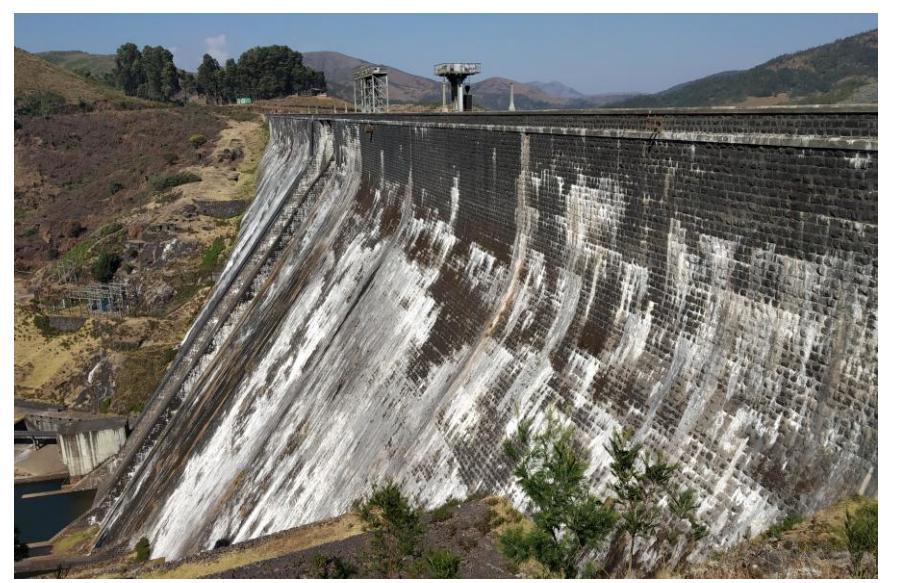
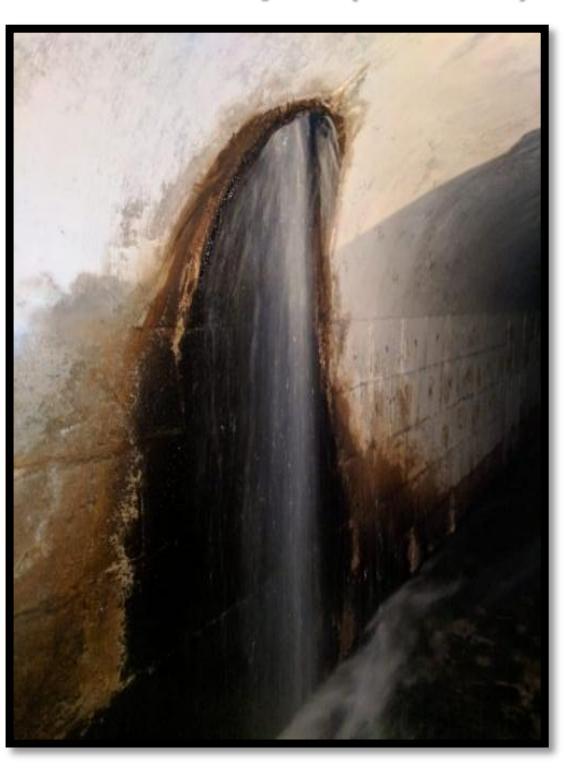
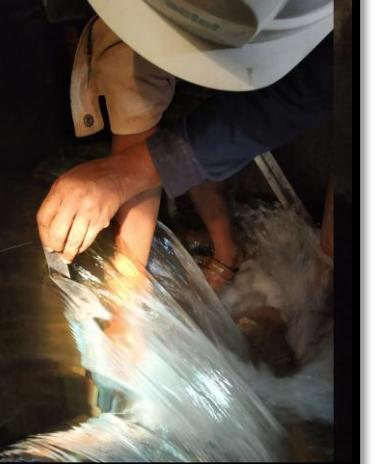
Condition of Dam before Rehabilitation

DECLARED AS DISTRESSED DAM IN 2005 BY THE DAM SAFETY PANEL OF CWC/CLIENT

Leakage

> 9000 Lpm
 (at 9 M Below FRL)
 > 15,000 Lpm (At FRL)

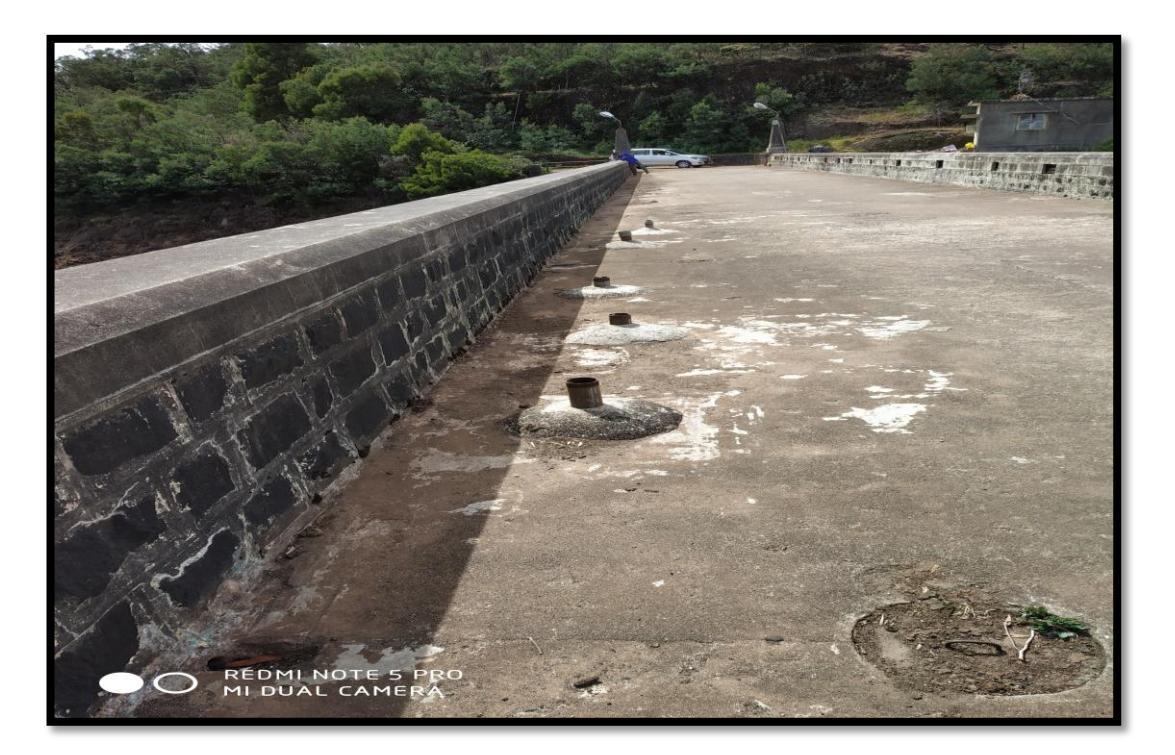
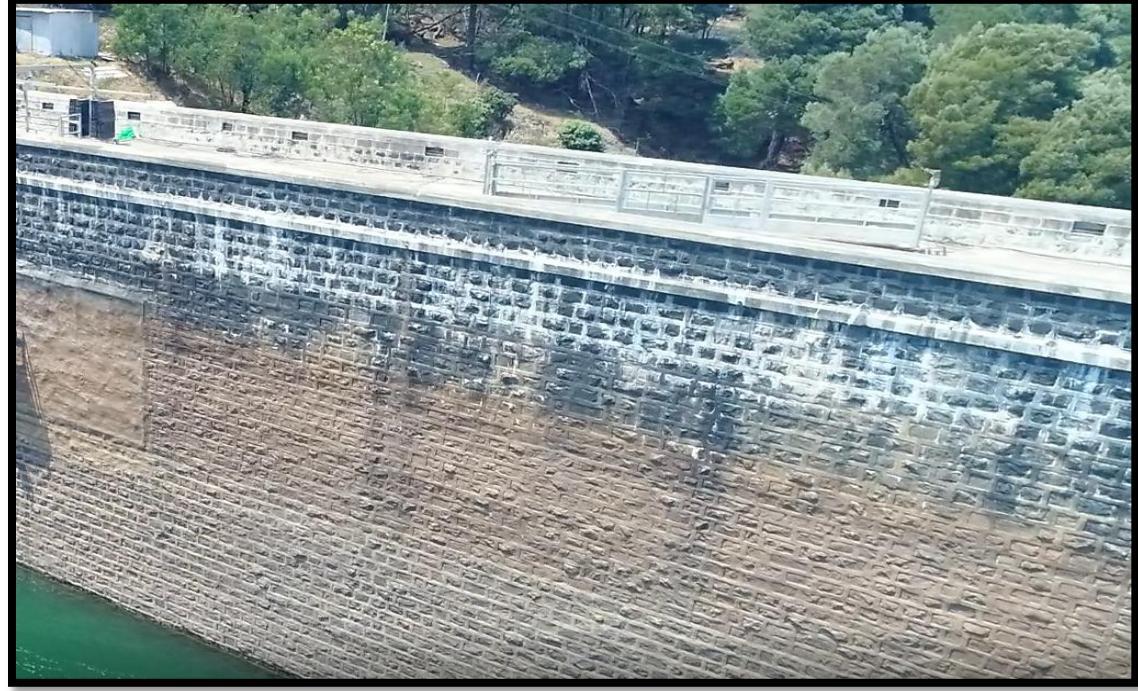
Performance of previous repairs

- Problems in Dam
- : Severe Leakage in shafts surrounding the spillway and leakage recored at 8200 LPM at 9.14 m below FRL level
- Previous Repair : Grouting, Epoxy Pointing, Guniting/Shot creting

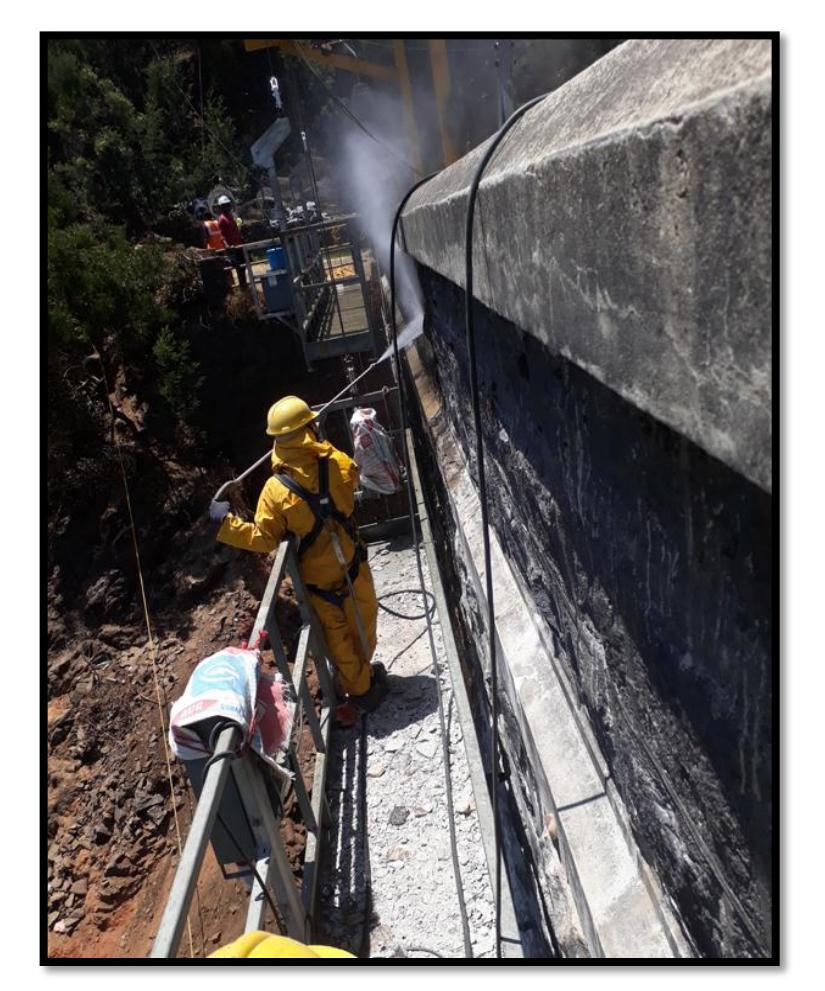
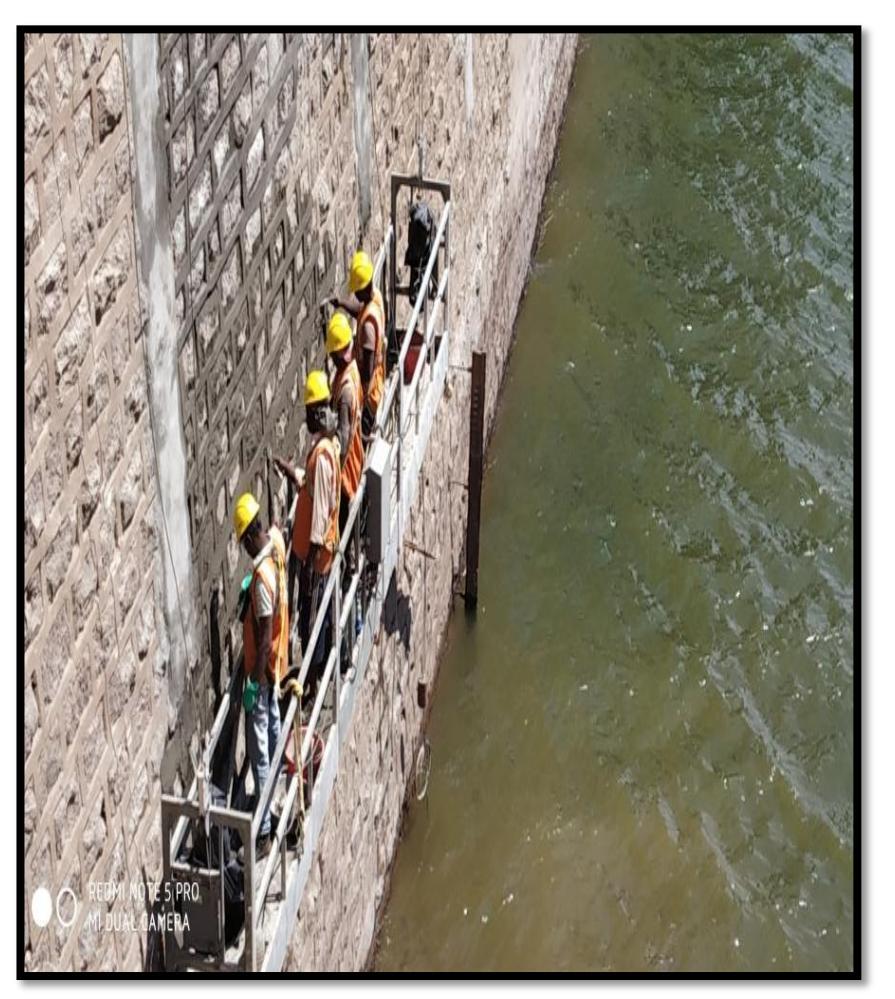
Hydrojet Washing & Pointing

Loose and weak zones were identified using hydrojetting method whereby water applied at high pressure around 150 bar is used to clear and clean the loose particles in the mortar joints.

The withered mortar joints are re-pointed with cement mortar

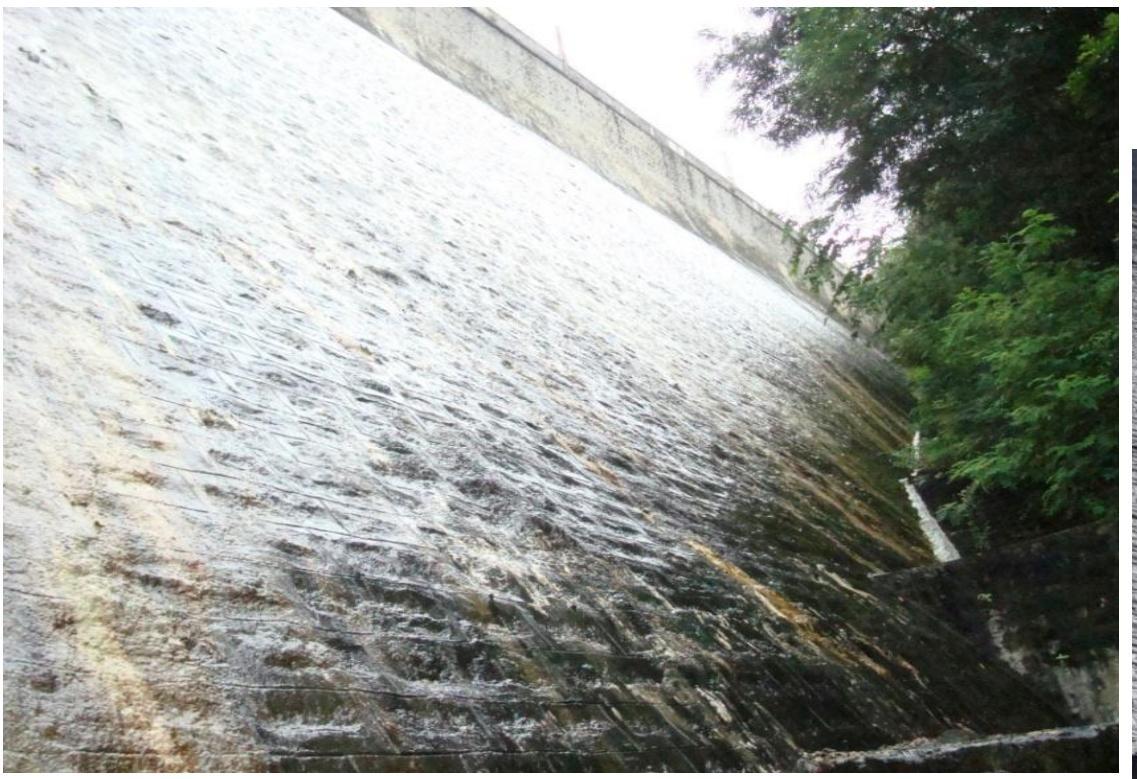
Before Geomembrane Installation – In 2014

Saturated Downstream

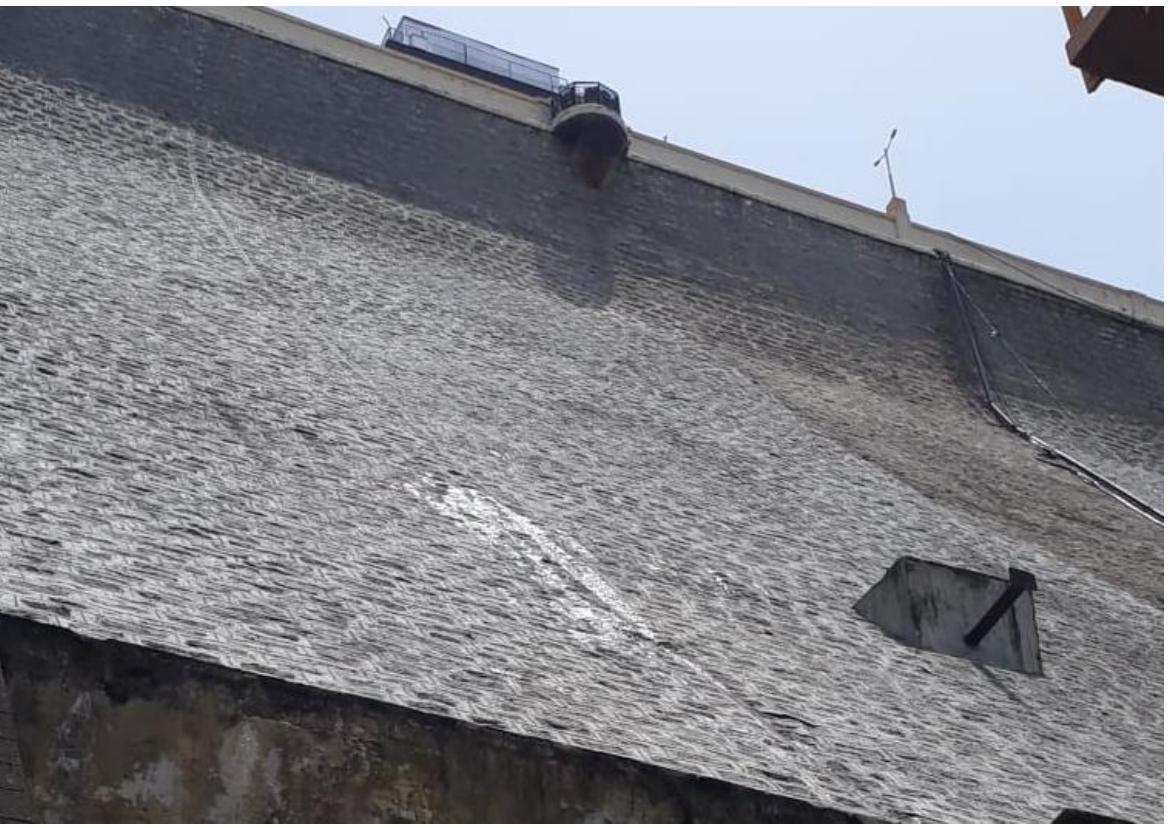
After Geomembrane Installation – In Aug 2018

Dry Downstream

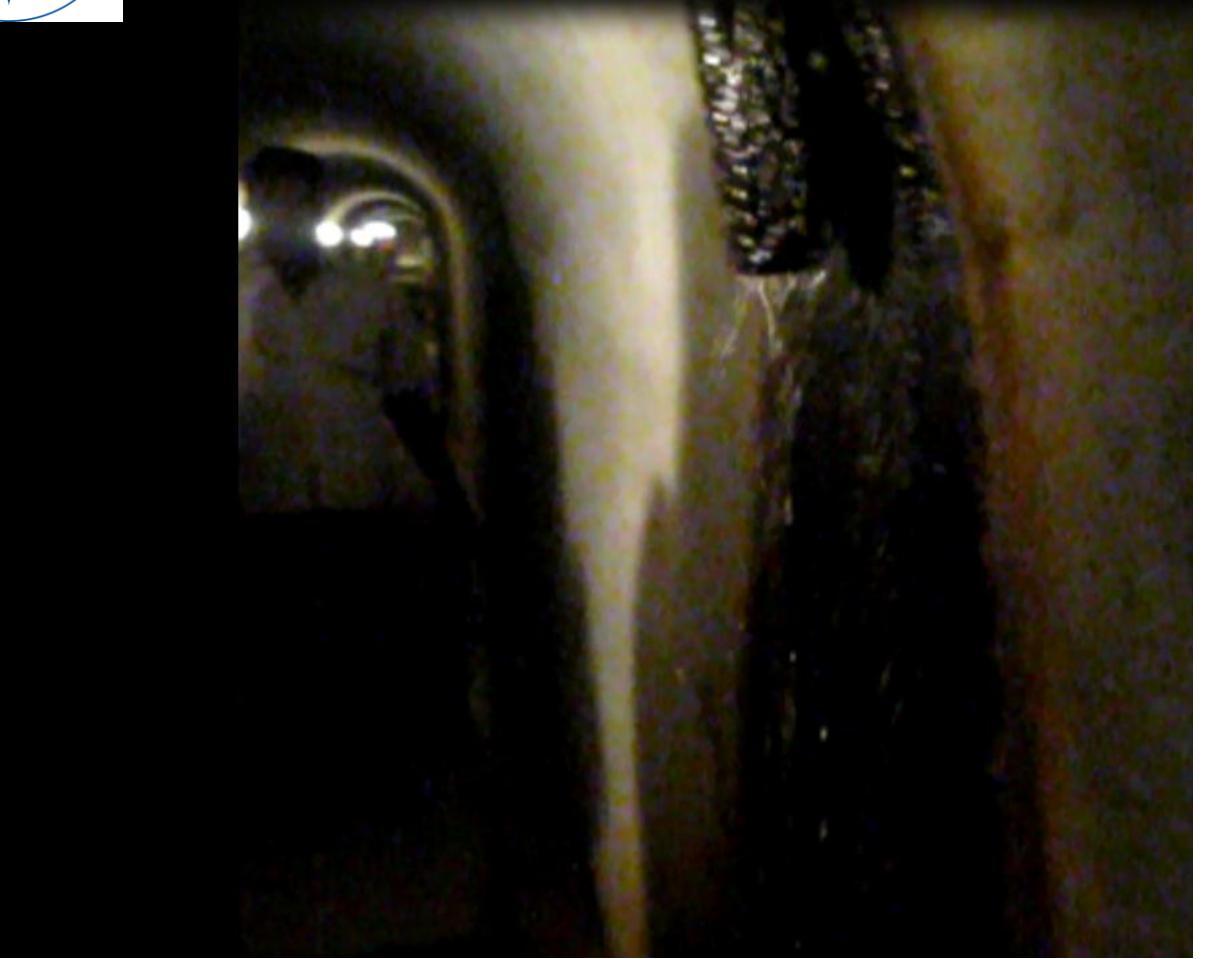
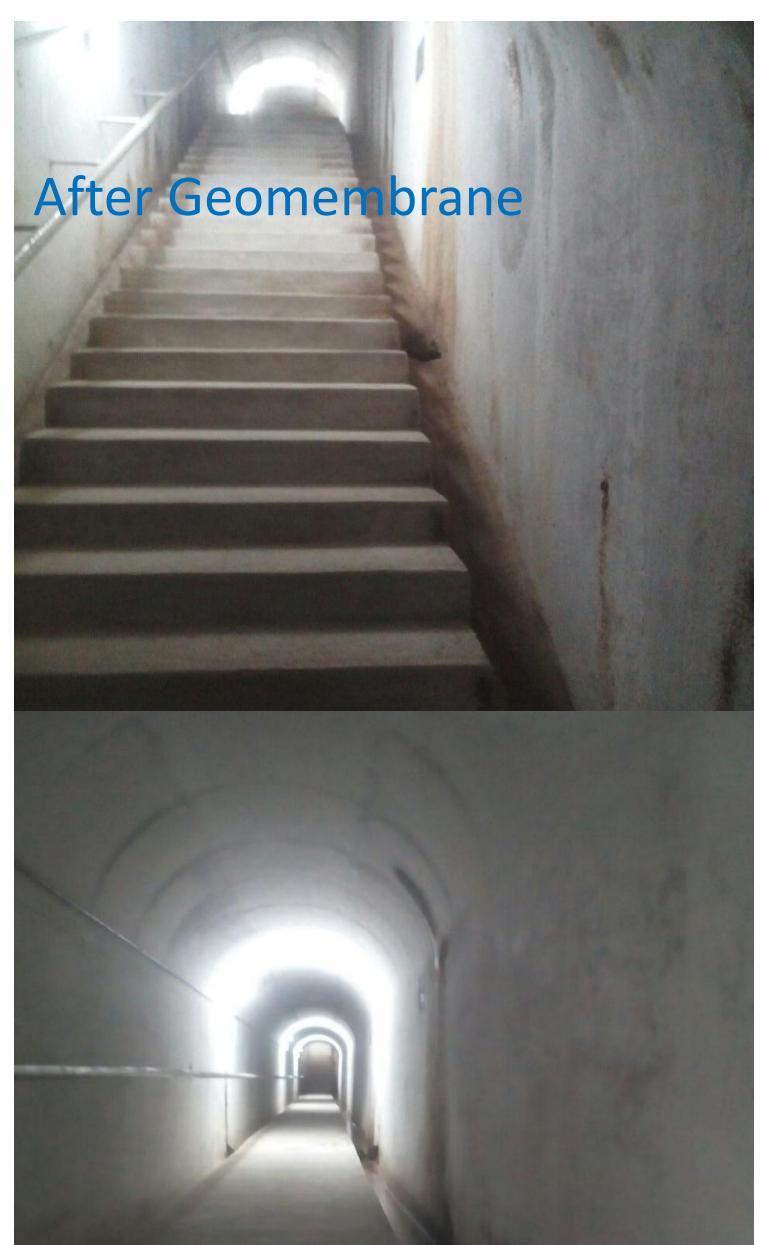
Before Geomembrane

Only the gallery was measured at 743 lpm in 2009

Porous shafts were choked resulting in saturation of dam body and leakage observed on the downstream side of the dam.

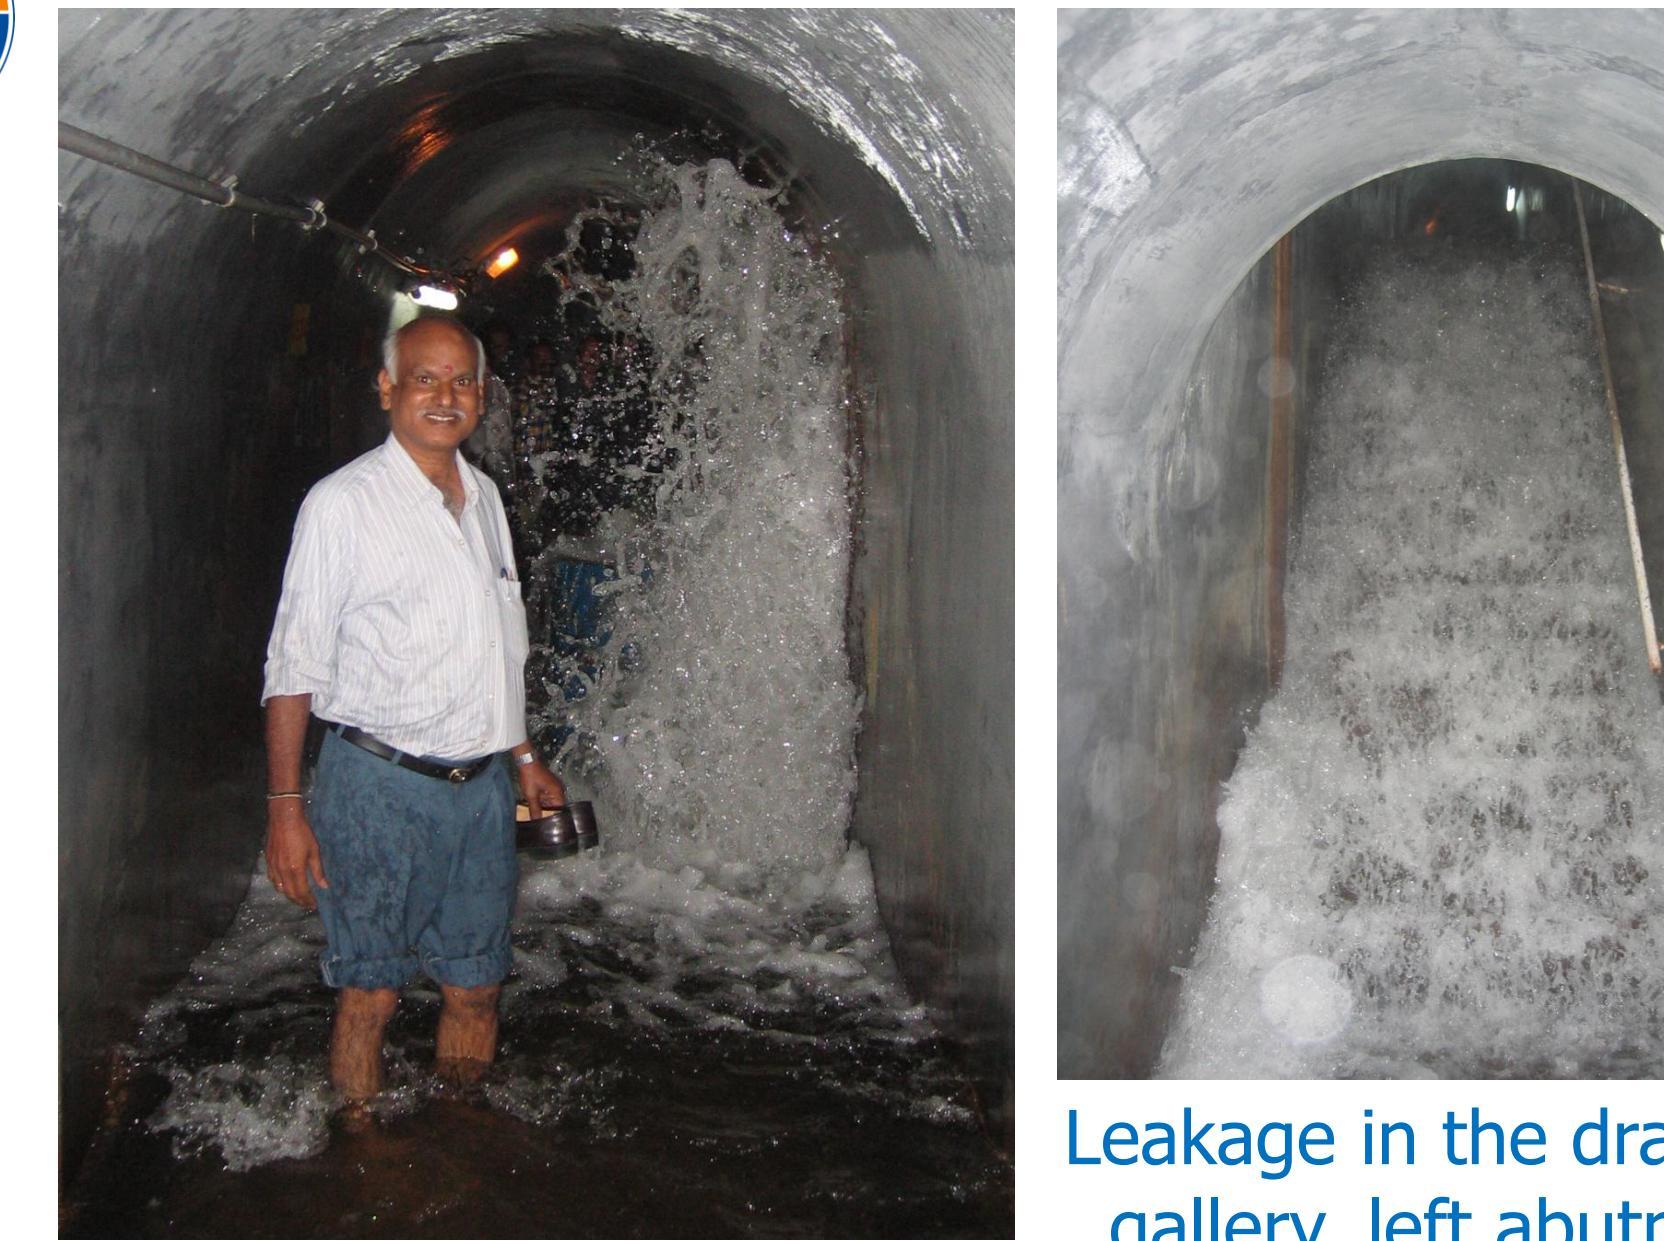
In 2003, Dam on the verge of decommissioning (for excessive leakage) was brought back to life after installation of Geomembrane System in 2005

Leakage in the drainage gallery, left abutment

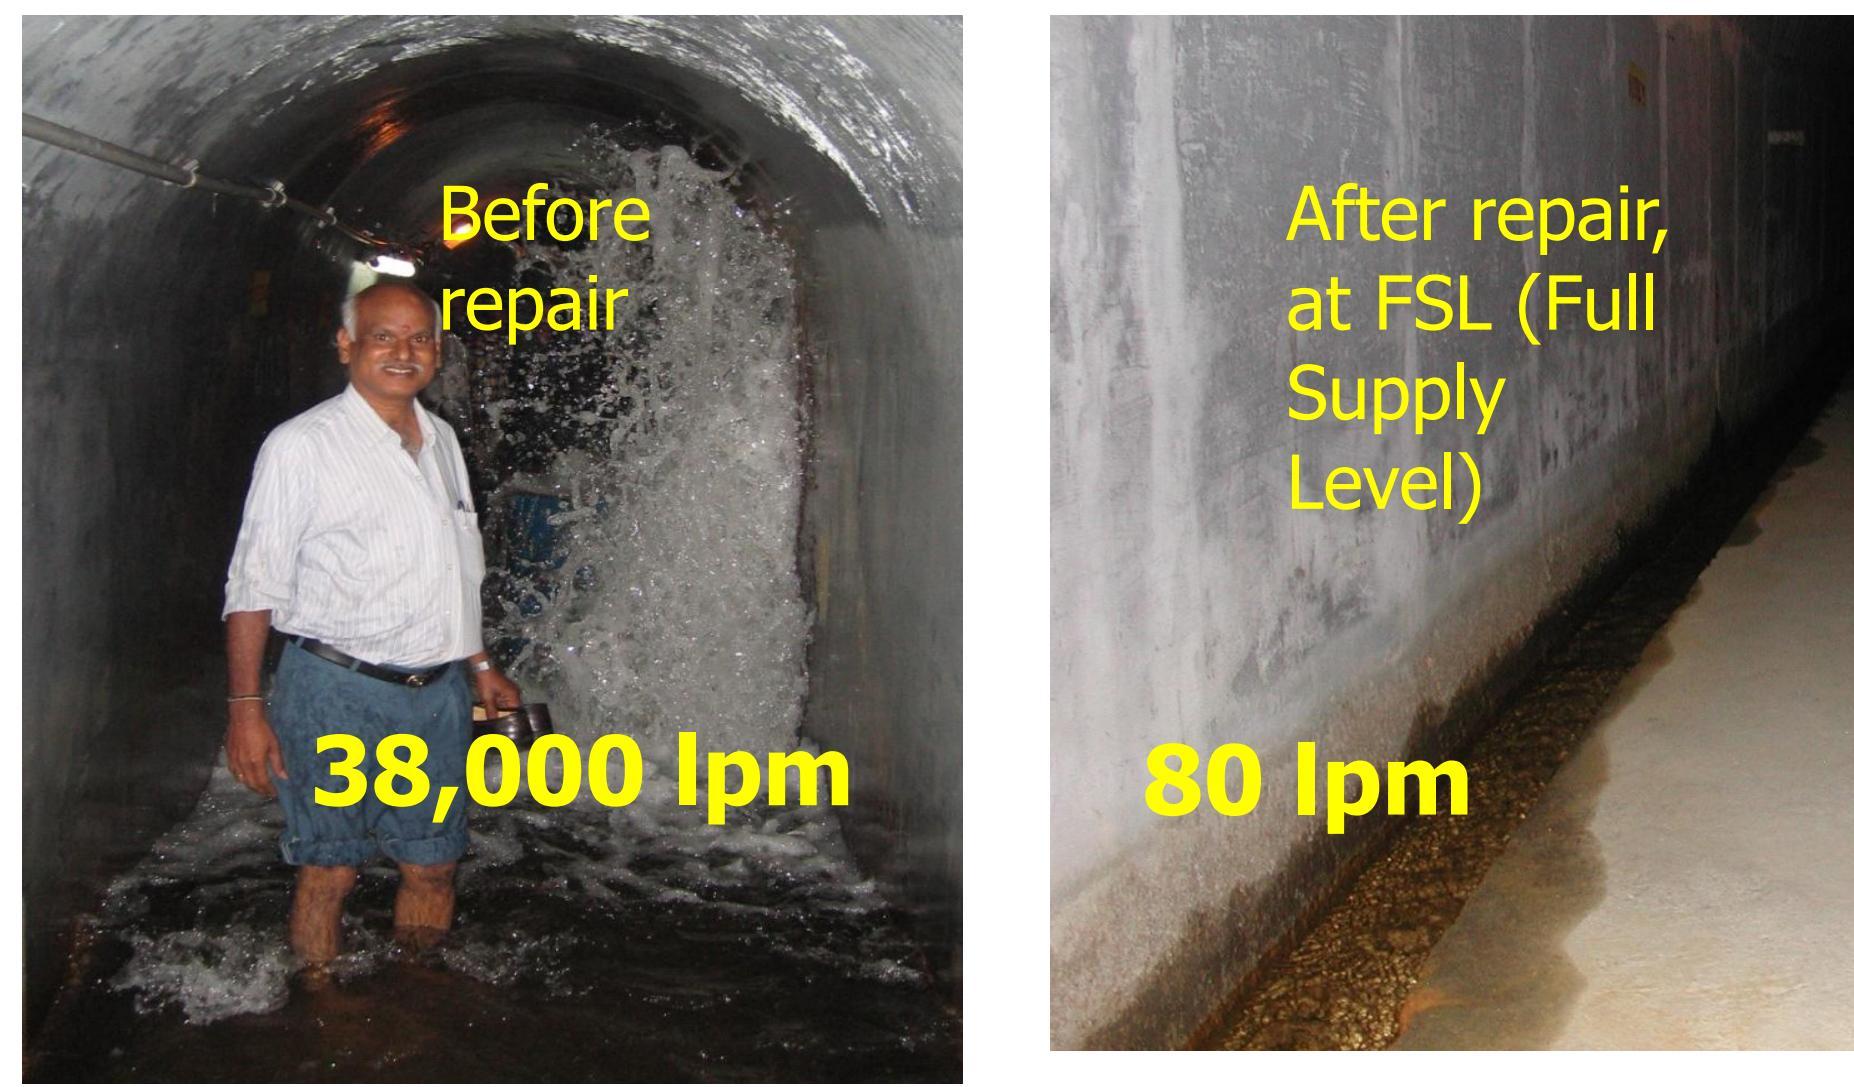
Kadamparai Dam In July 2022 – System still in tact after 17 years

Leakage still around 100 lpm
