Inspection Manual for Dam Field Engineers after Seismic Events, Maithon Dam, Damodar Valley Corporation, Jharkhand

Doc. No. CDSO_MAN_DS_05_v1.0

February 2019

Prepared by
Japan Water Agency, Japan

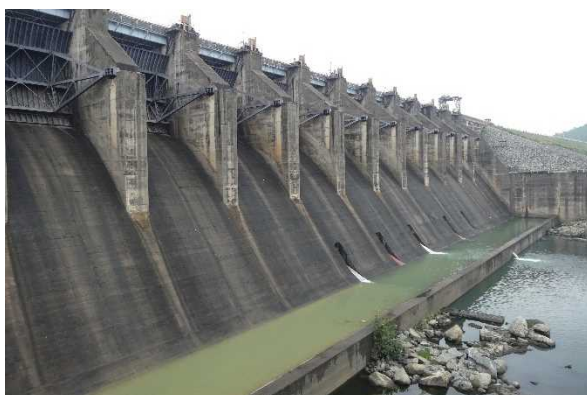
Down side of concrete gravity portion of Maithon Dam: surface of concrete seems to be in healthy condition despite 60 years old since its completion. Due to low water level, leakage from the gate was not observed, but some from sluice gates.

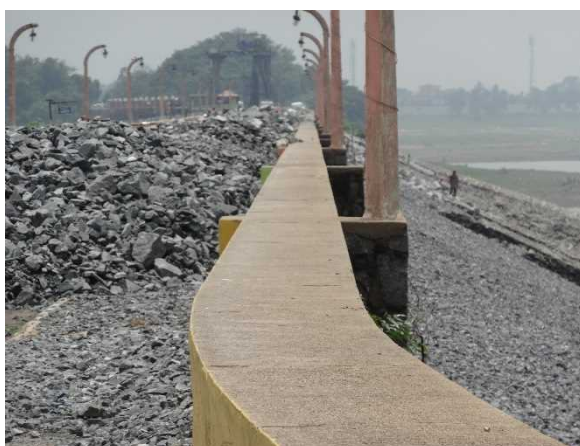
Parapet wall on left side earth dam: if sever deformation such as significant settlement or slope failure would happen; some change could be observed in this view.

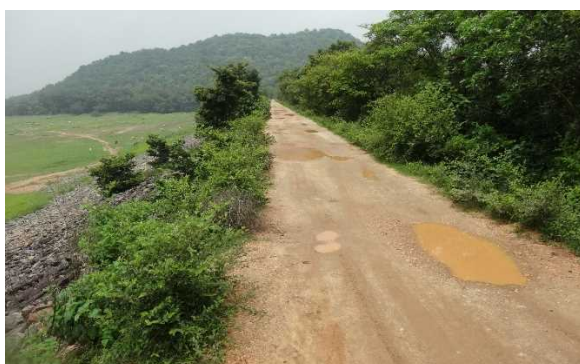
Saddle dam on left bank; the downstream slope is mostly covered with vegetation. It was recognized by DVC that cutting and clearing vegetation is necessary for appropriate maintenance. However, consultation with the forest authority is required to build the consensus.

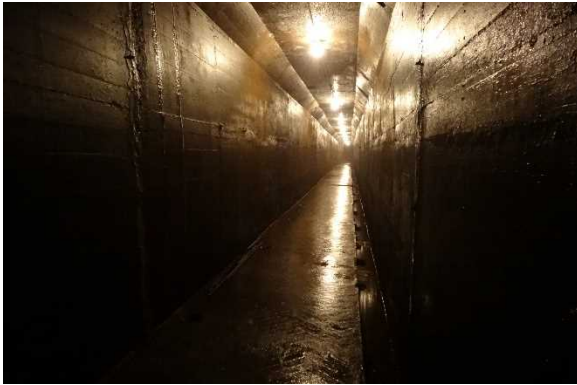
Inspection gallery in the bottom of gravity dam. Although there is no monitoring system, only limited leakage is visually observed even at the high reservoir water level. Drain holes along the gallery were well maintained.
