International Conference on Dam Safety, 2023

# Dam Break Analysis of Annamayya Dam across Cheyyeru River, Andhra Pradesh

# Annamayya Dam Details

# Cascading Dam failures Flash Floods of 19-November-2021

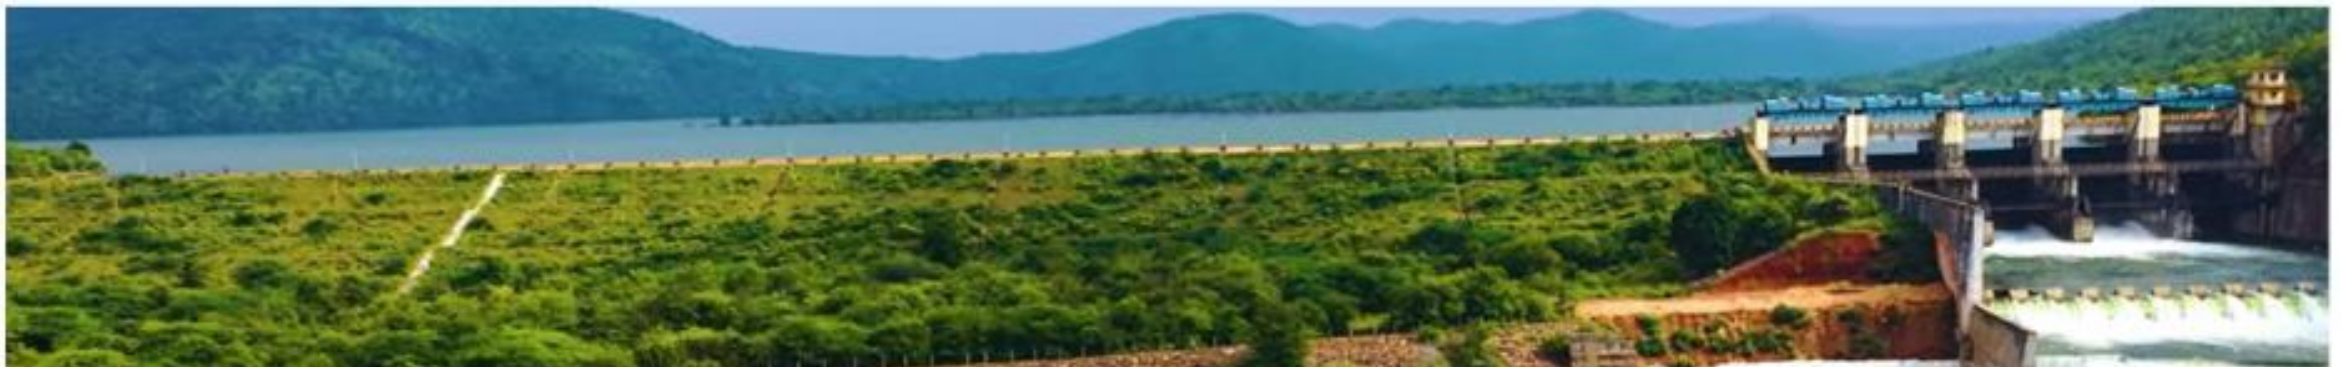
Dam	Annamayya Dam (Medium Height Large Dam)
Gross Storage	63.16 Mcum / 2.23 TMC
Height	25m
Length	409m
Gates	5 no's (13.75m x 14m)

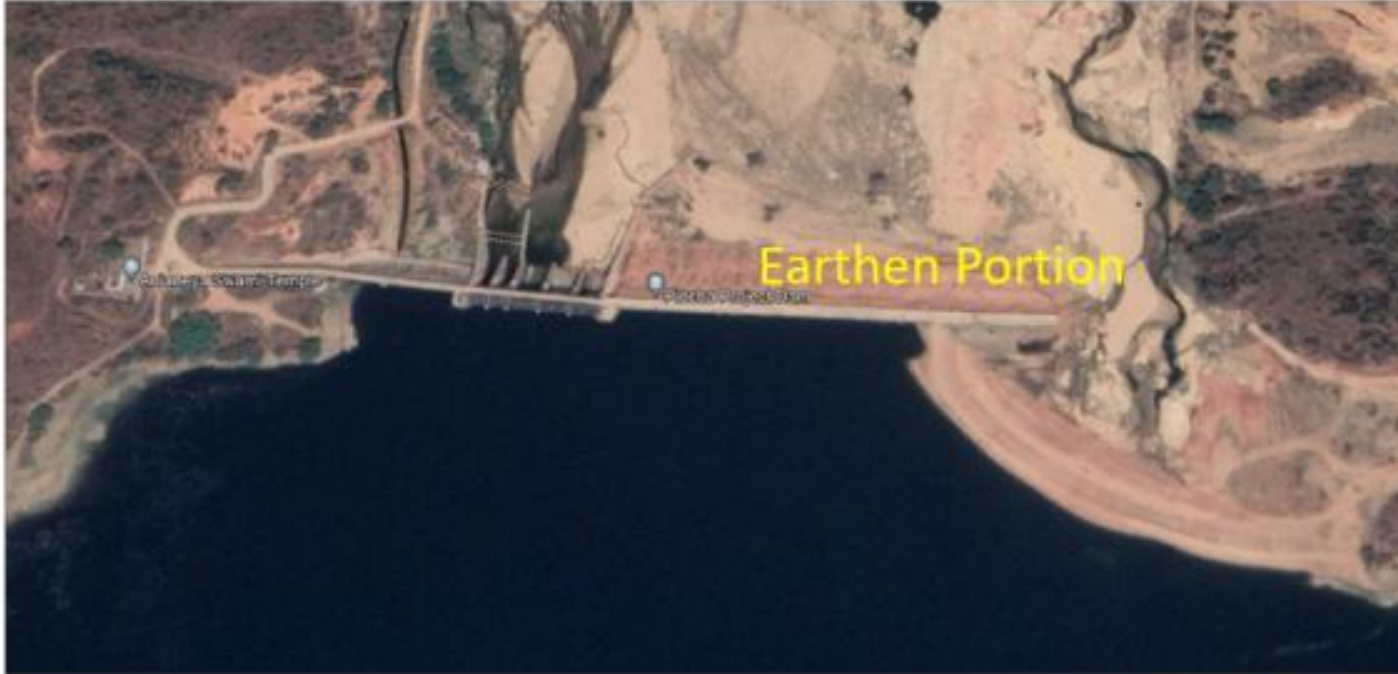
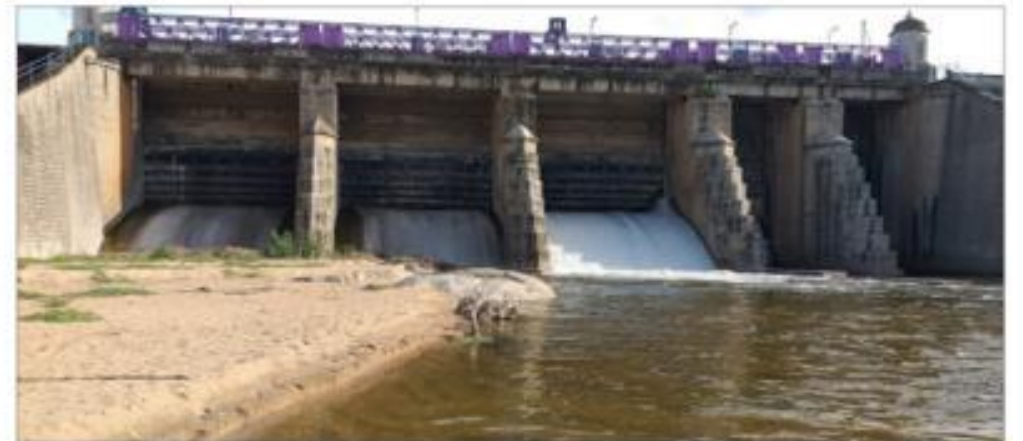
# Pincha Dam (Upstream Dam)

## MH Large Dam

Gross Storage = 9.28 Mcum / 0.33 TMC

Height = 21 m

Length = 486.0 m

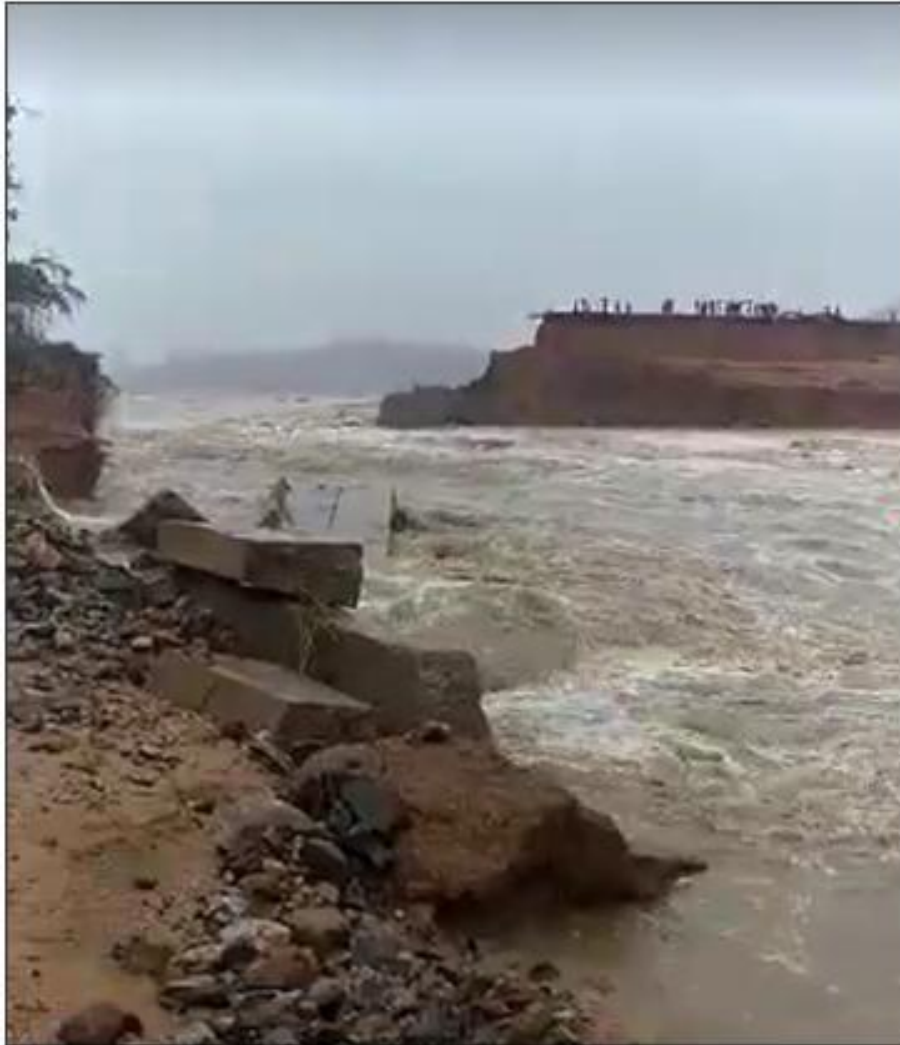
Pincha Dam Fails

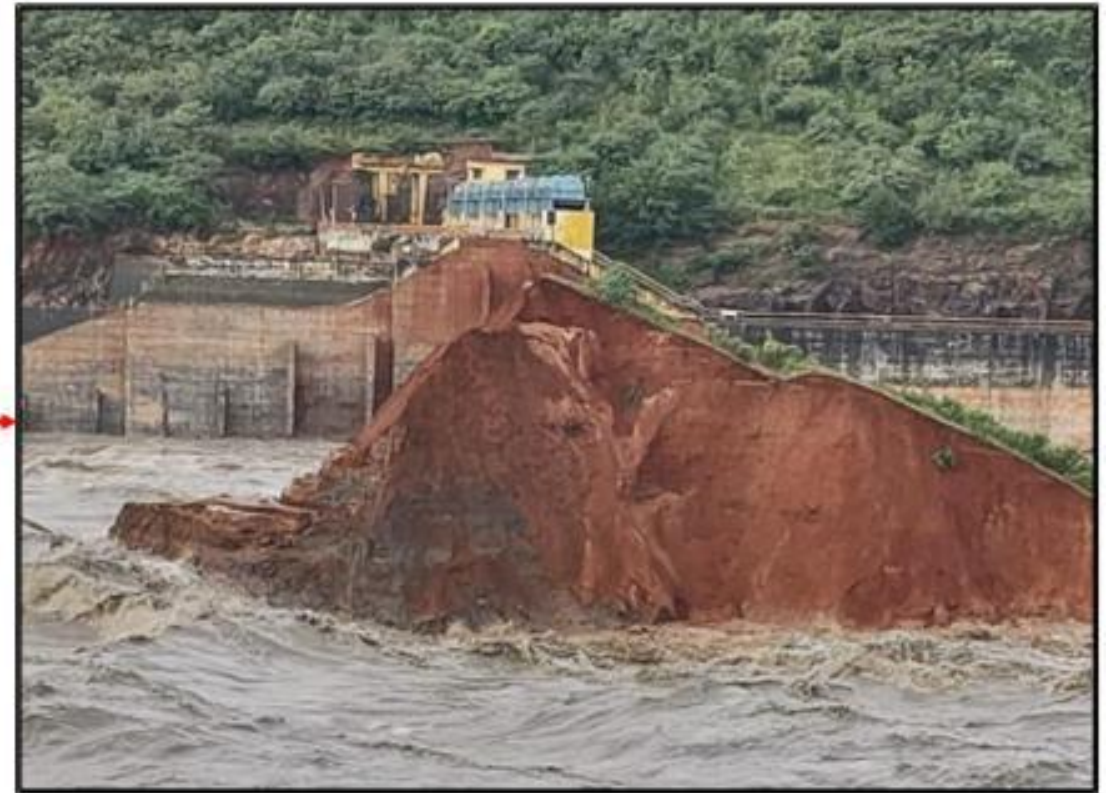
Annamayya Dam Fails

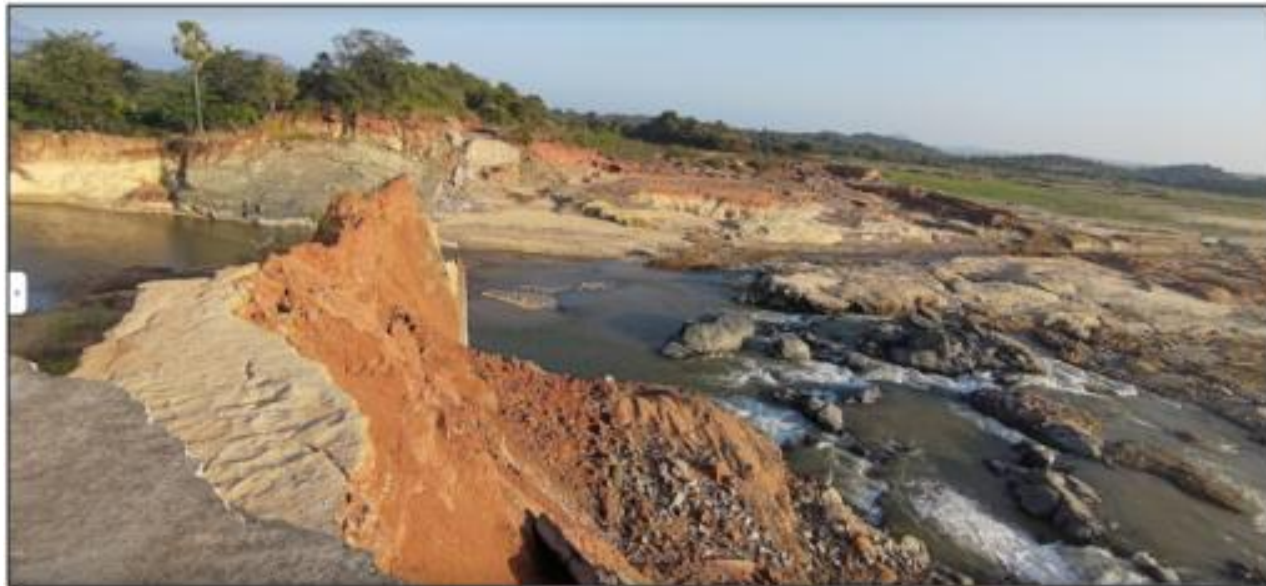
Pincha Dam

# After Flood Photos

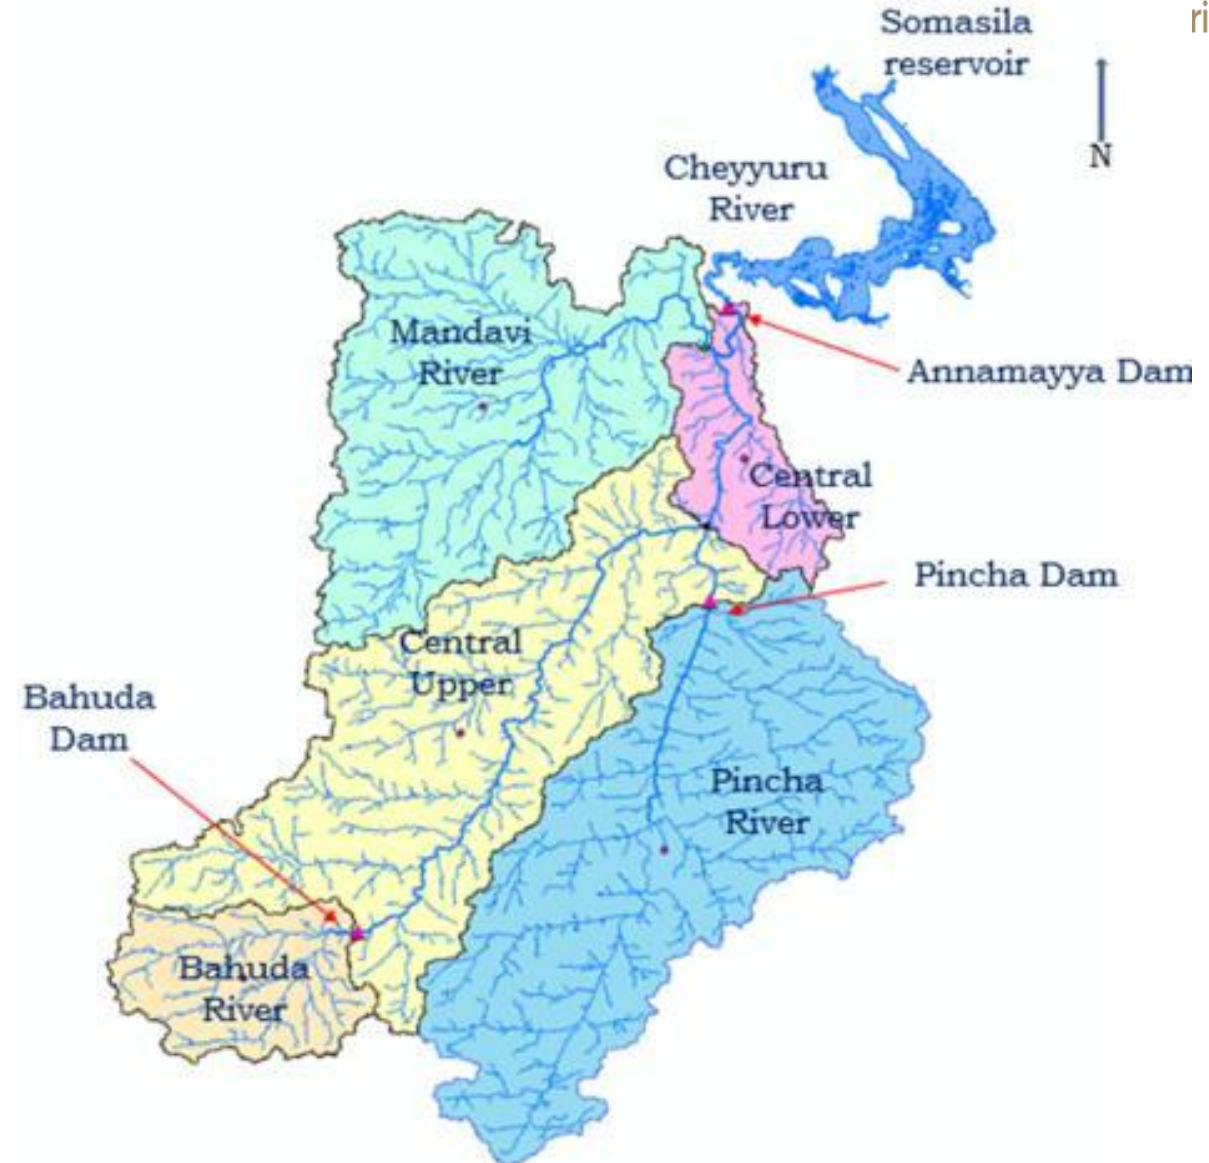
- ✓ The Total Annamayya catchment is partitioned to five sub catchments.
- ✓ Distributed model is considered. The hydrograph of each sub-catchment is subjected to channel/reservoir routing.
- ✓ Various scenarios are considered considering two upstream dams for Annamayya dam breach analysis.

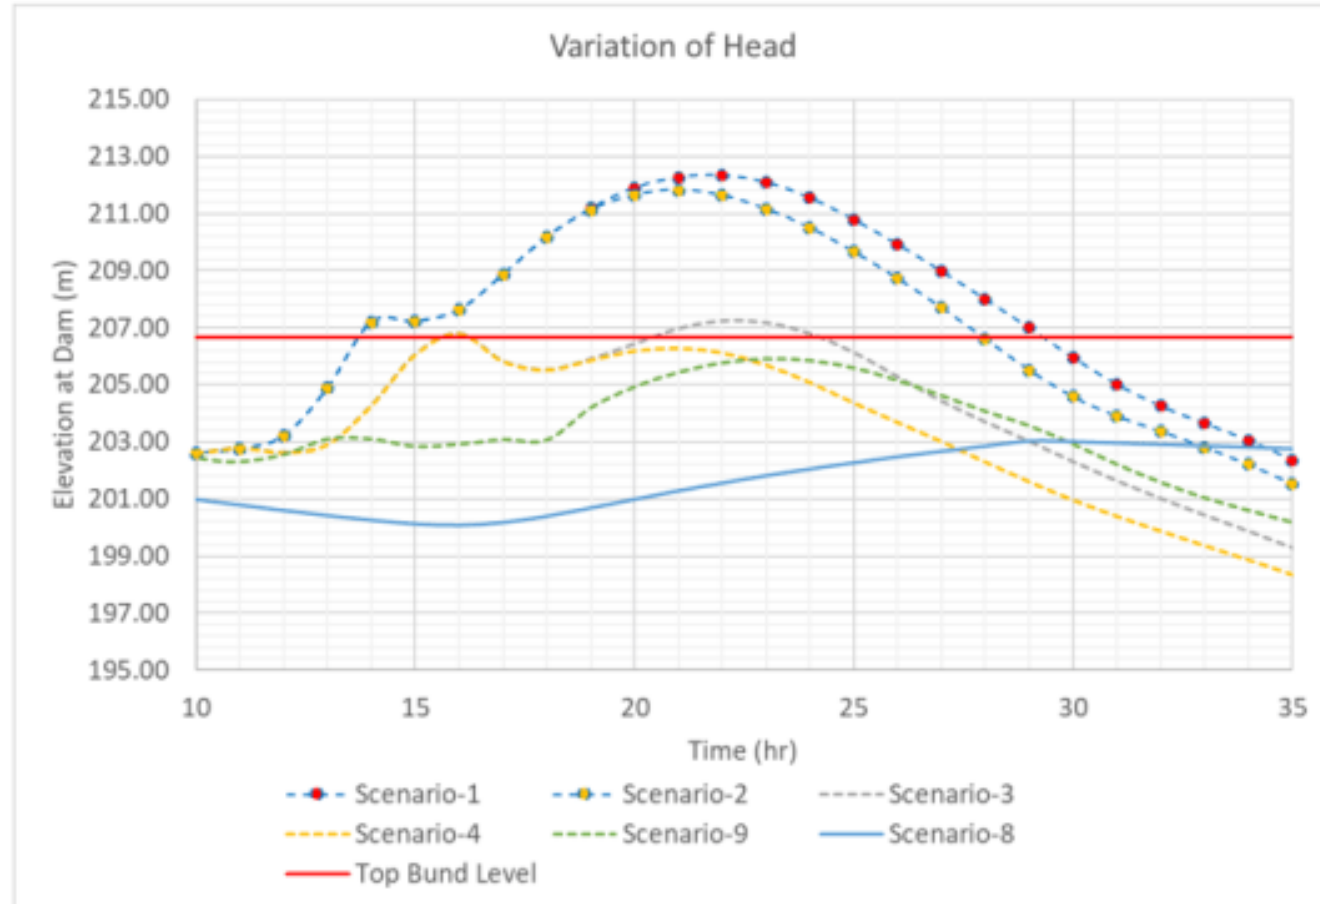
# Variation of Head for various scenarios

<b>Severe weather condition</b>	Scenario-1	Pincha and Bahuda dam fails
	Scenario-2	Only Pincha fails
	Scenario-3	Only Bahuda fails
	Scenario-4	Both dams are safe
	Scenario-9	Bahuda, Pincha and Mandavi catchments do not contribute flow
Fair weather condition	Scenario-8	Pincha and Bahuda dam fails

- Annamayya dam failure can be a catastrophic event.
- The upstream Pincha dam is found to have significant effect in inducing failure of the Annamayya dam under extreme weather condition.
- The inundation on either side of the Cheyyeru river is expected to be significant and lives of nearly 71,000 people could get affected by flood waters.
- The Nov-2021 floods took almost 33 lives, caused huge economic loss.
