International Conference on Dam Safety, 2023

**CURTAIN GROUTING & CUT-OFF TRENCH ALONG U/S RIGHT
BANK OF JOSHIYARA BARRAGE OF MANERI BHALI, STAGE-II
HEP-304 MW, TO PREVENT WATER LOGGING IN GYANSU
VILLAGE AREA IN DISTT-UTTARKASHI (UTTARAKHAND)
EXECUTED UNDER DRIP PHASE-II: A CASE STUDY**

UJVN LTD, DEHRADUN (UTTARAKHAND)

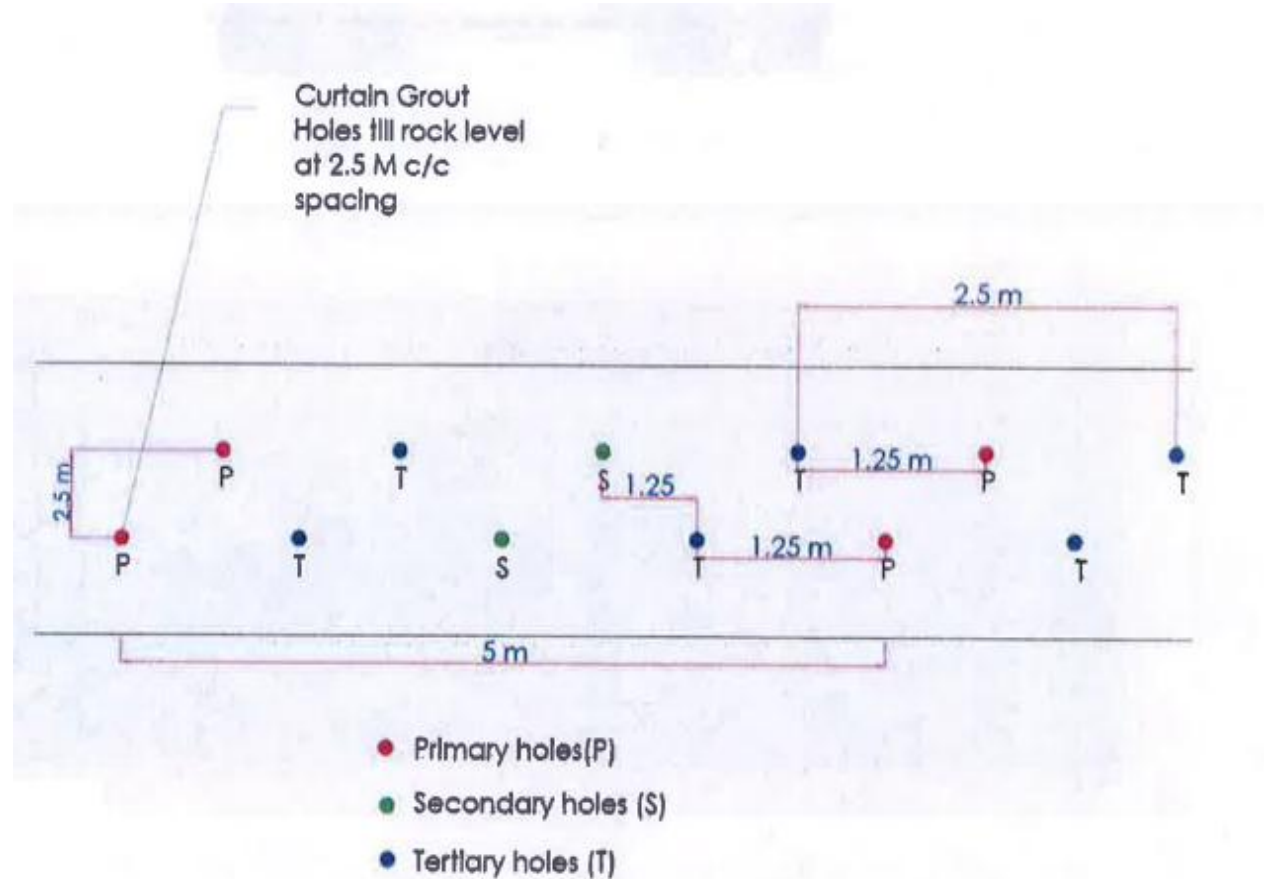
Groutability Test (triangle method):

- 1st Primary hole of 35 m depth were drilled at corner position of triangle & grouted in ascending order by double packer
- 2nd & 3rd Primary holes of 35 m depth were also drilled at corner position of triangle of 2.5m side & grouted in ascending order by double packer
- Test hole was drilled in centre position & tested for permeability & traces of grout material

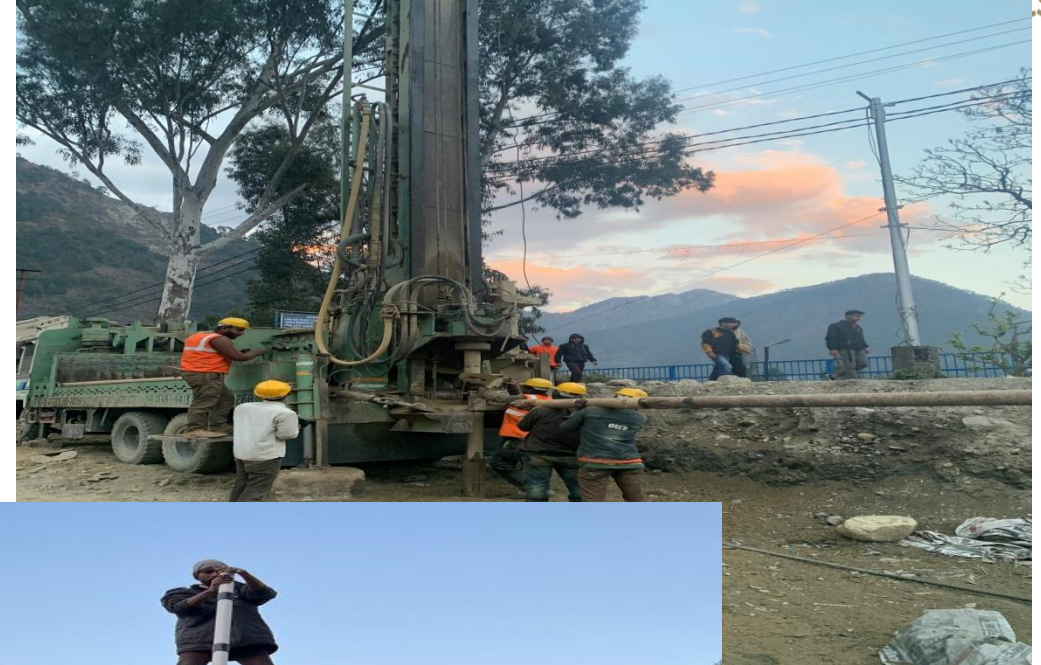
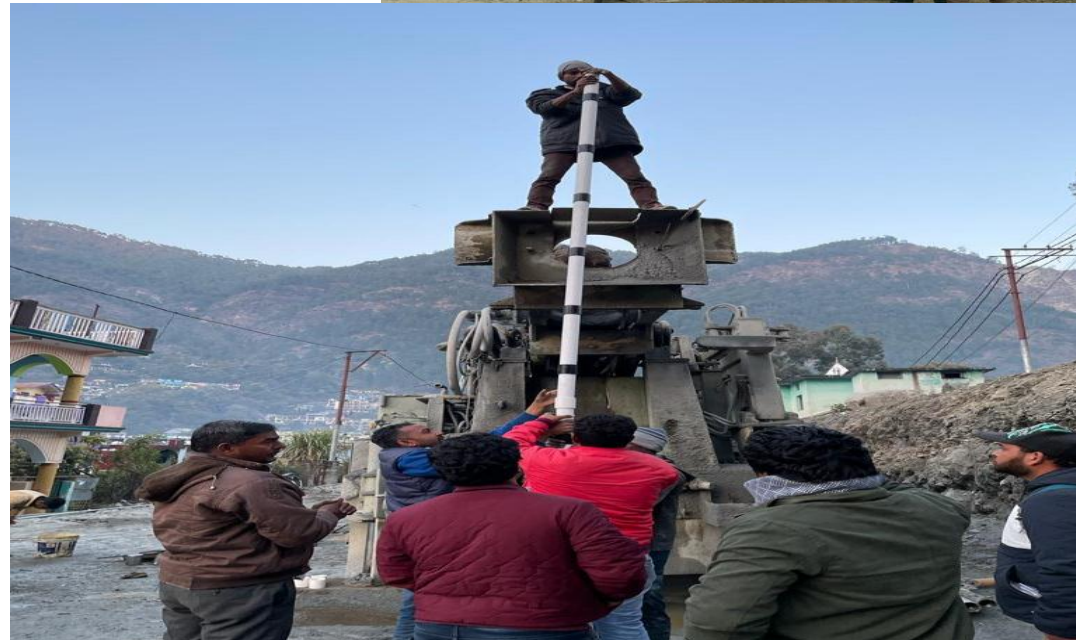
Execution of TAM Grouting:

- As overburden strata consist of RBM, boulders & coarse sand, Tube-a-Manchette (TAM) grouting technique was found most suitable and adopted for making cement grout curtain.
- As strata was in collapsible nature, MS casing pipe was lowered simultaneously with drilling
- Depth of bore hole: 35m-40m
- Diameter of bore hole : 172 mm
- Diameter of MS casing pipe: 168 mm
- Diameter of TAM pipe: 62 mm
