International Conference on Dam Safety, 2023

Lessons Learned from Dam Failure

Anil Jain, A.K. Verma and Gaurav Tiwari

Central Water Commission

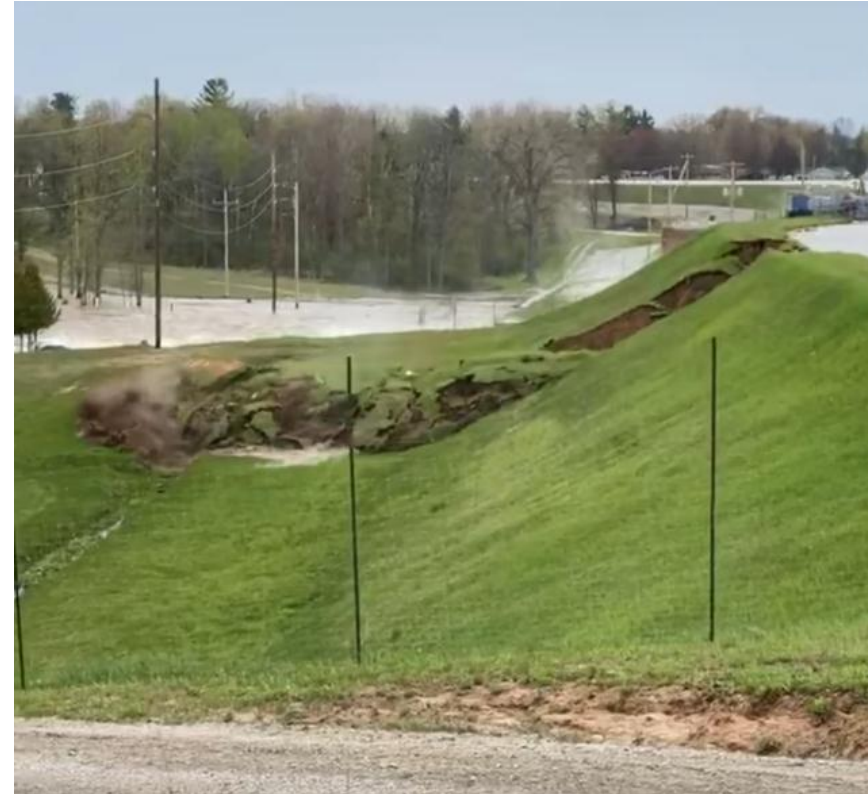
Modes of Dam Failures

- **Shear failure/slope failure:**
Sliding failure of U/s or D/s slope due to Inadequate shear strength or poor construction practices
- **Overtopping during a flood:**
Surface erosion and downstream slope breach

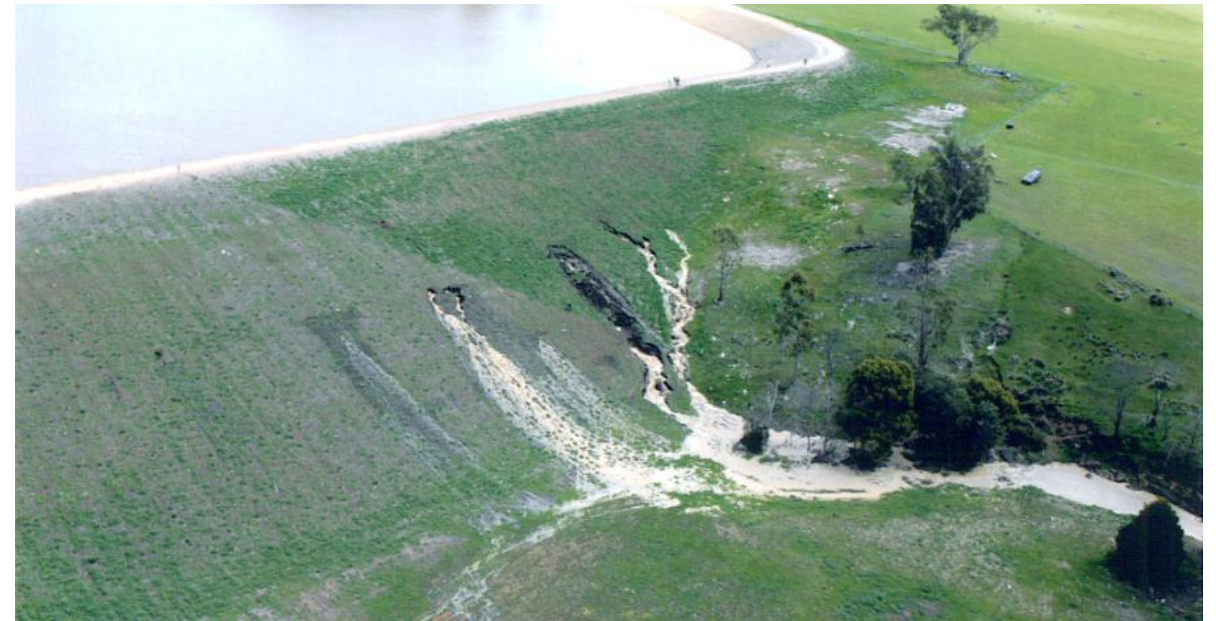
Modes of Dam Failures

- **Internal erosion:** Excessive seepage and leakage
- **Earthquake-induced failures:** Dynamic forces, slope instability, soil liquefaction
- **Neglecting maintenance:** Gradual deterioration, erosion, vegetation overgrowth, seepage

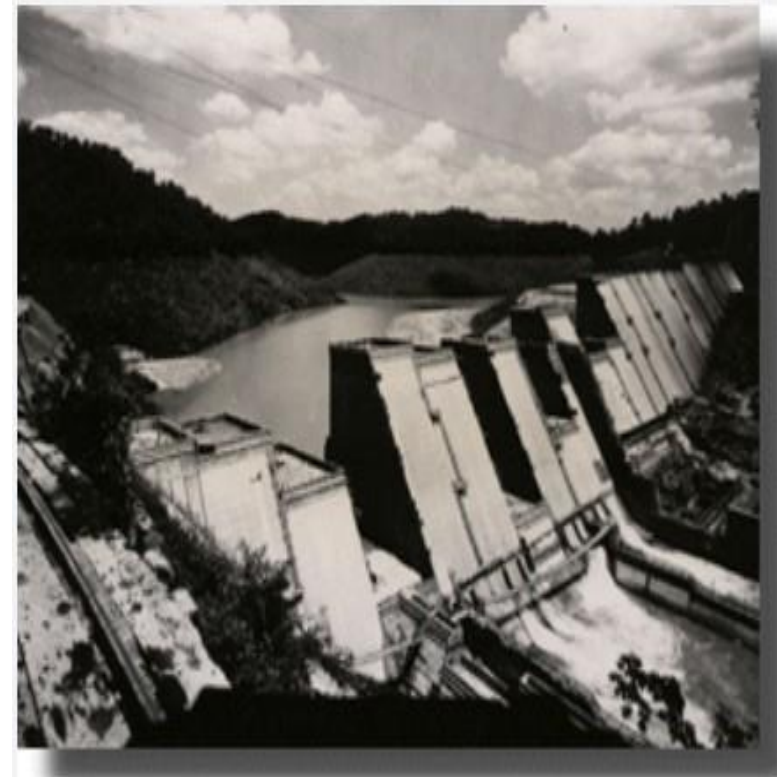
Modes of Dam Failures

- Concrete cracking, Leakage in joints
- Uplift and foundation sliding, Overturning
- Dam breakage, abutment failure

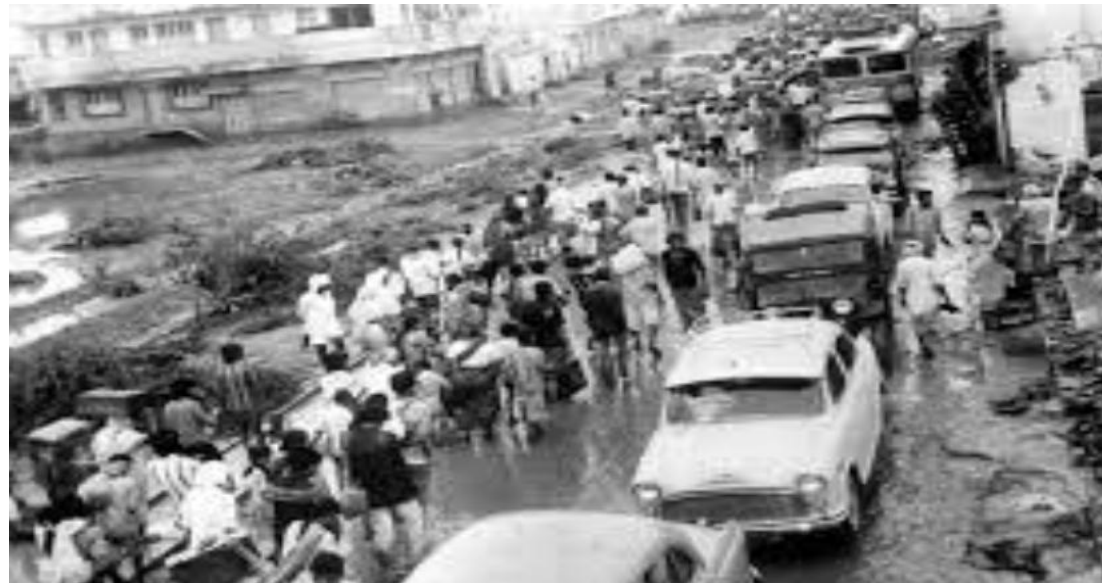
Machhu II dam failure... cont

- Abnormal floods and inadequate spillway capacity leading to disintegration of earthen walls of 4km long Machhu dam.
- Actual observed flow reached to $16307\text{m}^3/\text{s}$, thrice of what dam was designed for.

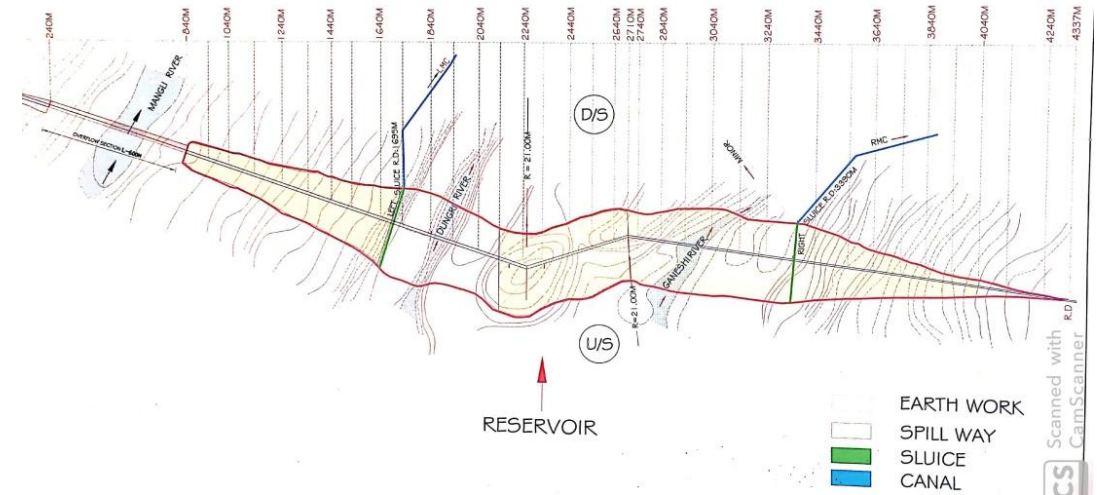
Gararda dam failure

- Garada irrigation project, Rajasthan consists of 30m high earthen dam with masonry spillway. Total length of the dam is around 4270 meter
- The Dam taps the discharge of the three Chambal basin drainage channels, namely Mangli Nala towards the left end across which there is a spillway site, Dungi river is in the middle and the Ganeshi nala is at the right end of Dam axis.
- The Garada dam, a zoned earthfill dam was completed in March, 2010 and subsequently breached on 15.08.2010 during initial filling of the reservoir when it was filled only up to 4.0m below the ungated crest level (FRL).
