Efficient Design and Usage of Synthetic Geomembranes for Wateproofing in Dams to restore Watertightness and increase service life of the structure

Jagadeesan Subramanian & Vinayagam Subramanian

September 14th – 16th 2023, Jaipur, Rajasthan

UPPER BHAVANI DAM

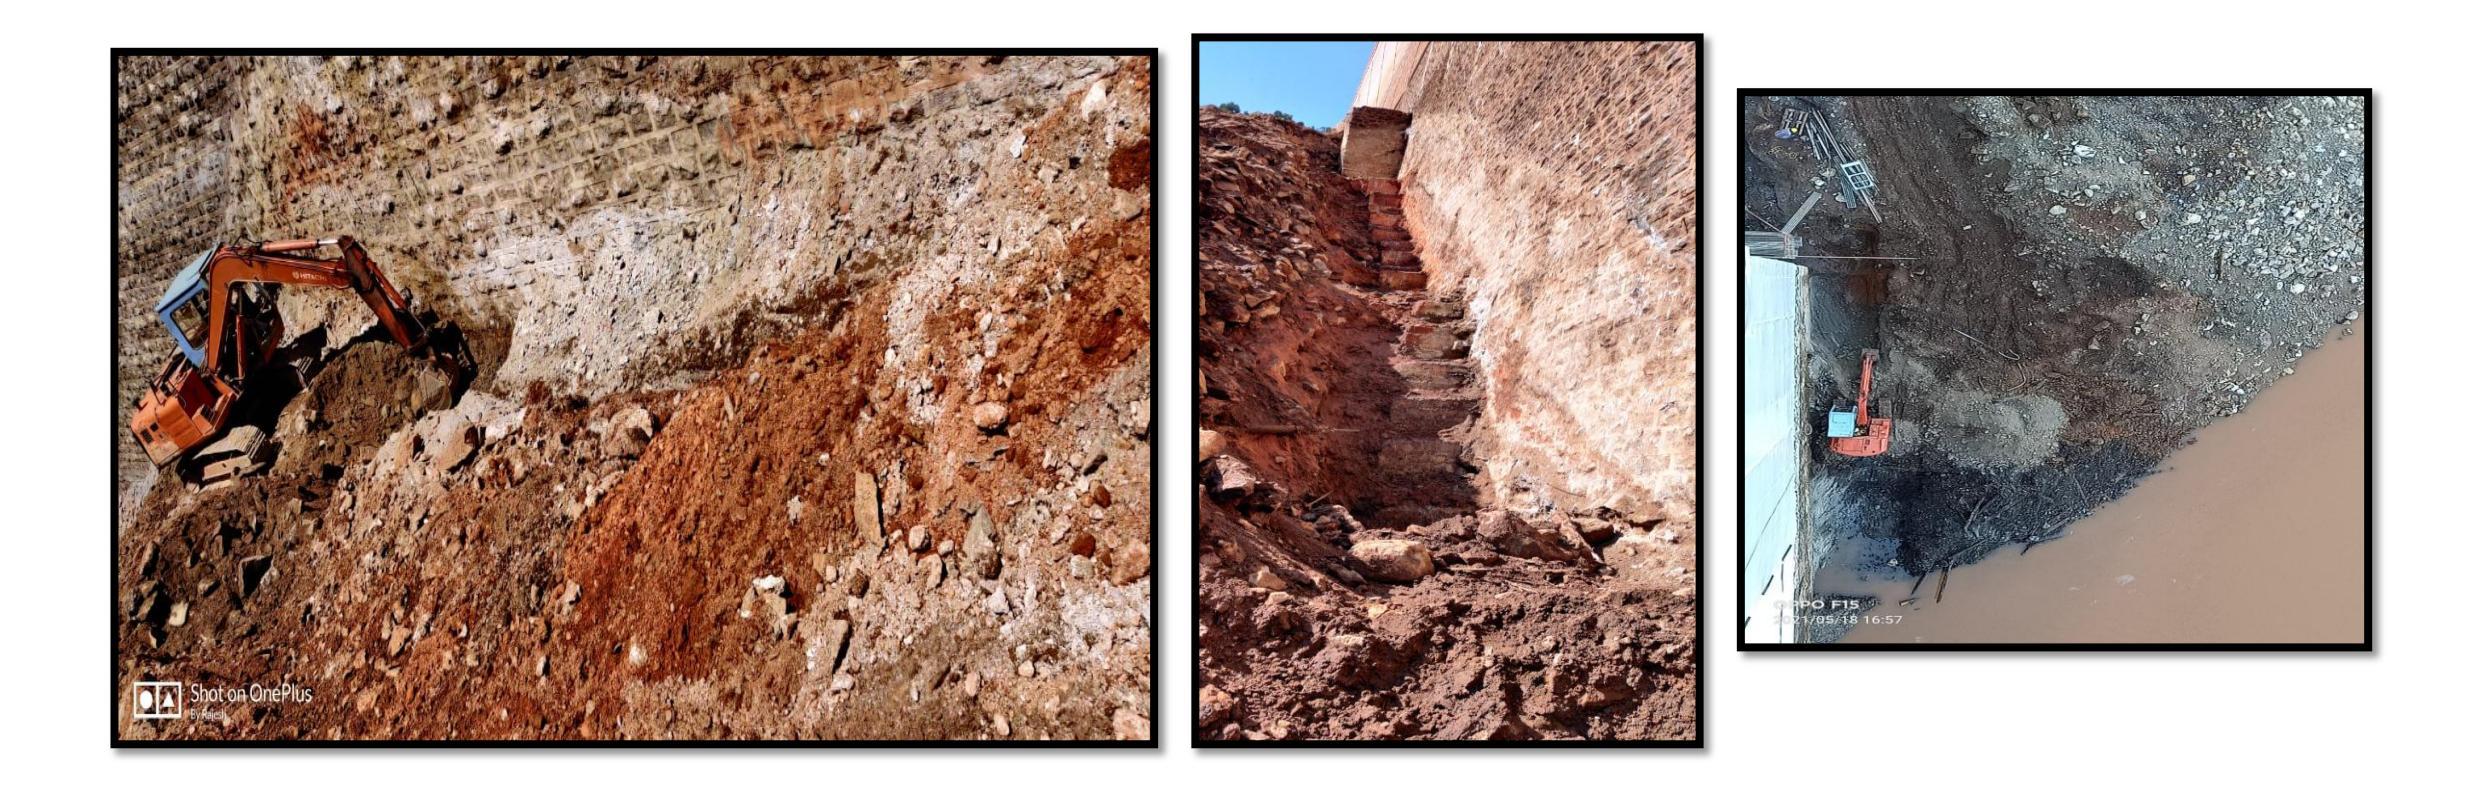
Desilting was carried out to expose the toe end of the masonry dam.

Complicated Steep Left Flank. Fairly Safer and levelled Right Flank. Desilting in some places were as deep as 15 meter

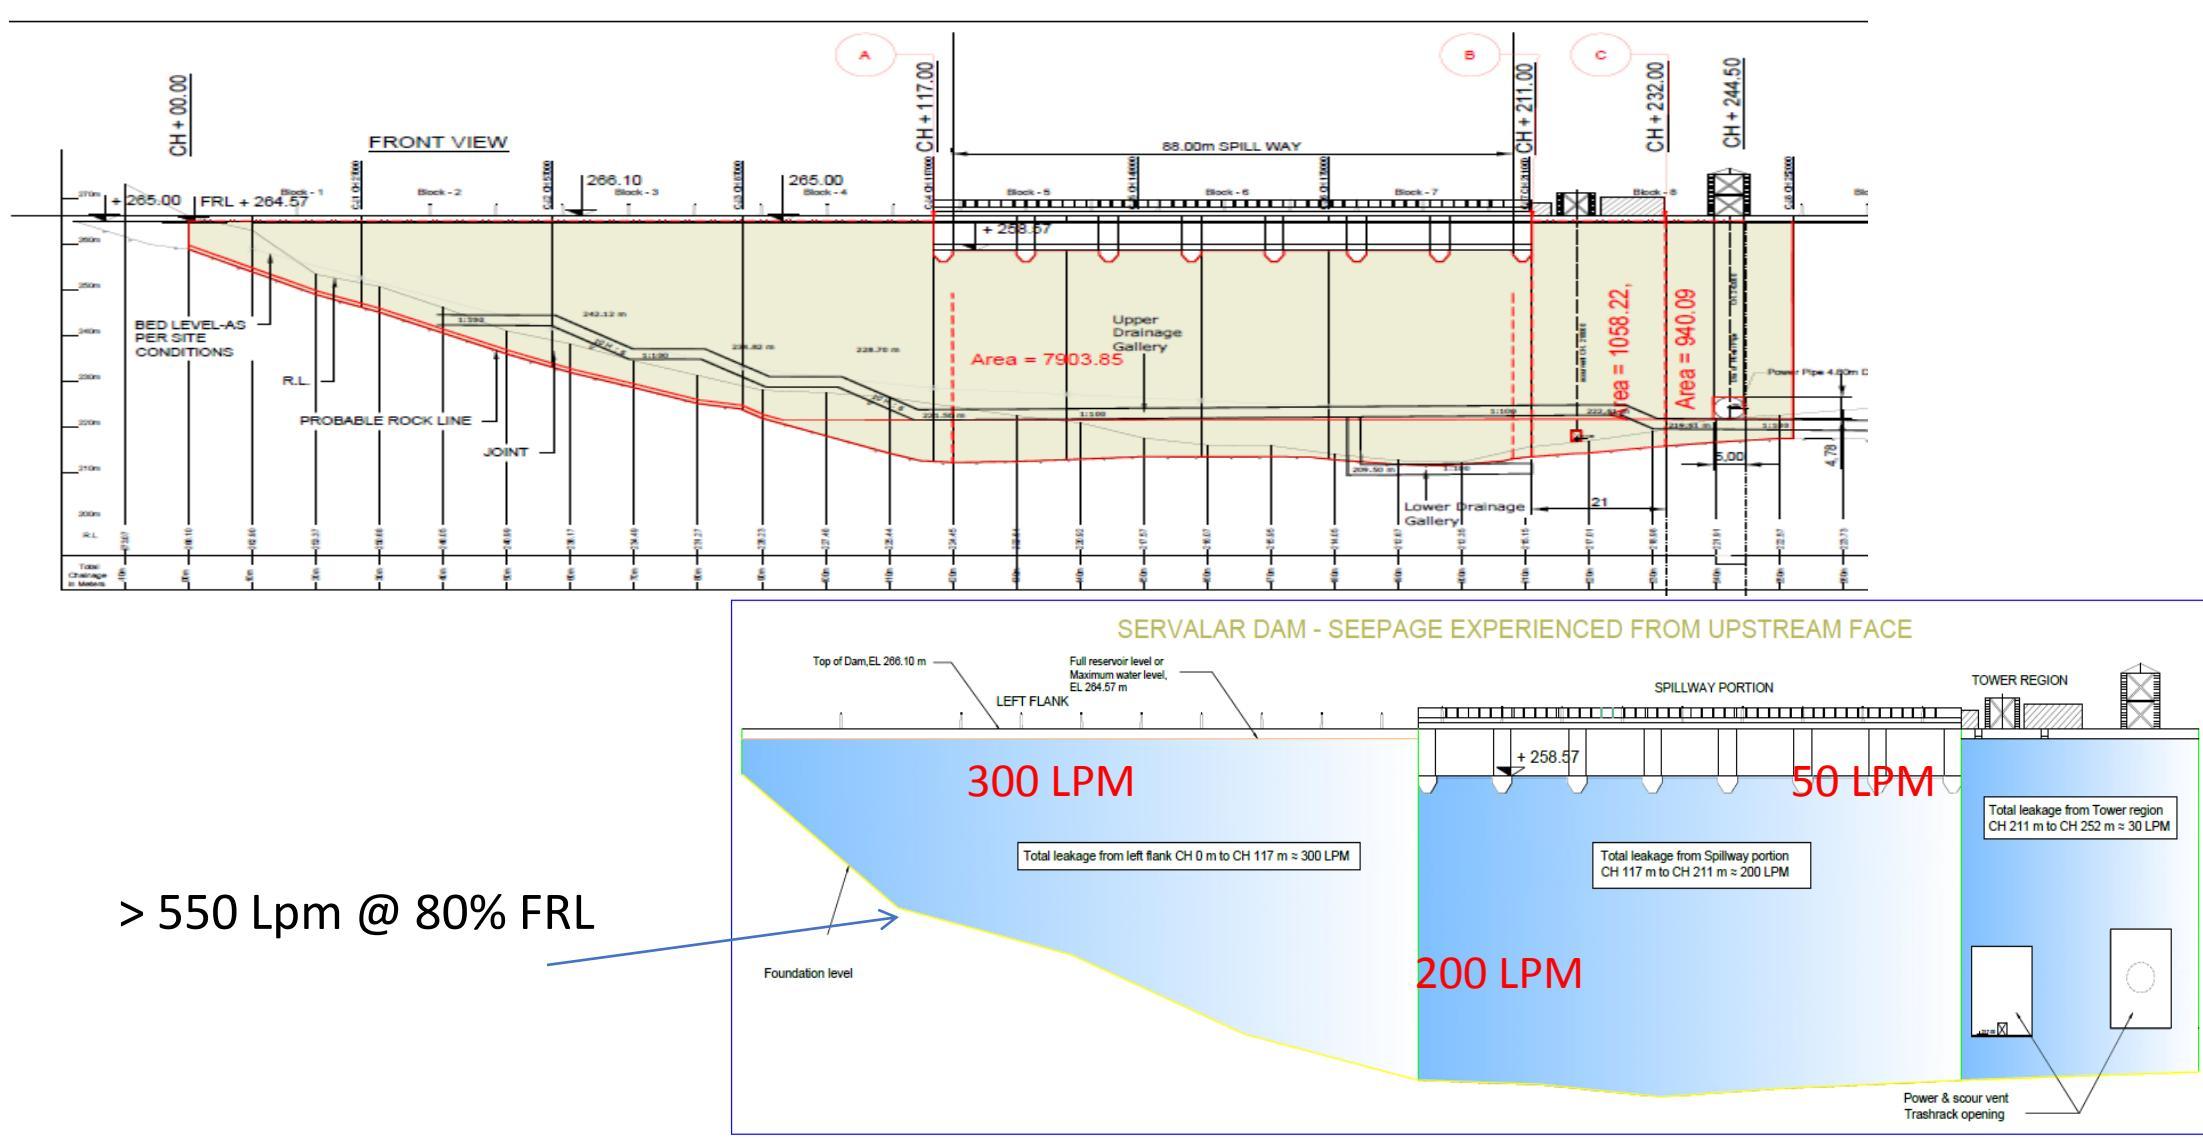
Part of the Dam – Left Flank and Spillway

Heavy Seepage in the dam

Only the gallery was measured at 743 lpm in 2009

Porous shafts were choked resulting in saturation of dam body and leakage observed on the downstream side of the dam.

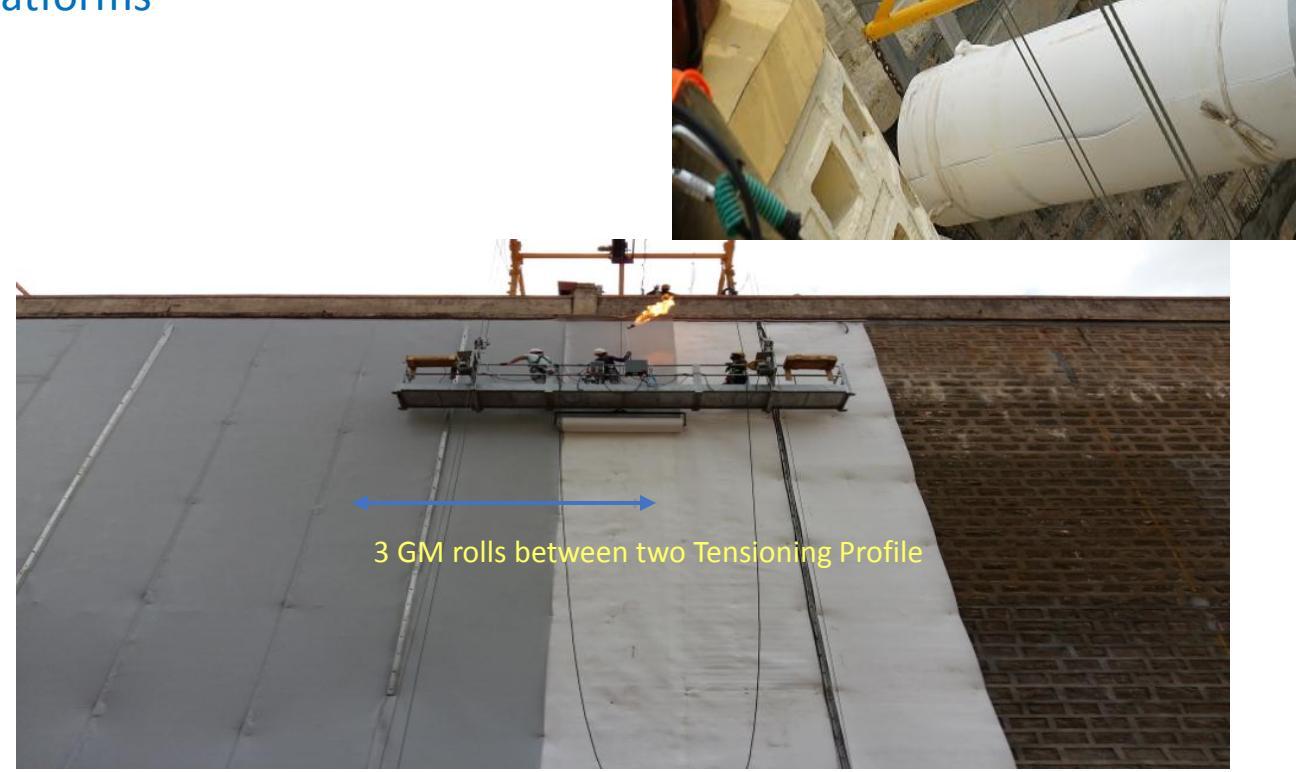
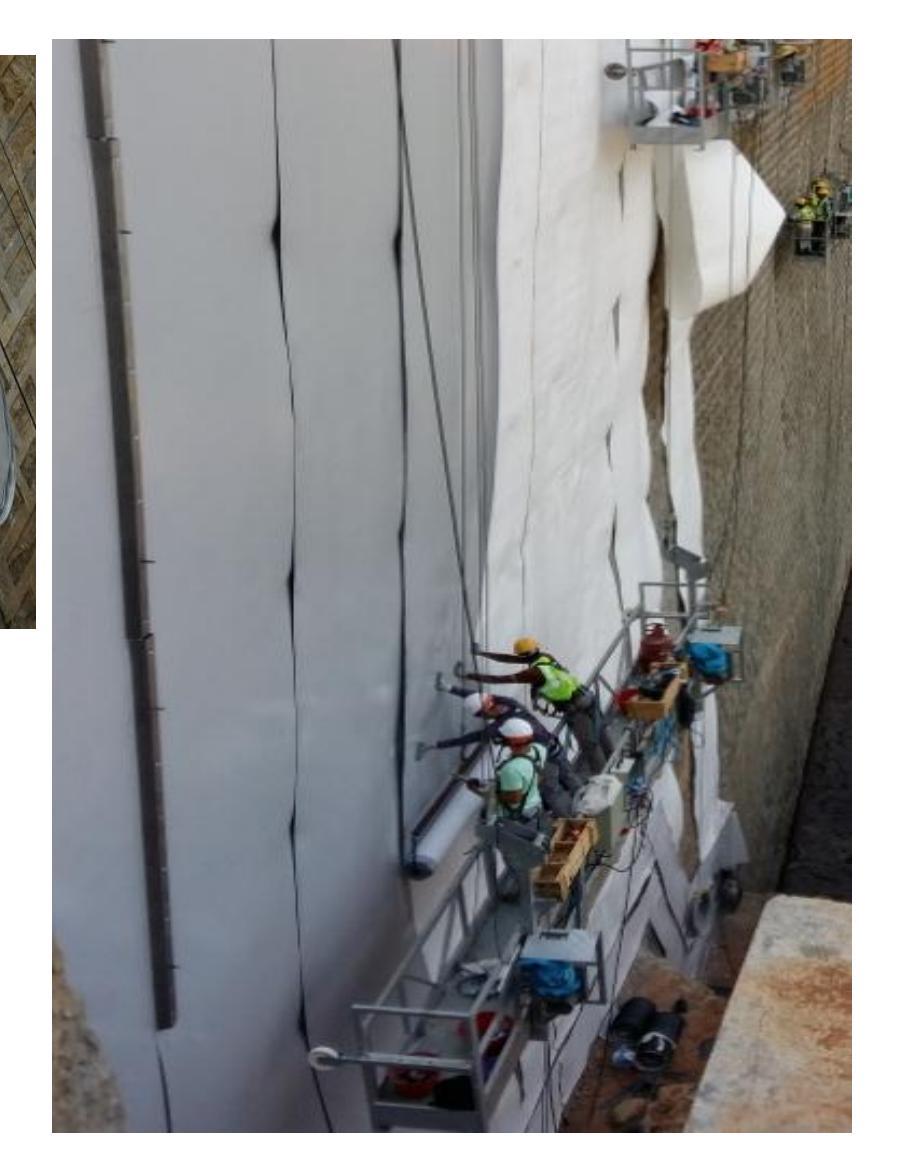
Geocomposite rolls are unrolled using the lifting mechanism inbuilt in the suspended platforms. The lowered rolls are put in place by the installers in the platforms

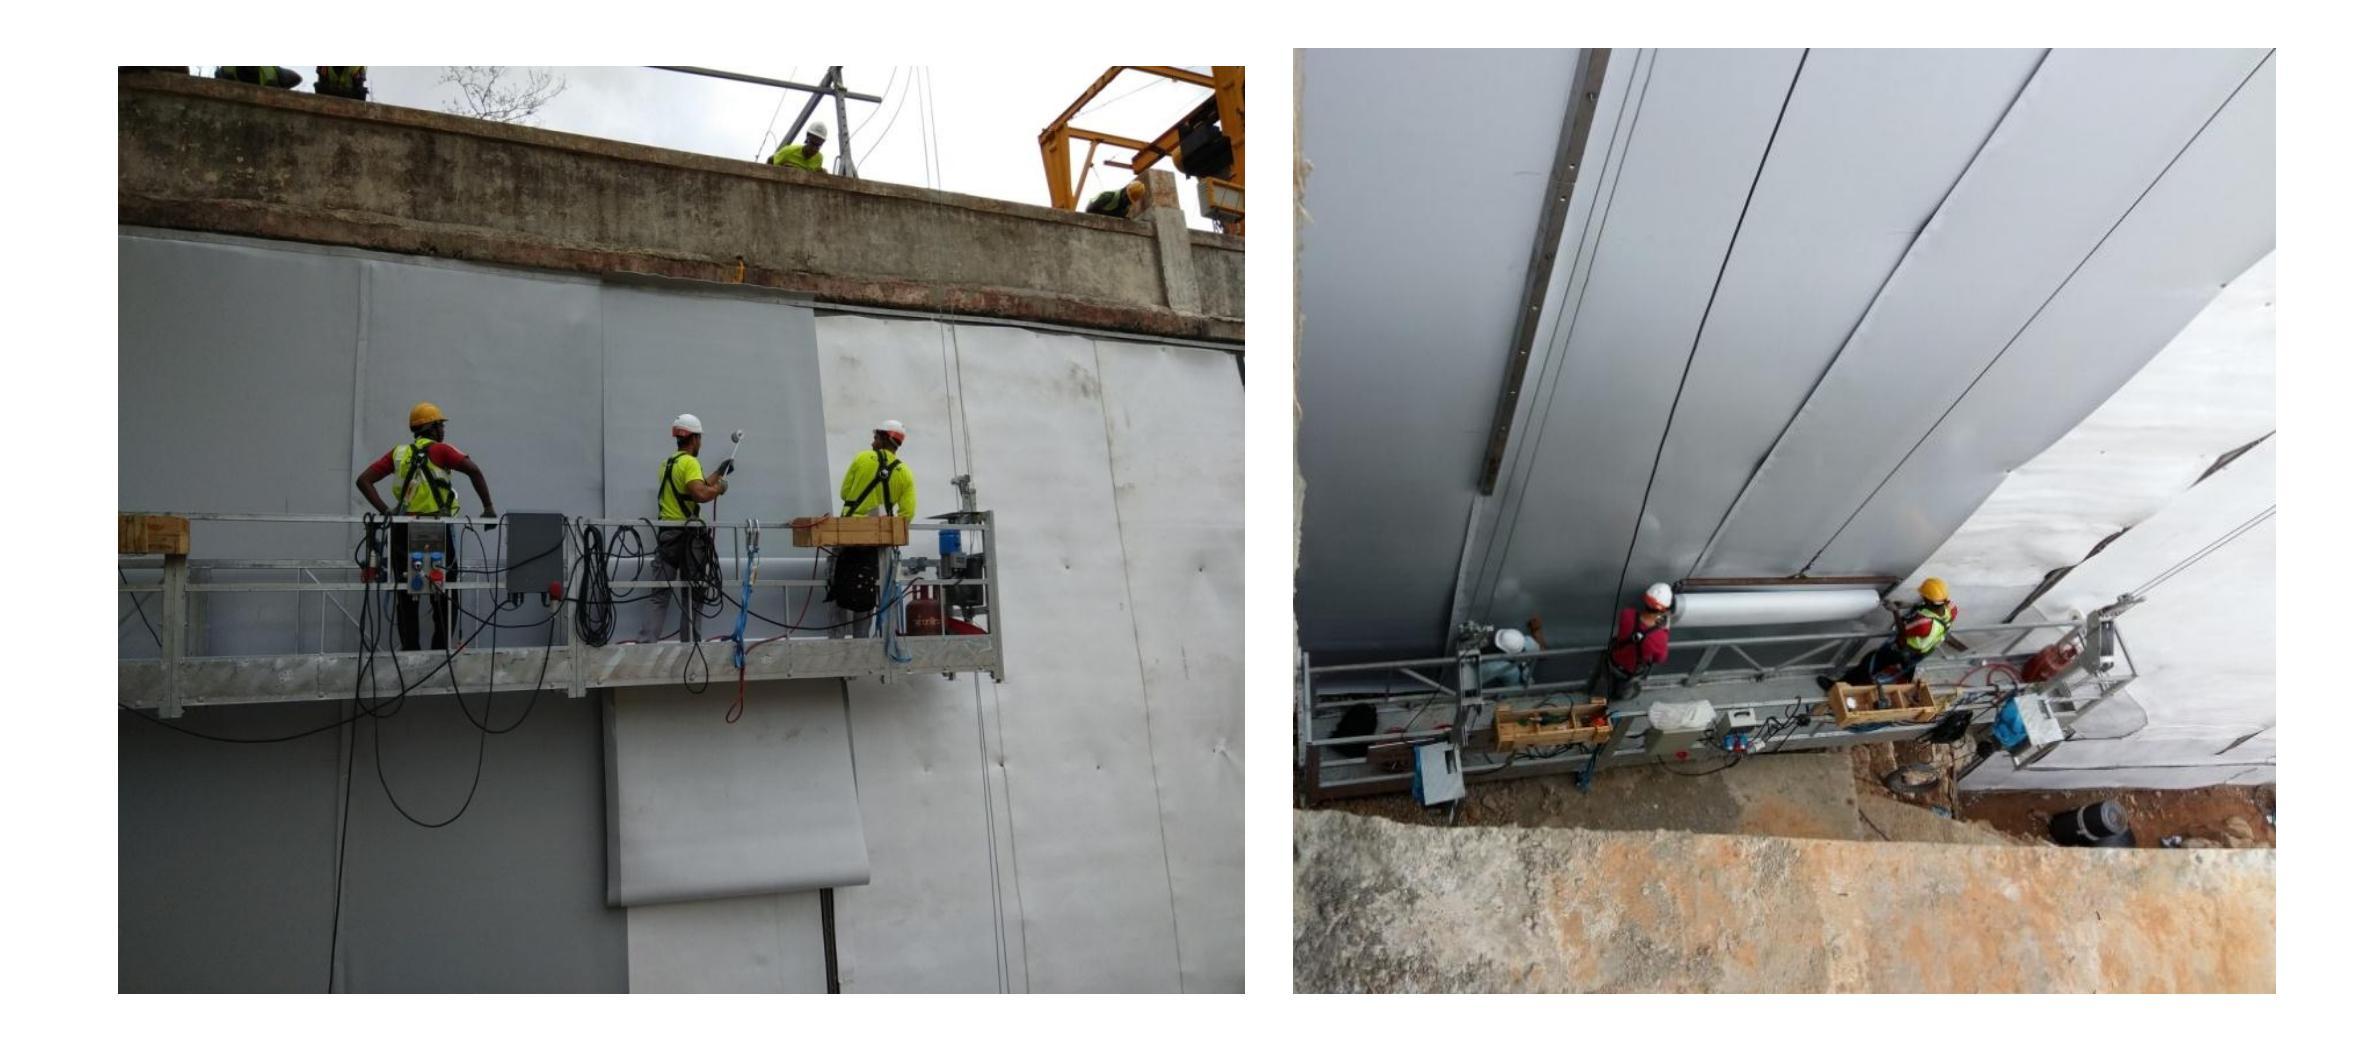
Geocomposite Welding

Multiple Rolls of Geocomposite are welded by Hot Air Welding.

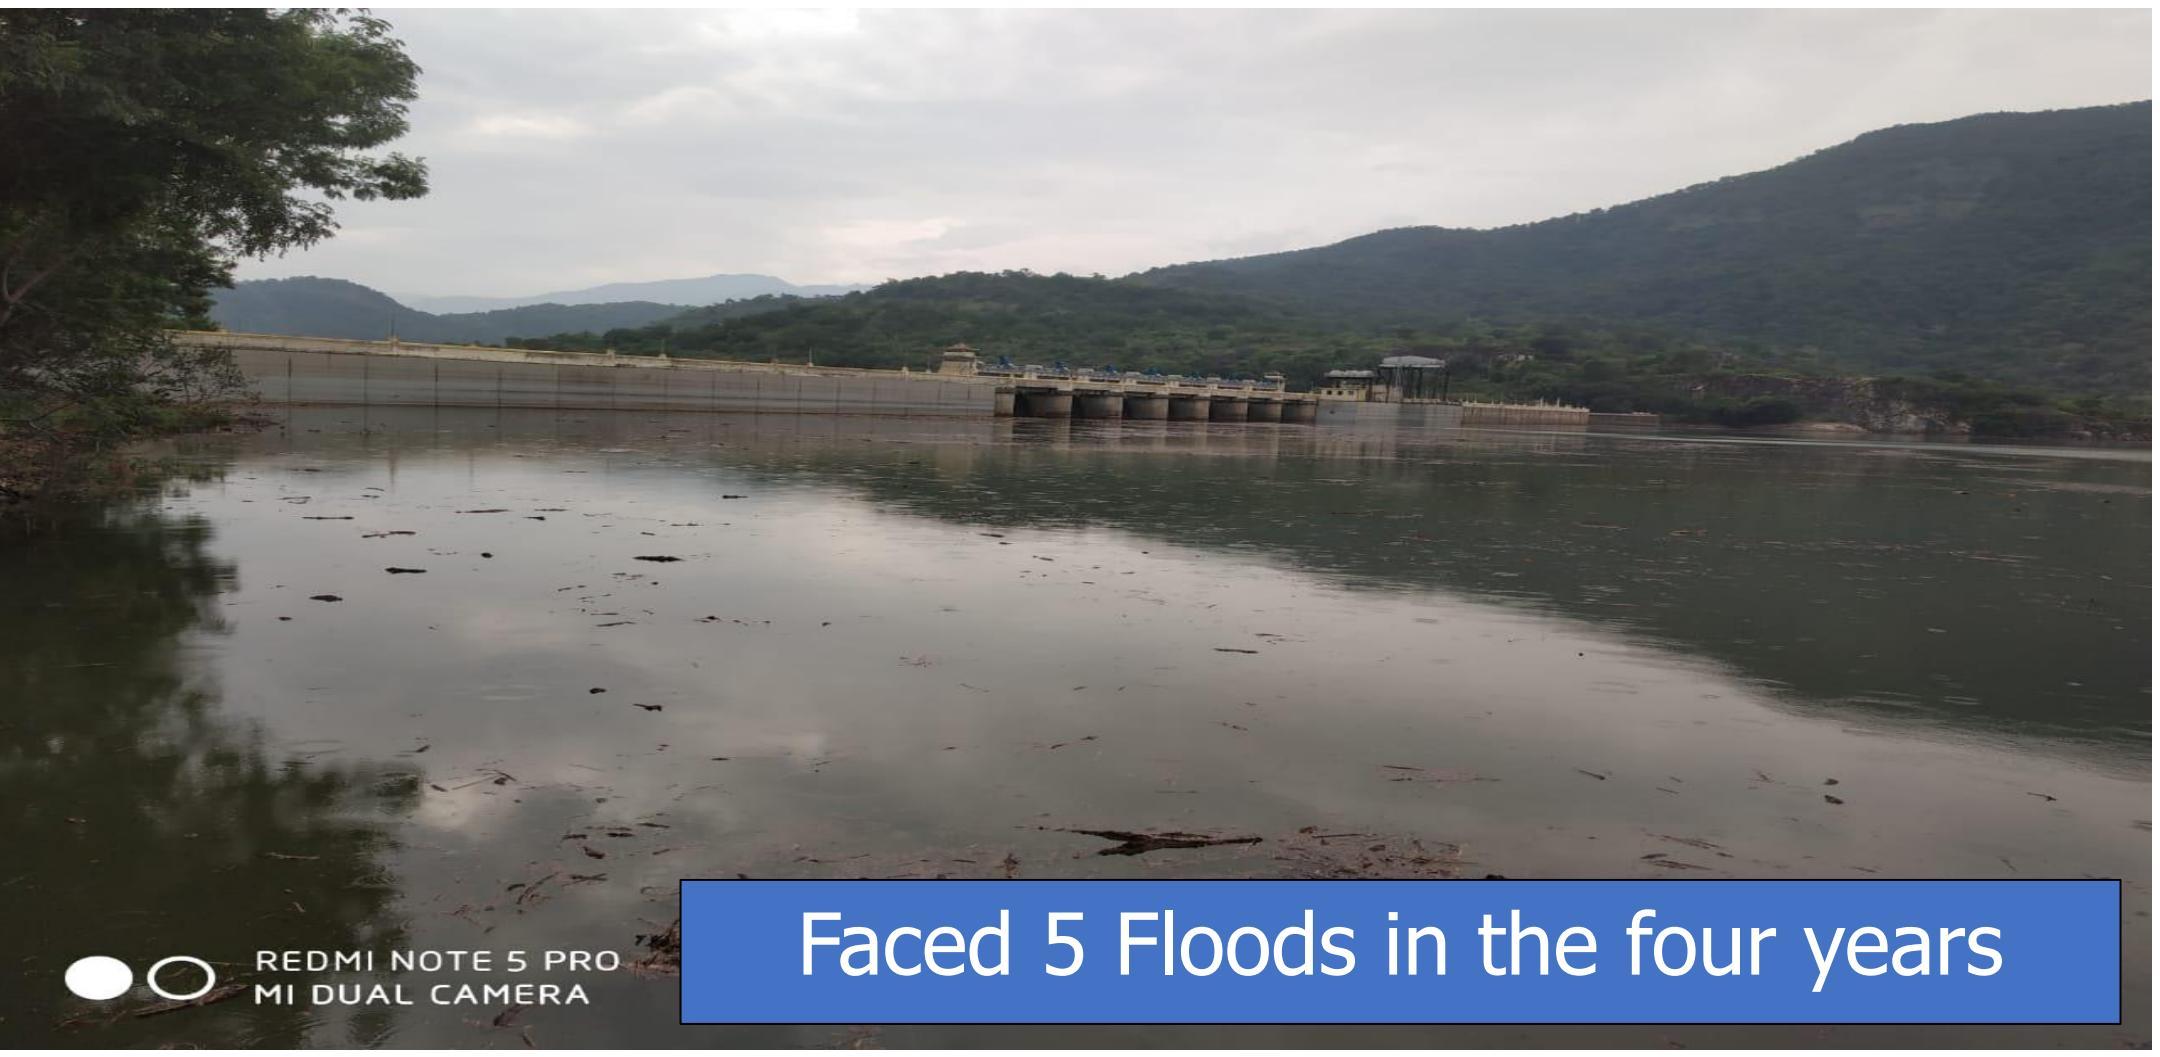
After nearly 4.5 Years of Service

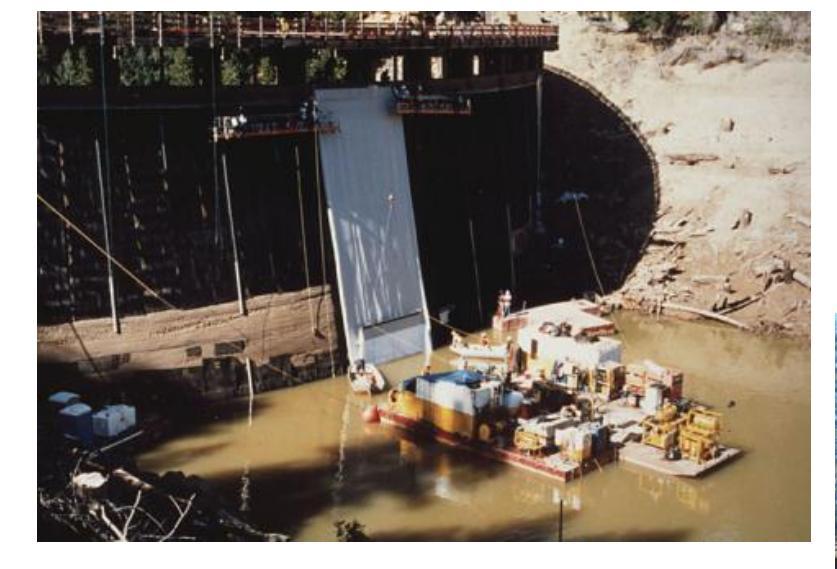
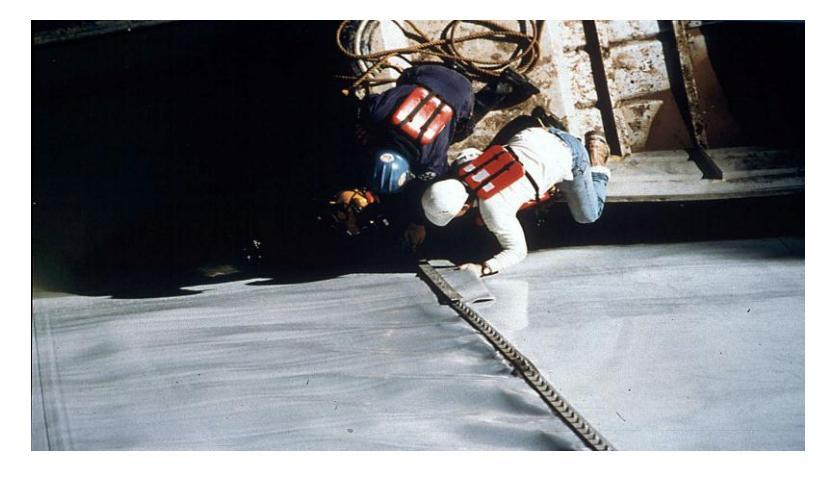
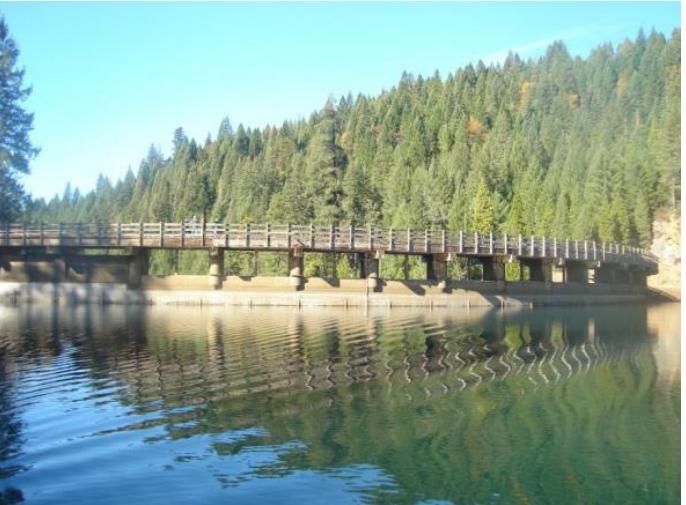
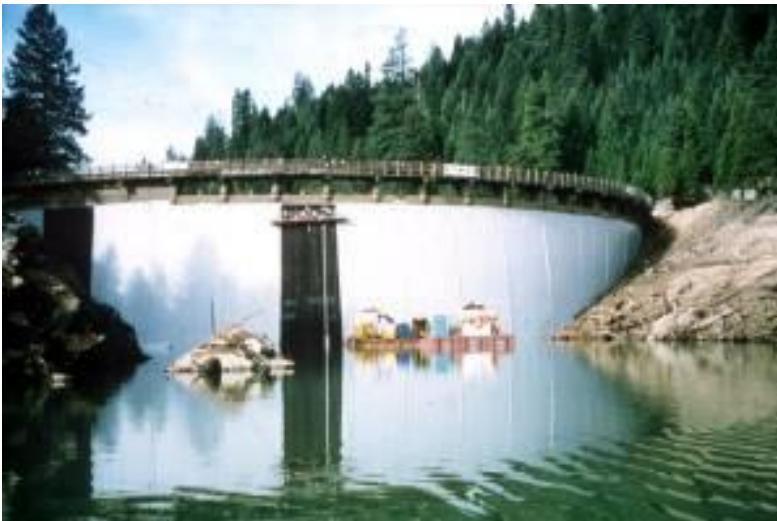
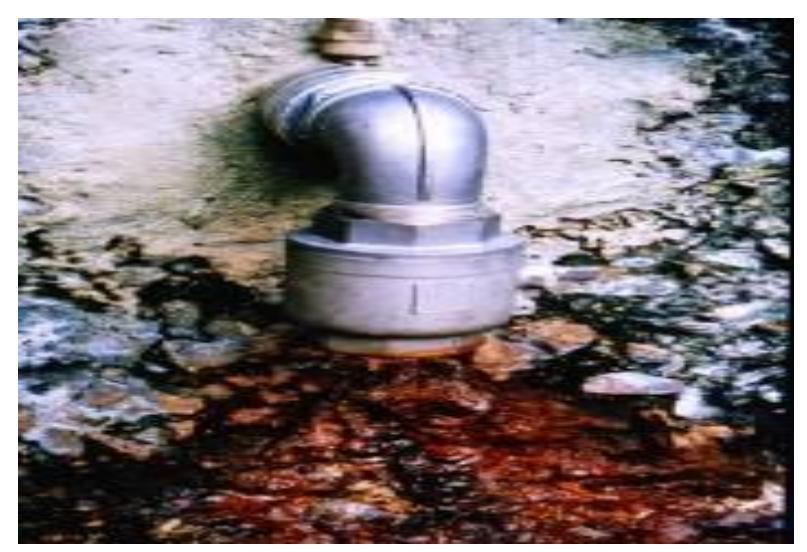
First project in USA 1997, rehabilitation for the full face of Lost Creek arch dam.

Total leakage < 0.0126 l/s

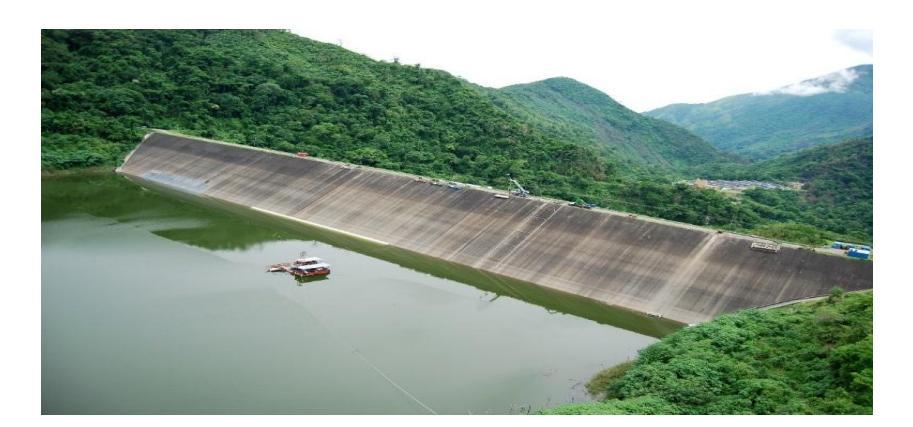
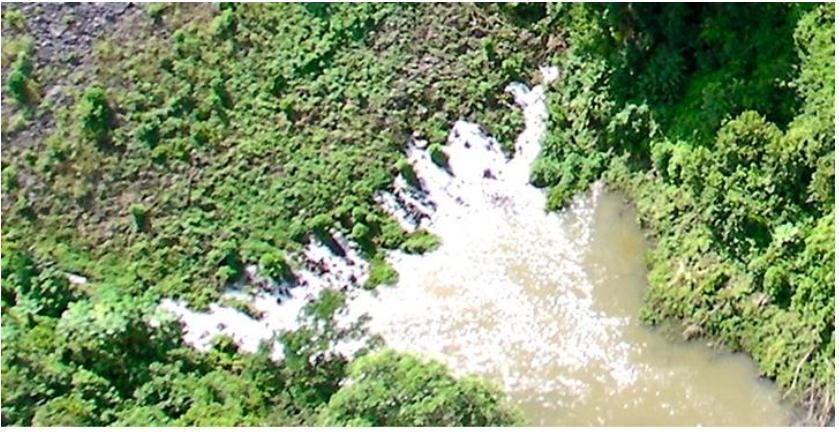
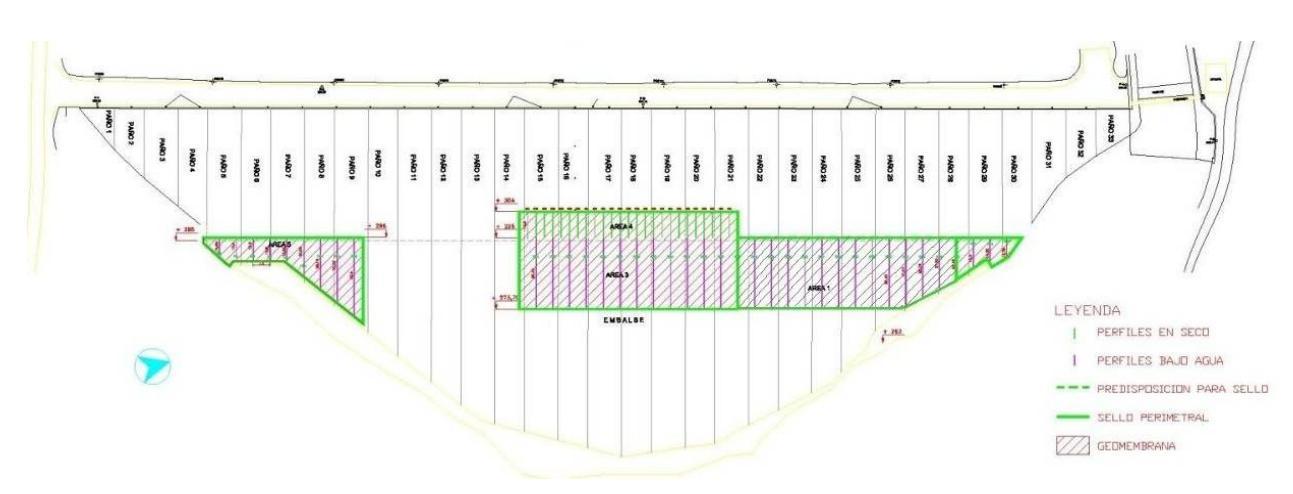
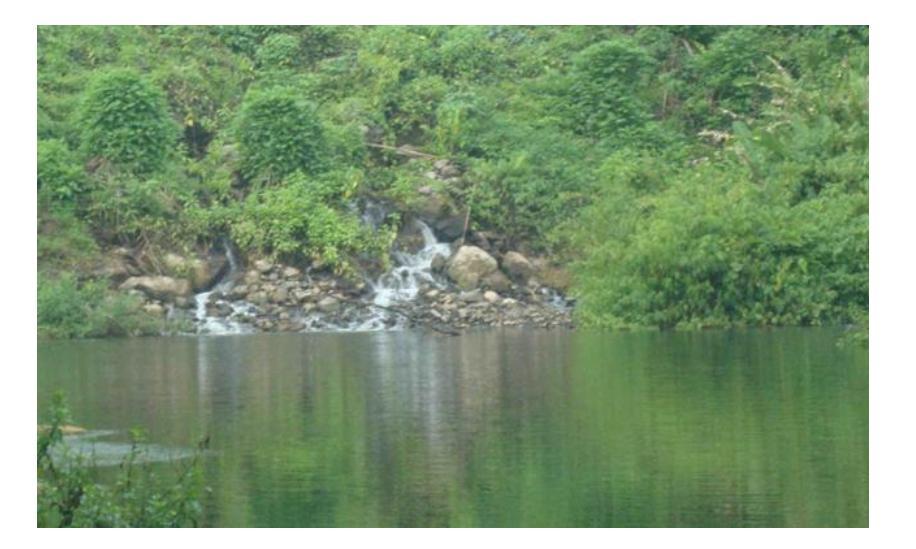
First large project in Venezuela, 2010/2011 for the rehabilitation of some 20% of Turimiquire upstream face. Maximum diving depth 65 m

Leakage reduced from 9,800 l/s to 2,400 l/s

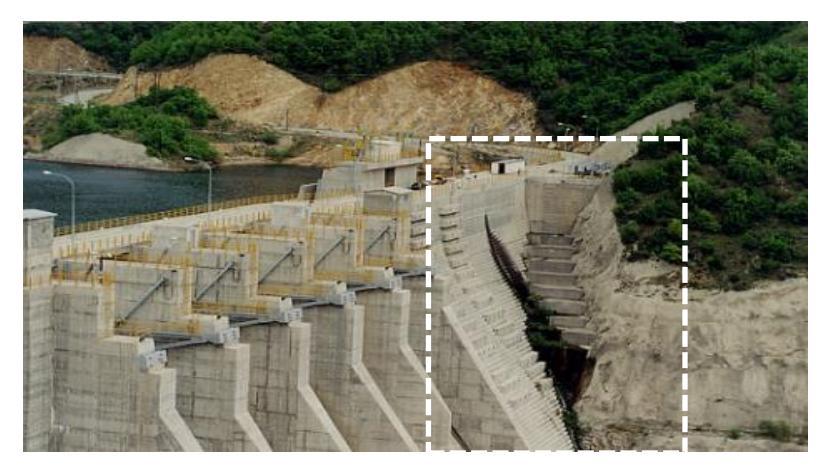
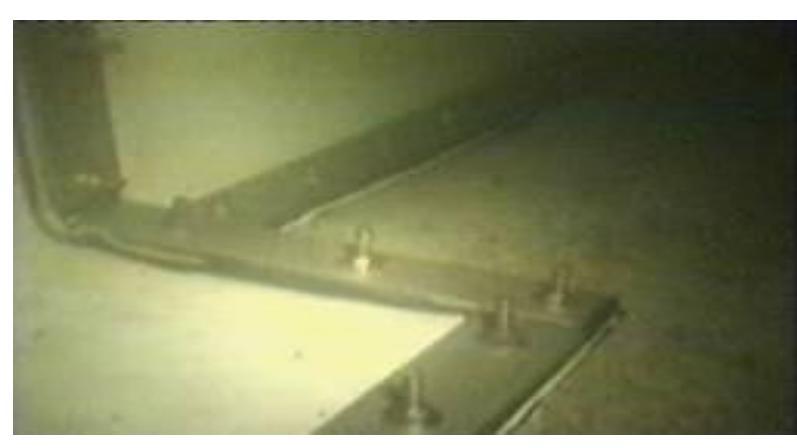
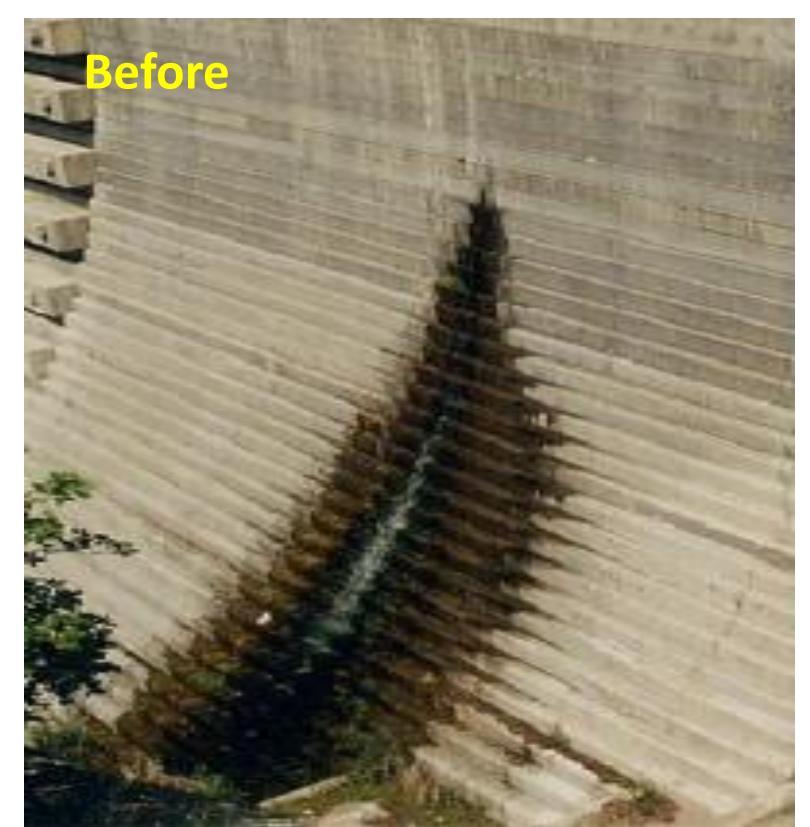
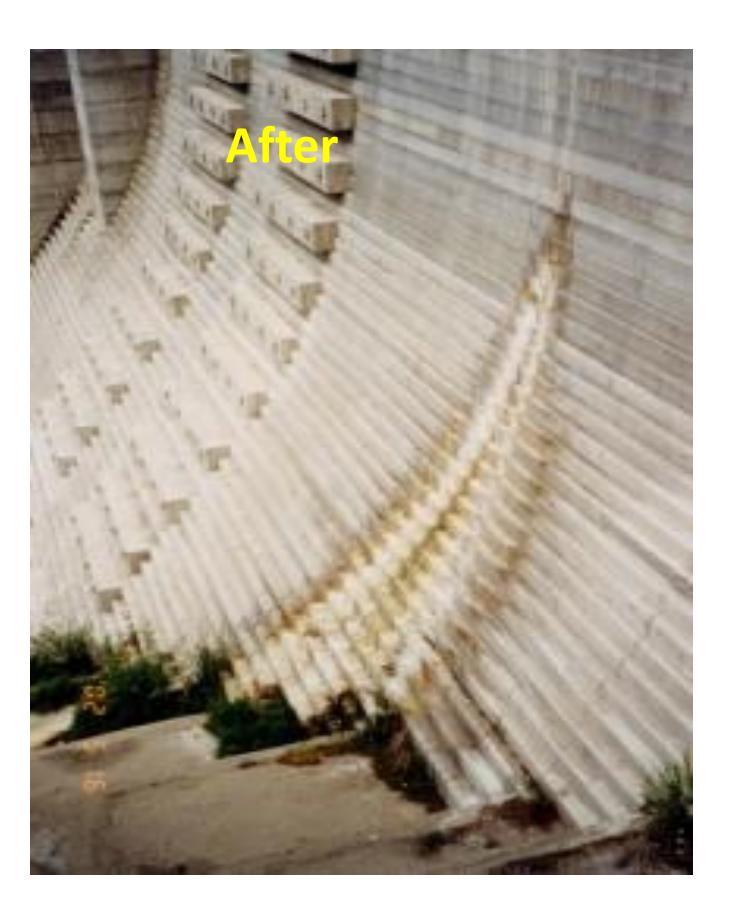
Platanovryssi 95 m high RCC dam Greece, 2001 Waterproofing of cracks in new concrete

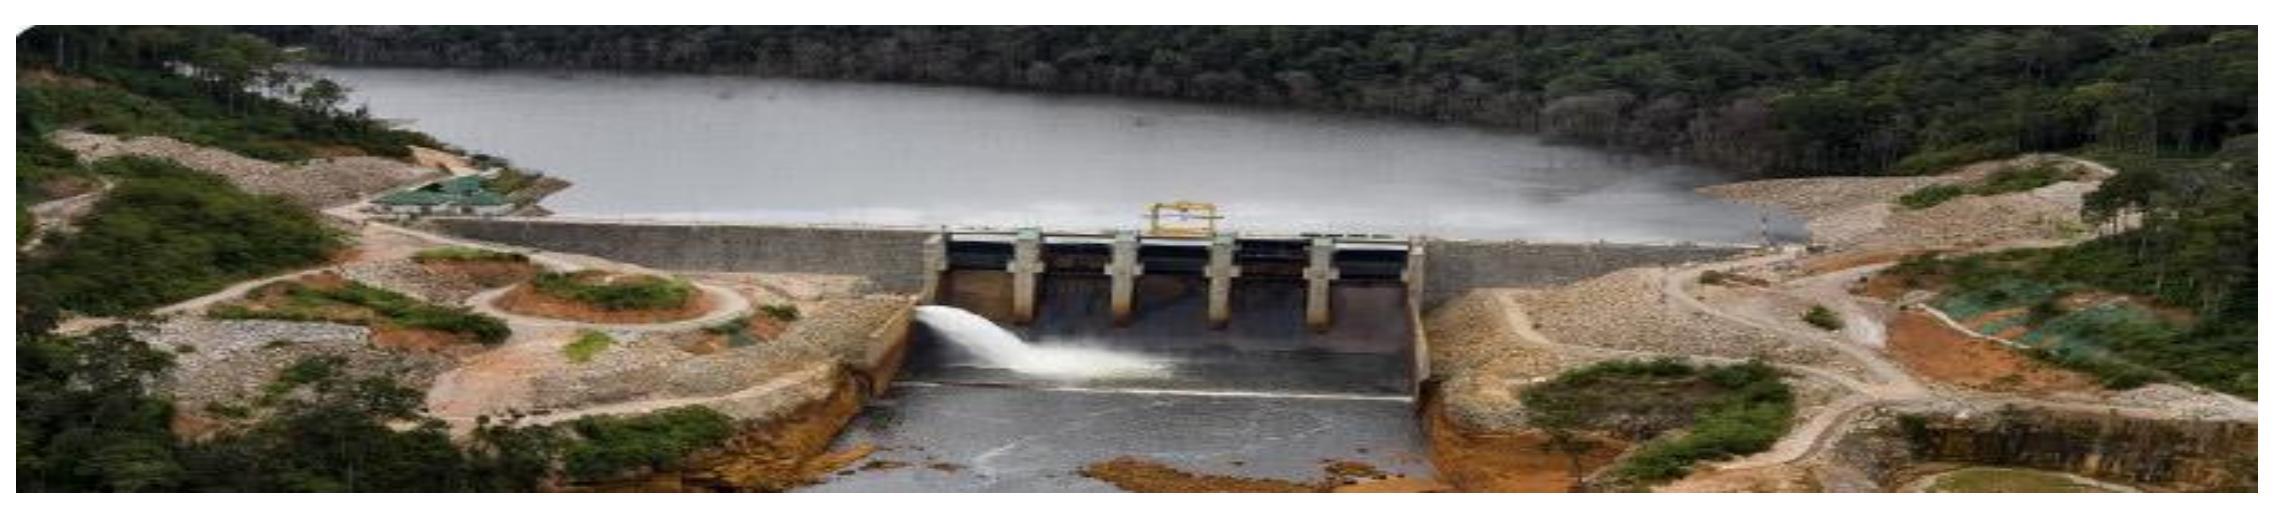
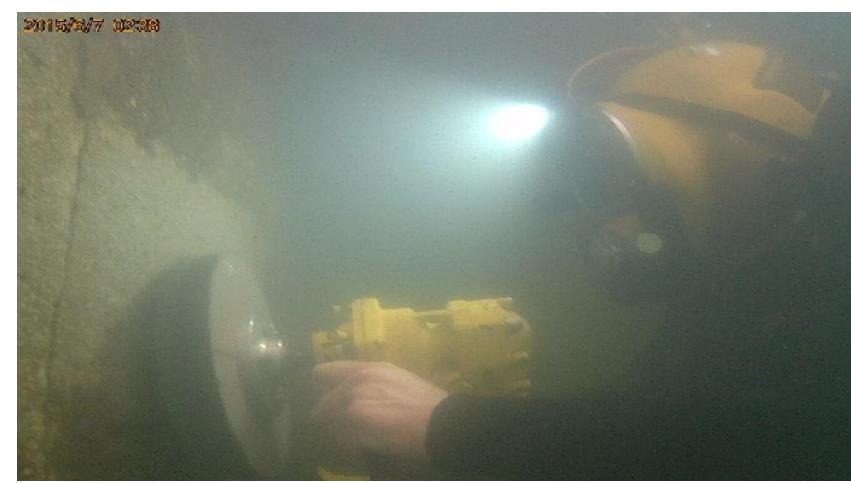
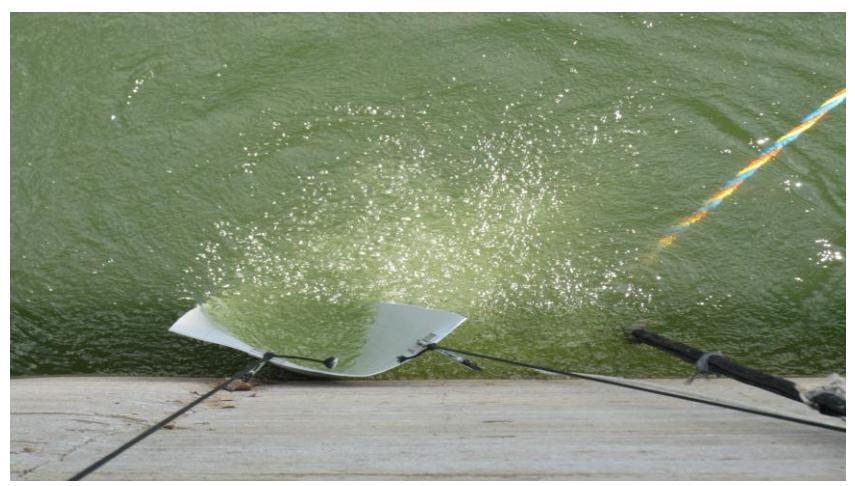
Nakai RCC dam, Laos 2016

Waterproofing of joints, holes, cracks

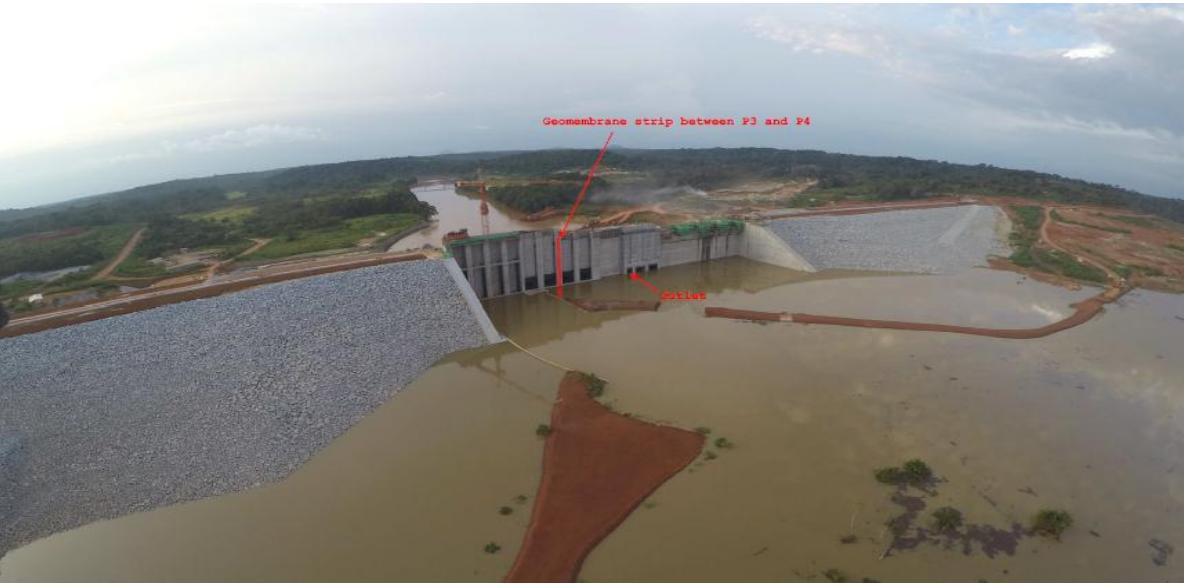
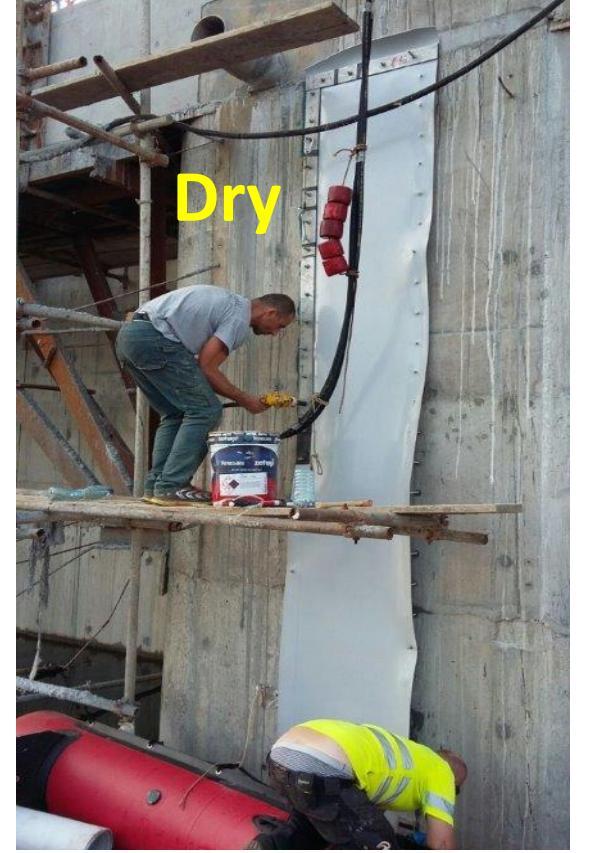
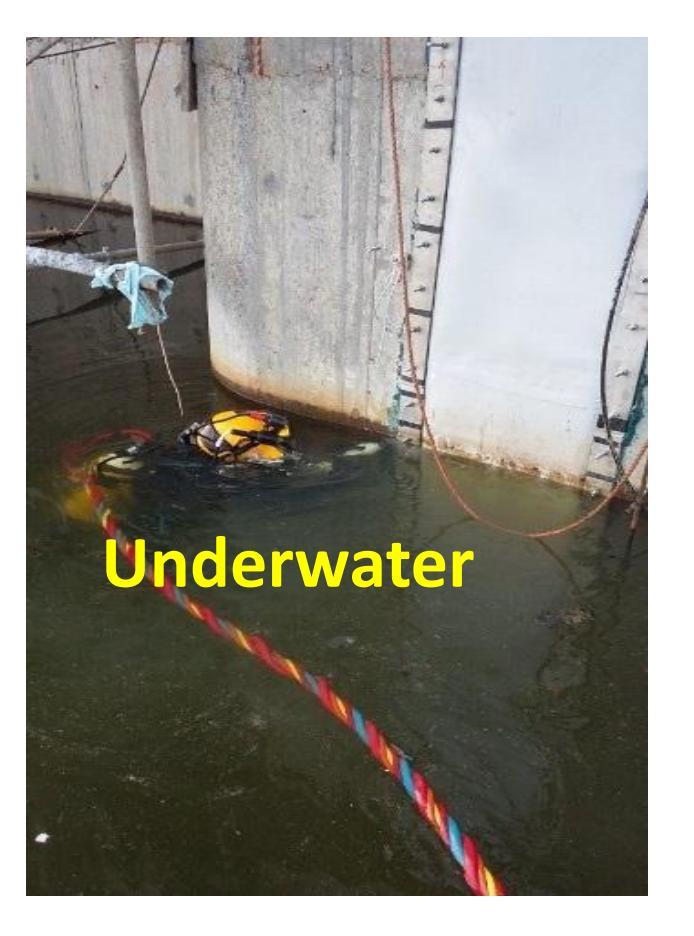
Lom Pangar embankment + RCC dam Cameroon, 2016

Waterproofing of joint
