Efficient Design and Usage of Synthetic Geomembranes for Wateproofing in Dams to restore Watertightness and increase service life of the structure

Jagadeesan Subramanian & Vinayagam Subramanian

September 14th – 16th 2023, Jaipur, Rajasthan

UPPER BHAVANI DAM

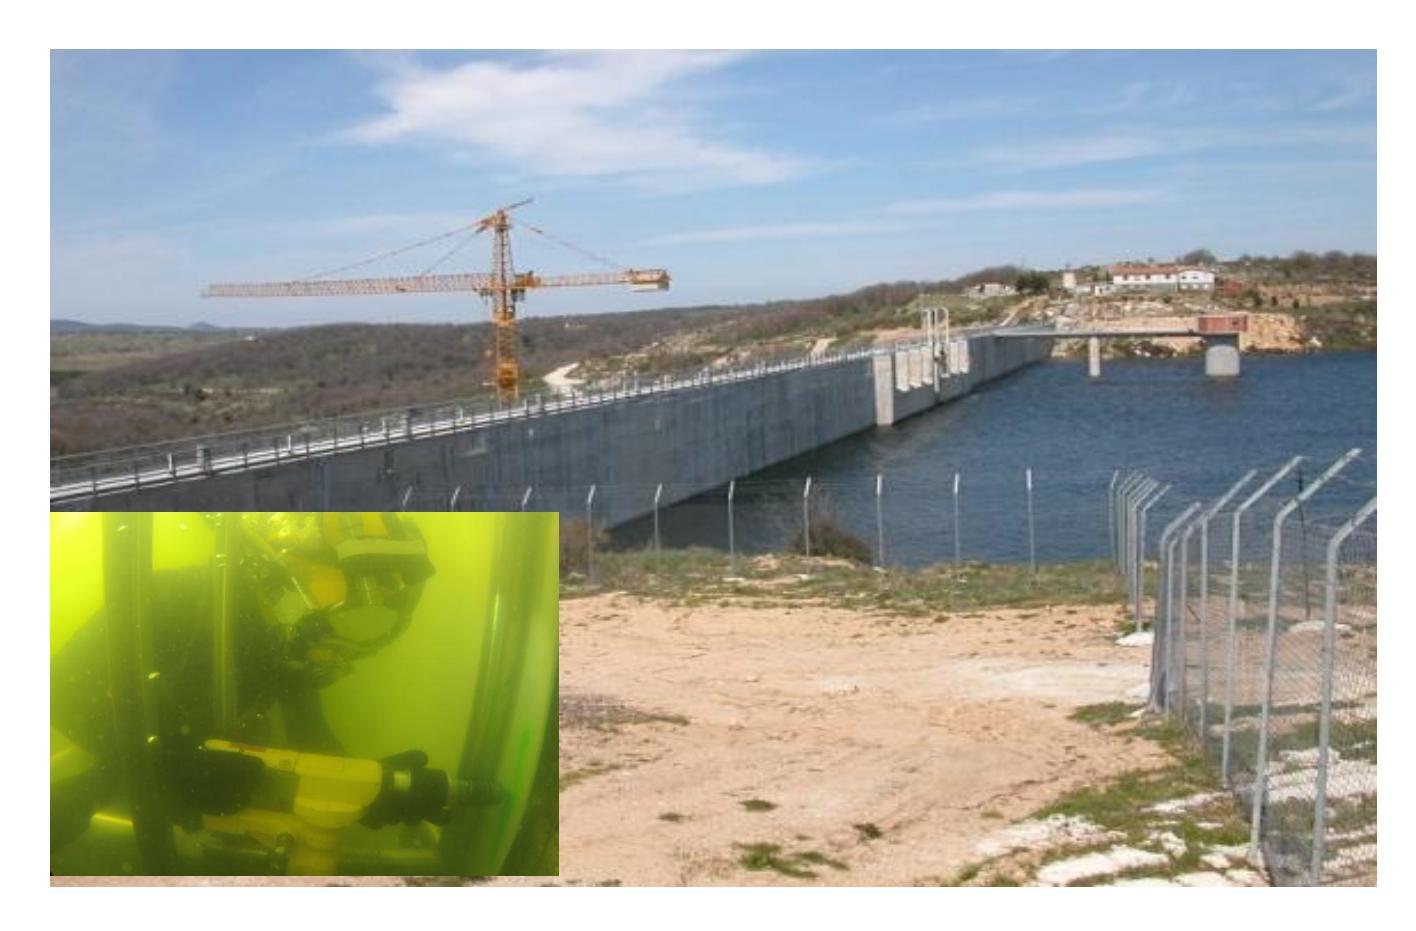
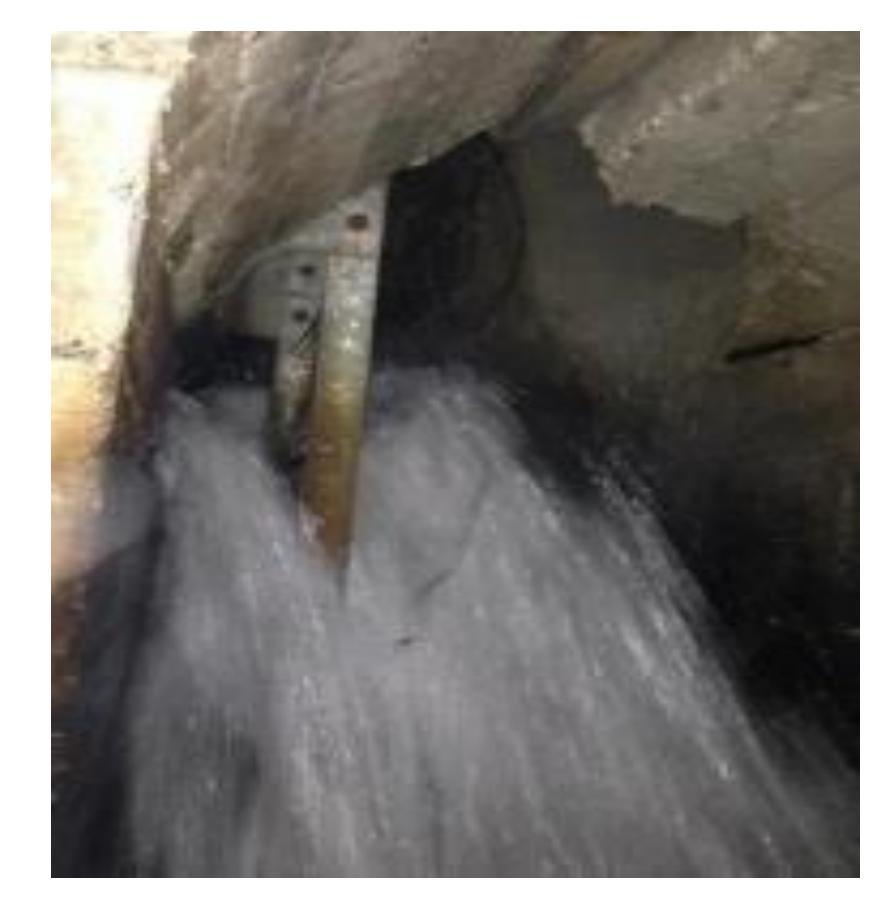
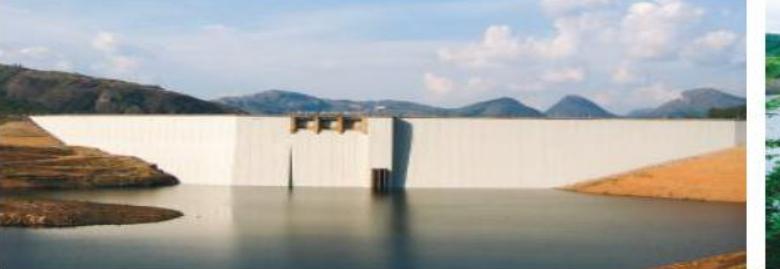
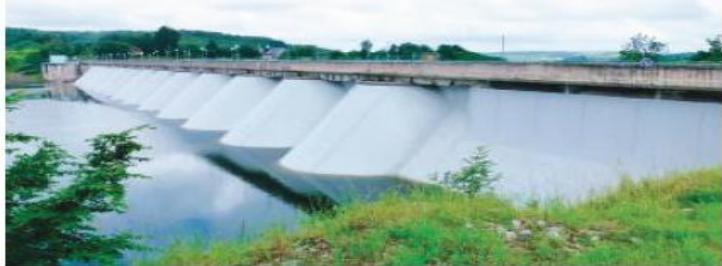
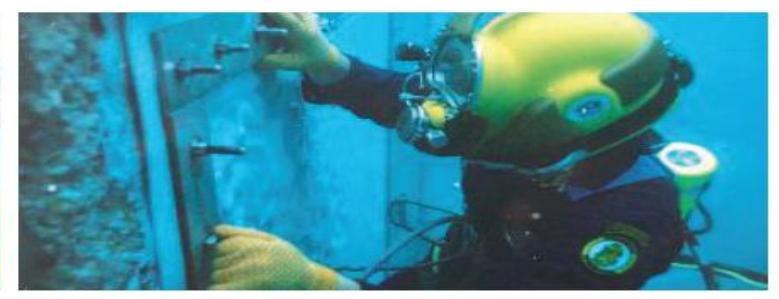
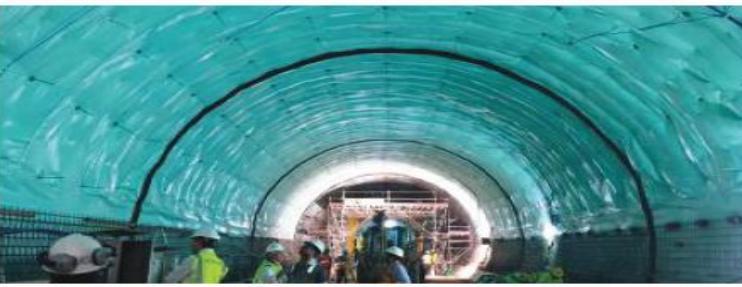
Olai gravity dam, Italy, 2013

Waterproofing of joints
