Inspection Manual for Dam Field Engineers after Seismic Events, Maithon Dam, Damodar Valley Corporation, Jharkhand

Doc. No. CDSO_MAN_DS_05_v1.0

February 2019

Prepared by
Japan Water Agency, Japan

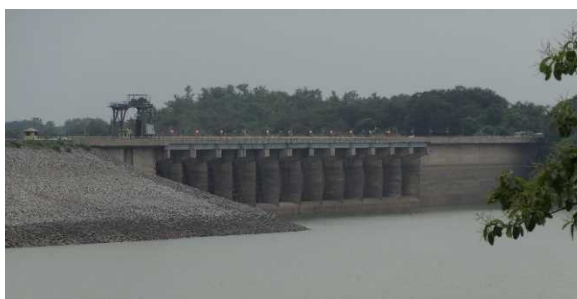
Upstream side of Maithon Dam.
12 spillway gates on the top

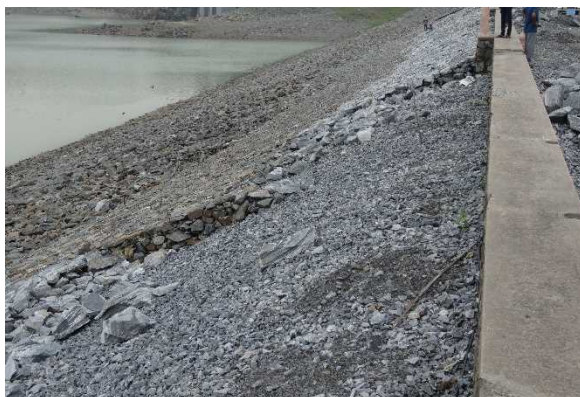
Under renovation of riprap financed by DRIP.

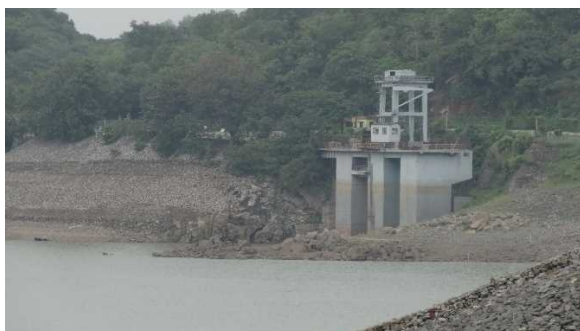
Intake tower for power generation which is one of the key assets for managing the dam.

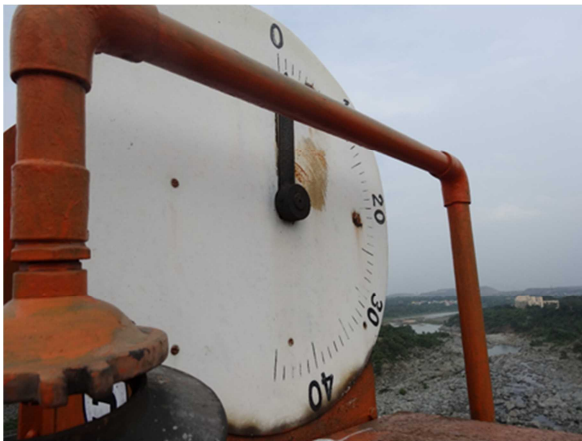
Gate opening meter

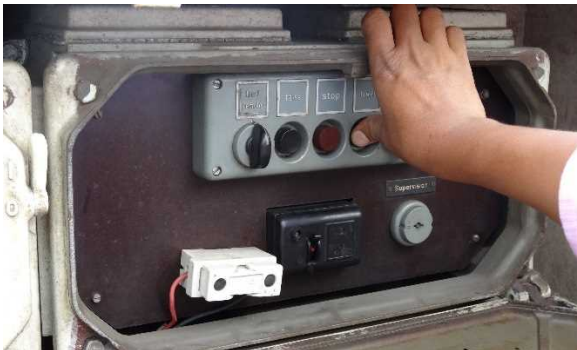
Switch box for gate operation at field

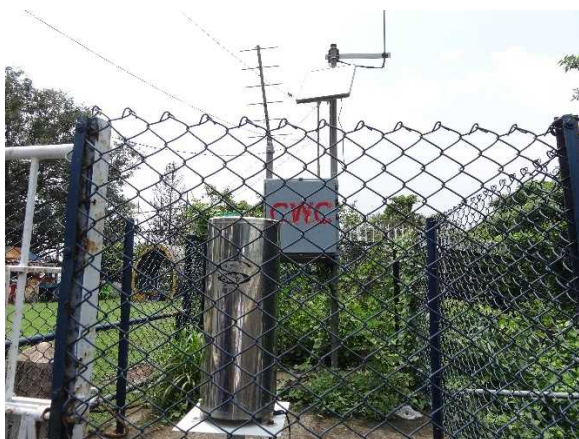
Together with water level, precipitation is also observed by and sent to CWC in Delhi.
